E7907A-03

S E R V I C E N O T E

E7907A 2-Port OC-3c/12c ATM/POS Routing Test Card

**Sometimes E7907A fails to power up.
Applies to any units not modified to A10 indicated by the label on the main
PCA as shown in Figure 1 and Figure 2.**

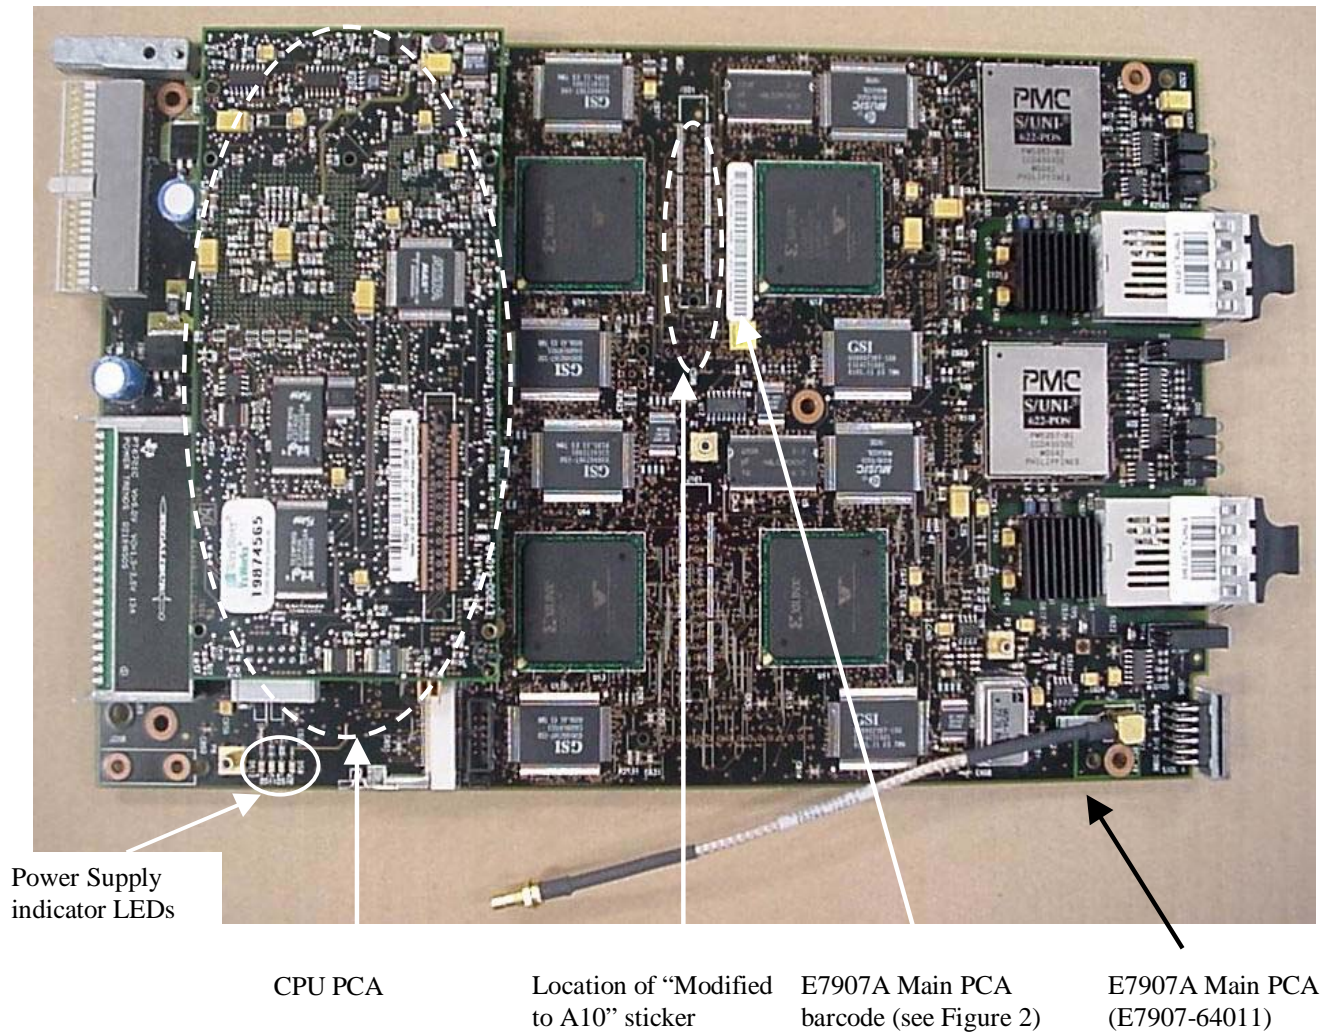
Figure 1 - Identification

The failure of the E7907A Test Card to power up is detected by the absence of any LED activity on the front panel of the Test Card. Alternatively, in an open RouterTester 900 4-Slot Chassis (E7900A) the power supply LED indicators (located at the rear left of the E7907A Test Card) fail to light when the Chassis is powered up, refer to Figure 1 on page 3.

1. Remove the E7907A Test Card from the E7900A Chassis.
2. Determine the current revision of the E7907A main PCA as follows (see Figure 1 below):
 - If a sticker is found on the E7907A main PCA indicating “Modified to A10” or “Modified A10”, no further work is required. Do not confuse with a potentially similar sticker on the CPU PCA.
 - If the E7907A main PCA barcode sticker indicates A10, no further work is required. Refer to Figure 2 below where the barcode sticker indicates PCA revision A09. In the absence of a “Modified to A10” sticker, the modification will be required.
 - The E7907A main PCA barcode sticker is generally located near U12, however on earlier versions of the PCA this sticker was randomly positioned on either side of the PCA by the Contract Manufacturer.
 - Do Not confuse the barcode sticker on the CPU PCA with that of the main E7907A PCA sticker.

16. Check that the E7907A TestCard power rail indication LEDs are all lit. Refer to Figure 1 on page 3 for their location on the main PCA. If any of these LEDs fail to light, re check the capacitor solder joints.
17. Check that the E7907A TestCard has correctly numbered up (refer to the Built In Self Test section of the E7900A service manual for further information).
18. Execute the Automated diagnostics section of the E7900A service manual with the E7907A TestCard in slot number one of the E7900A chassis to verify that operation of the E7907A TestCard.
19. End of process.

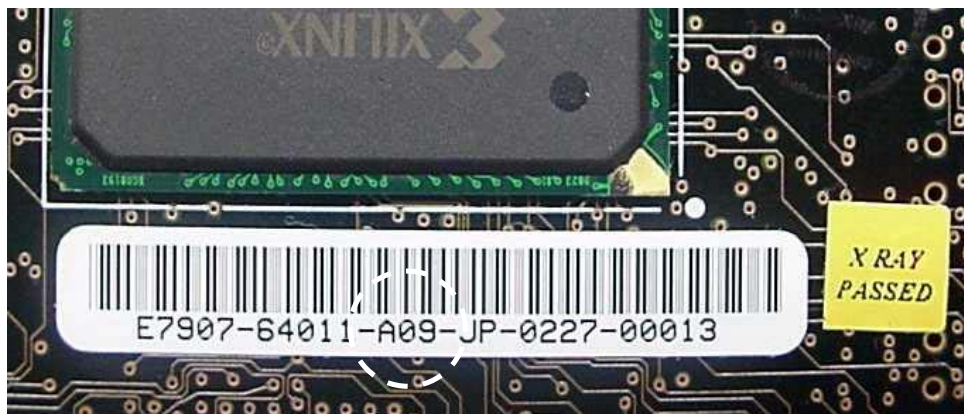
Figure 2 - E7907A PCA identification Barcode

PCA Modification / Revision number

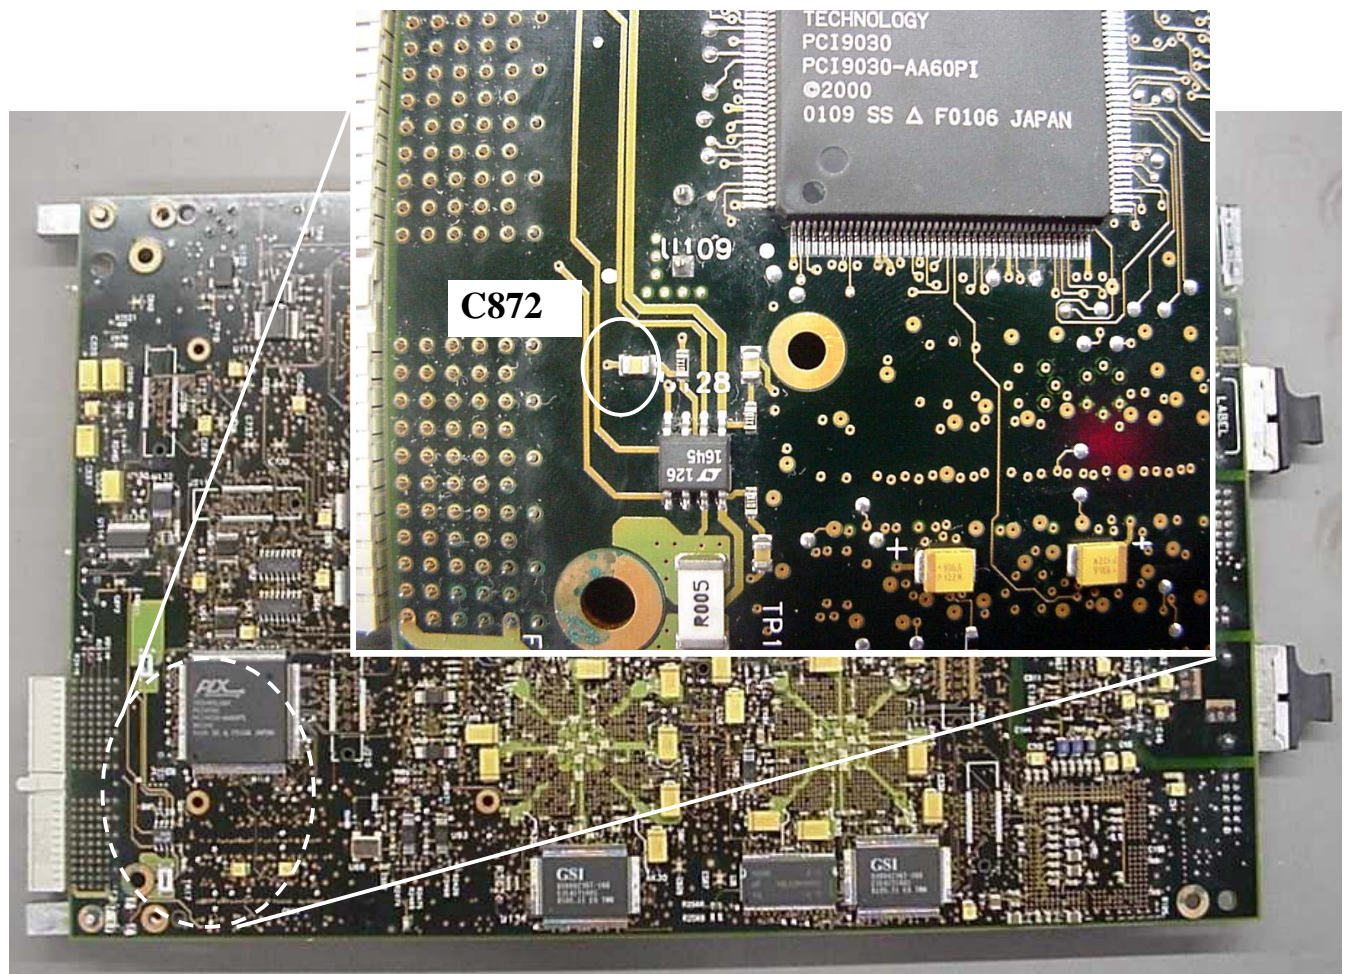
Figure 4 - Capacitor Identification for Replacement

6. The surface mount capacitor (C872) to be replaced can be located by referring to Figure 4 below.

7. Carefully remove C872 as identified in Figure 4 above. This part can be scrapped.
8. Carefully position and solder the new P/N 0160-7409, a 0.0068uF capacitor in place.
9. Carefully feed the two optical transceivers through the front panel, while holding the rear of the PCA clear of the metalwork standoff's to ensure no surface mount parts are dislodged.
10. Replace and retighten the six retaining screws.
11. Align the CPU PCA correctly with three connectors and firmly push down to make a solid fitting.
12. Replace and retighten the four retaining screws.
13. Feed the cable connector fitting through the front panel and retighten the retaining nut of the SMB connector.
14. Place a "Modified A10" sticker P/N E7907-00025 close to the E7907A Test Card PCA barcode, refer to Figure 1 on page 3 above for sticker location guide.
