**SN J1981B-01**

**S E R V I C E N O T E**

J1981B VQT

**Updated replacement of analog card for improved PESQ scores**

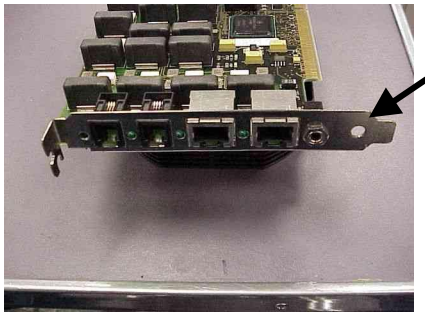
Adapting the Infineon ALIS FXO chipset for use in the E&M ports of the analog board results in extra circuit noise. This limits the maximum PESQ scores. Replacing this board with the modified assembly reduces the circuit noise and improves the possible PESQ scores when using the E&M ports.

Replace the analog FXO E&M card with the latest version. This, along with downloading the VQT application Software Version 4.1.1 or later. When the “defective” analog card is removed the metal grounding tab MUST be swapped to the new assembly.

Move metal tab to  
new assembly
