SN J1987A -02

S E R V I C E N O T E

J1987A RATS

Updated replacement of analog card for improved PESQ scores

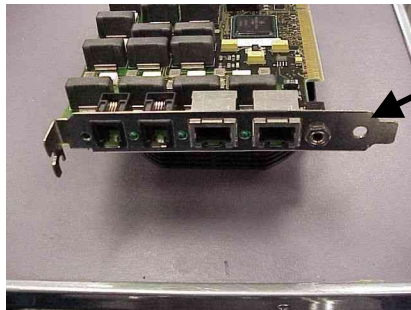
Adapting the Infineon ALIS FXO chipset for use in the E&M ports of the analog board results in extra circuit noise. This limits the maximum PESQ scores. Replacing this board with the modified assembly reduces the circuit noise and improves the possible PESQ scores when using the E&M ports .

Replace the analog FXO E&M card with the latest version. This, along with downloading the VQT application Software Version 4.1.1 or later. When the “defective” analog card is removed the metal grounding tab MUST be swapped to the new assembly.

Move metal tab to
new assembly.
