J2126A-01

S E R V I C E N O T E

Agilent J2126A Transmission Test Set

Failure of Optical Covers

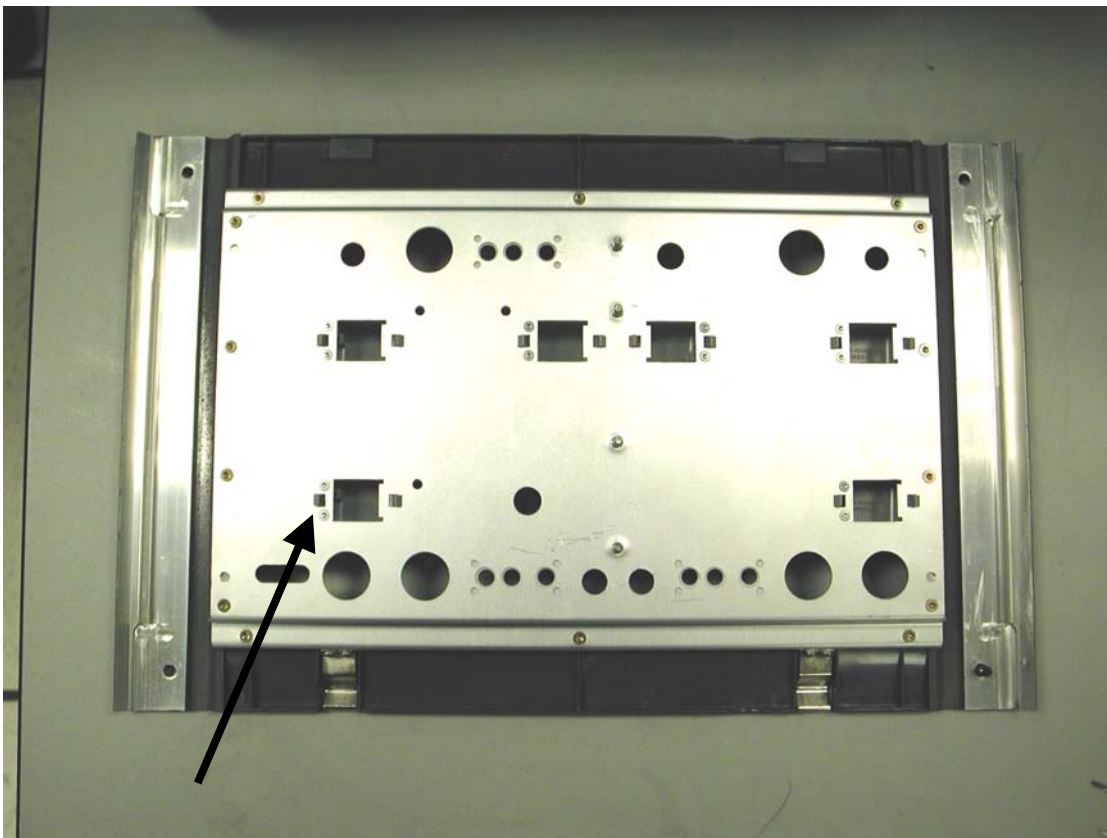
J2127A Instrument Panel - Reverse

1. Remove the instrument top panel by unscrewing the four corner screws.
2. Lift off the instrument top panel.
3. Each optical cover is secured to the instrument top panel by a lip on each leg of the cover and also by two screws attached to the base of each cover. See the example arrowed in the illustration below.

4. Remove the two screws from each cover first and then lever free one lip of the cover.
5. The cover should then lift free from the instrument panel.

6. Remove all the remaining covers.
7. Fit the replacement covers by performing the reverse of steps 4 to 6 taking care to position the covers as described below. Ensure the screws on the cover are tightened to a torque of 0.15nm maximum.
