J2126A-04A

S E R V I C E N O T E

J2126A AGILENT Transmission Test Set

Problems with ESD clips on the Clock and Electrical/Digital boards

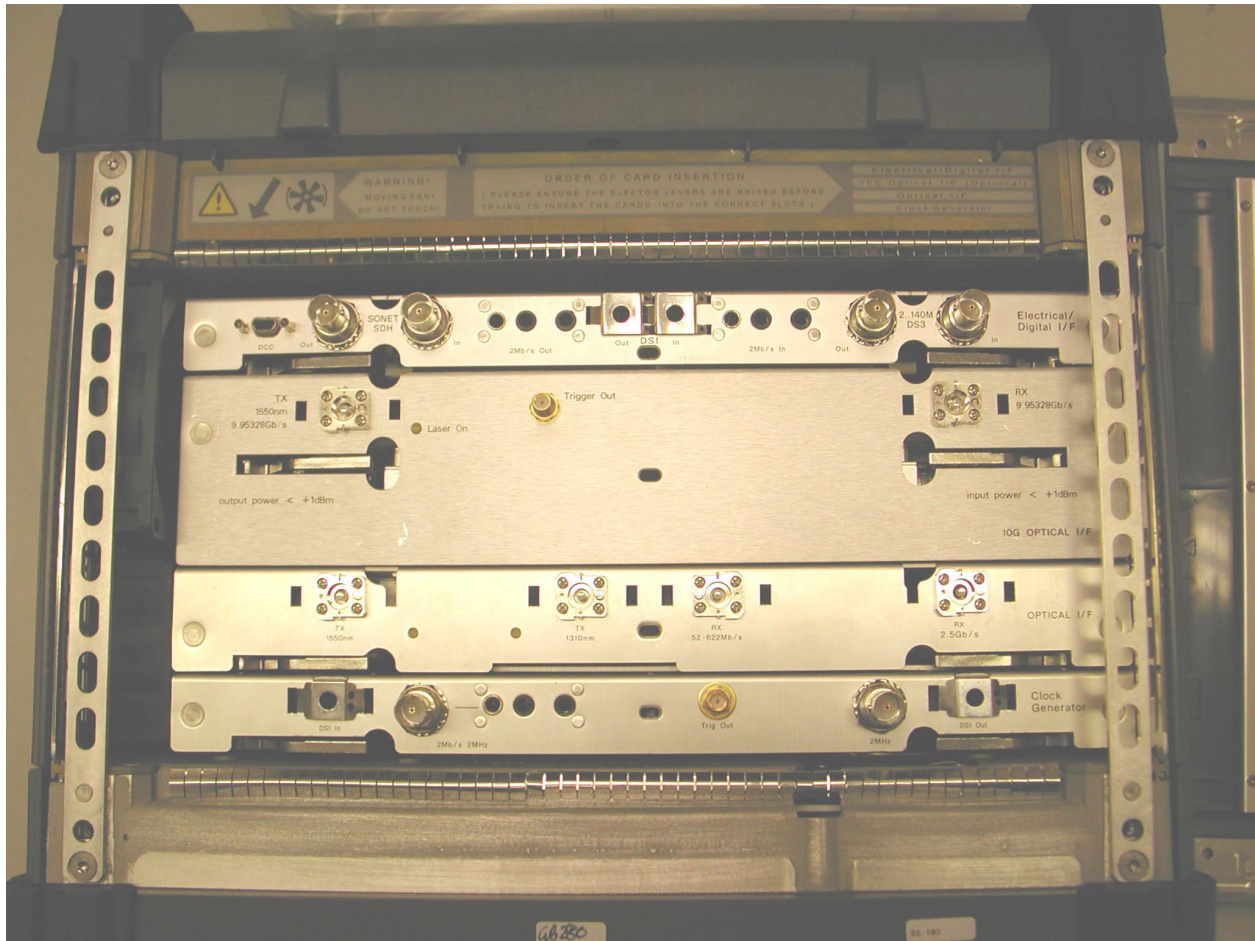
Figure 1 Location of ESD Clips

On early shipment of units we have experienced some problems when inserting or removing a bantam cable connector to the DS-1 ports on the Clock board and the Electrical/Digital board. The DS1 port on the boards are fitted with ESD clips and some instruments may be fitted with the wrong size clips. This causes the cable connector to scrape against the clips, leading to small metal scrapings falling into the instrument.

1. Unscrew the torque #15 screws at each corner of the top panel.
2. Remove the top panel.
3. Check that the ESD clips are properly aligned with the holes on the board panels.
4. Insert and remove the DS1 bantam cable into all of the ESD clips.
5. If the cable moves in and out smoothly, replace the top cover and retry.
6. If the cable still requires pressure to insert and remove, replace the clips using a suitable tool such as tweasers.

Note 1: To remove the clips, lever out one side first and then the other. To fit a new clip, fit one side of the clip first and then the other.

Note 2: When the clips are being replaced, the boards should be removed and the inside of the instrument inspected for any small pieces of metal scrapings. These should be removed before refitting the boards.
