J2126A-08

S E R V I C E N O T E

Agilent J2126A Transmission Test Set

Incorrect operation of Signal Wizard at STM-0 due to incorrect fitting of resistors

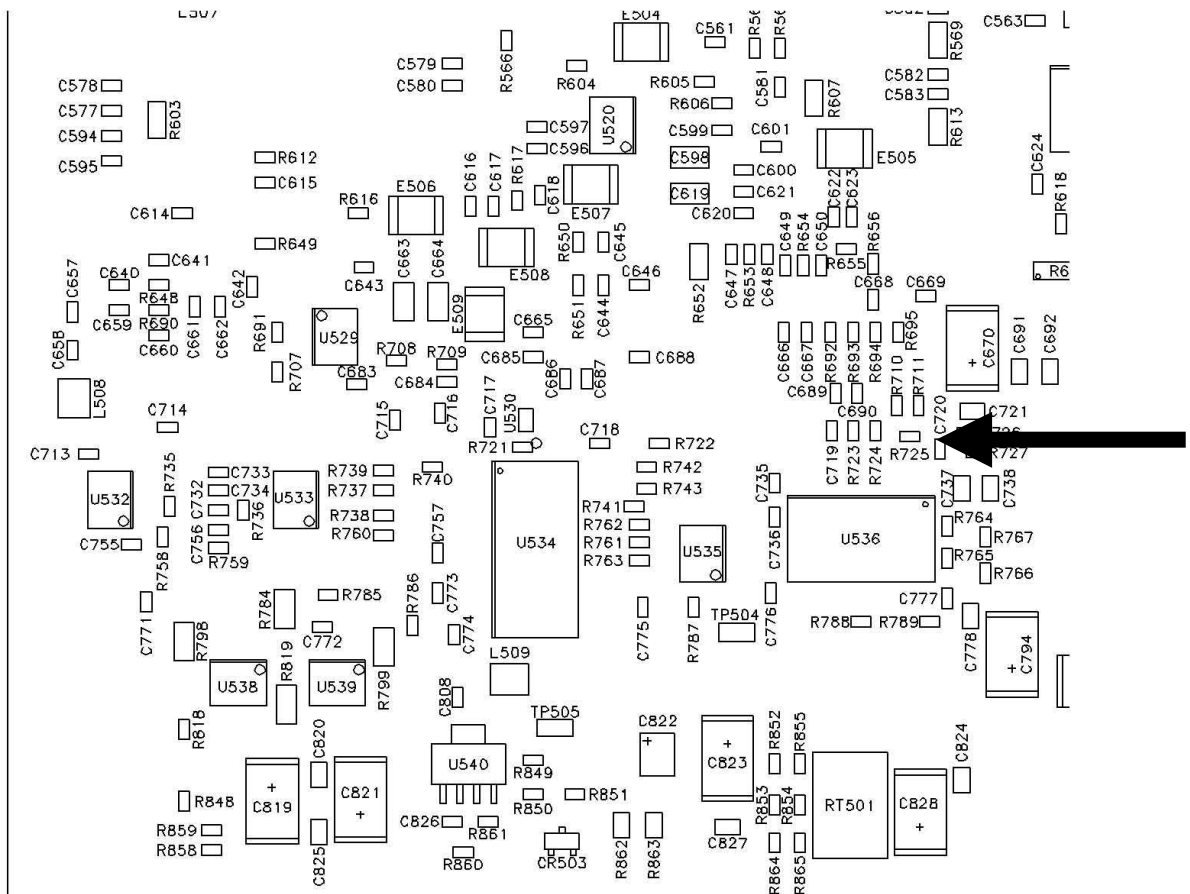
Location of R725 on J2125-63003 Board

A batch of instruments were shipped with the wrong value resistors fitted to the Digital Board (p/n J2125-63003). This causes incorrect operation of the instrument's Signal Wizard feature at the STM-0 signal rates. All other signal rates are unaffected.

5. Replace R725 with 100 ohm resistor 0699-3924 and resistor R797 with 0 ohm resistor 0699-3574.
6. Replace the Digital Board and instrument covers by performing the reverse of steps 1 to 3. Ensure the screws on the cover are tightened to a torque of 0.15Nm maximum. Ensure the screws securing the instrument top cover are tightened to a torque of 2.8Nm
7. End of procedure.
