J2127A-01

S E R V I C E N O T E

Agilent J2127A Transmission Test Set

Failure of Optical Covers

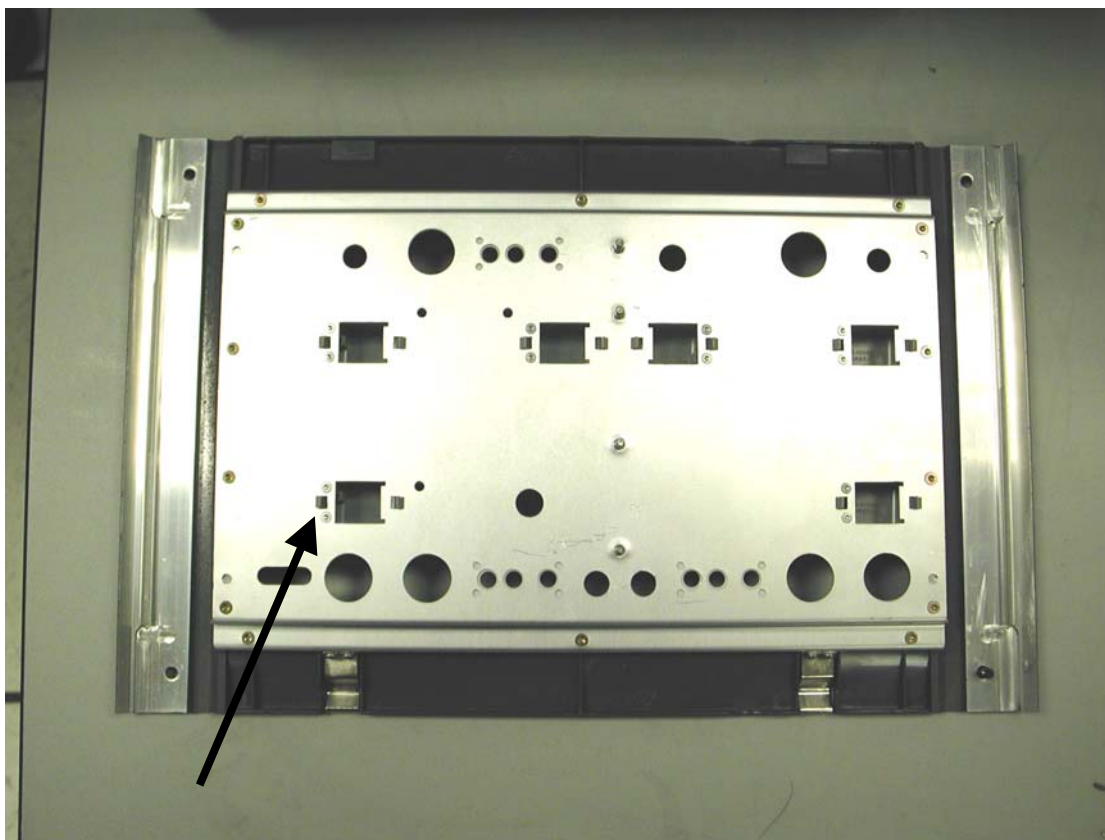
J2127A Instrument Panel - Reverse

Early shipments of the J2127A Test Sets have a design problem with the optical covers, which makes them prone to cracking.

1. Remove the instrument top panel by unscrewing the four corner screws.
2. Lift off the instrument top panel.
3. Each optical cover is secured to the instrument top panel by a lip on each leg of the cover and also by two screws attached to the base of each cover. See the example arrowed in the illustration below.

Replace all existing covers with new, more rugged cover.

4. Remove the two screws from each cover first and then lever free one lip of the cover.
5. The cover should then lift free from the instrument panel.

6. Remove all the remaining covers.
7. Fit the replacement covers by performing the reverse of steps 4 to 6 taking care to position the covers as described below. Ensure the screws on the cover are tightened to a torque of 0.15nm maximum.

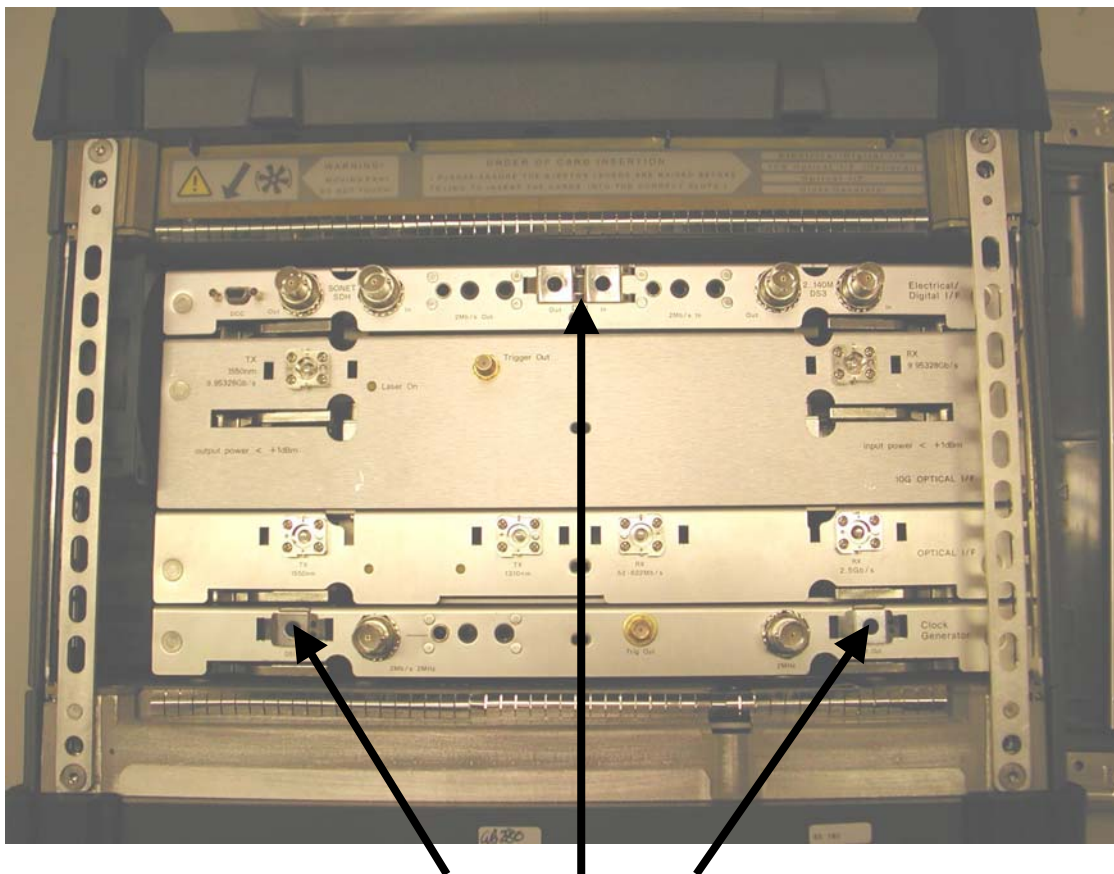
Instrument ESD Inserts

8. Before re-fitting the instrument top panel perform the following checks.
 - a) Check ESD inserts, as shown below, are properly aligned with the DS1 connector sockets.

- b) Replace any damaged inserts, using a suitable tool, such as narrow tweasers.
 - c) When removing any ESD inserts, lever out one side first and lift out the insert.
 - d) To fit a new insert locate one side of the insert first, then locate the other side.
9. Re-check the ESD insert alignment and then refit the instrument top panel.
 10. Ensure the screws securing the instrument top cover are tightened to a torque of 2.8Nm
 11. Finally, using a DS1 Bantam plug, check that there is no friction from the ESD insert as the plug is inserted into each of the DS1 sockets.
 12. End of procedure.
