J2127A-04A

S E R V I C E N O T E

J2127A AGILENT Transmission Test Set

Problems with ESD clips on the Clock and Electrical/Digital boards

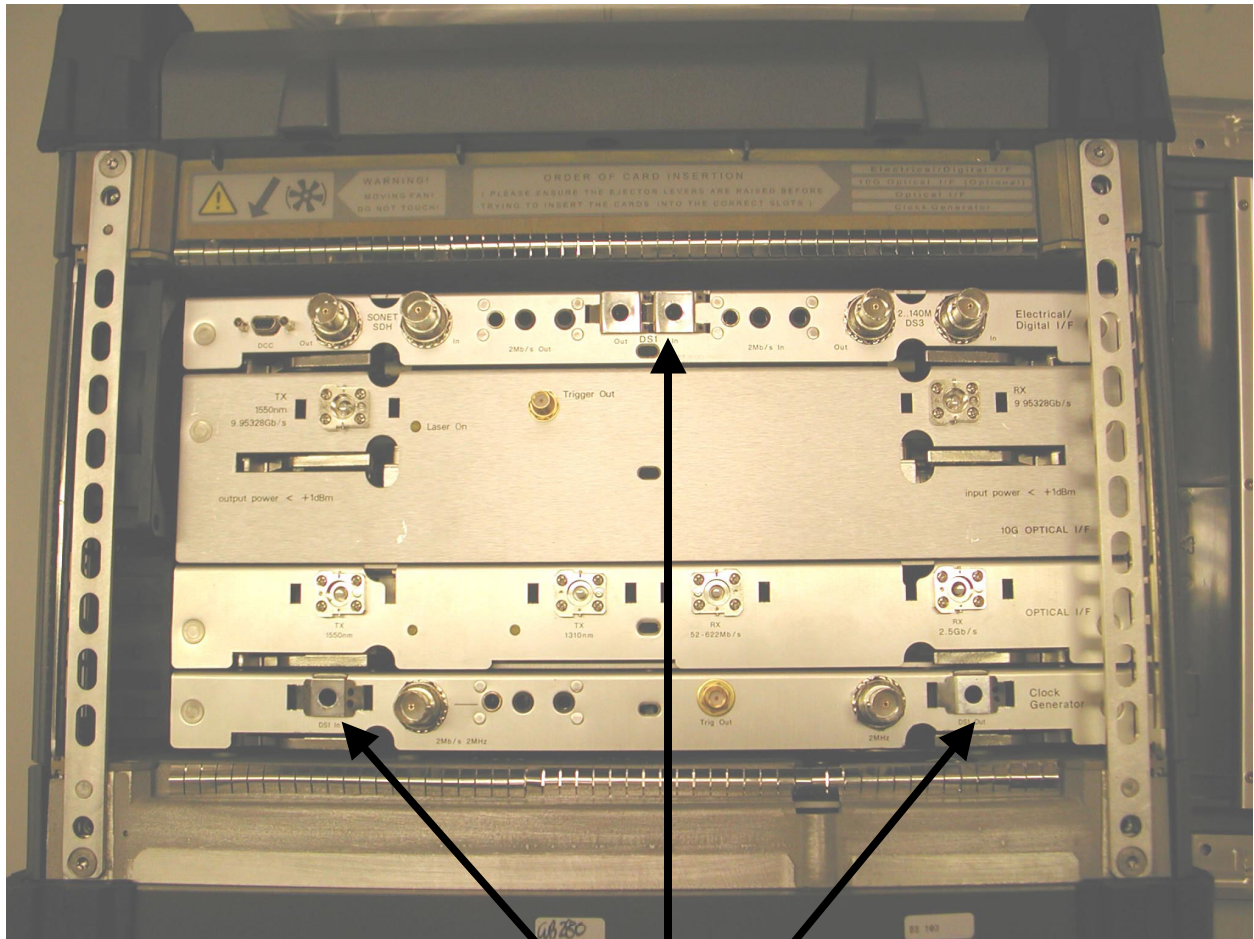
Figure 1 Location of ESD Clips

On early shipments of units we have experienced some problems when inserting or removing a bantam cable connector to the DS-1 ports on the Clock board and the Electrical/Digital board. The DS1 port on the boards are fitted with ESD clips and some instruments may be fitted with the wrong size clips. This causes the cable connector to scrape against the clips, leading to small metal scrapings falling into the instrument.

1. Unscrew the torque #15 screws at each corner of the top panel.
2. Remove the top panel.
3. Check that the ESD clips are properly aligned with the holes on the board panels.
4. Insert and remove the DS1 bantam cable into all of the ESD clips.
5. If the cable moves in and out smoothly, replace the top cover and retry.
6. If the cable still requires pressure to insert and remove, replace the clips using a suitable tool such as tweasers.

Note 1: To remove the clips, lever out one side first and then the other. To fit a new clip, fit one side of the clip first and then the other.

Note 2: When the clips are being replaced, the boards should be removed and the inside of the instrument inspected for any small pieces of metal scrapings. These should be removed before refitting the boards.
