J2127A-08

S E R V I C E N O T E

Agilent J2127A Transmission Test Set

Incorrect operation of Signal Wizard at STM-0 due to incorrect fitting of resistors

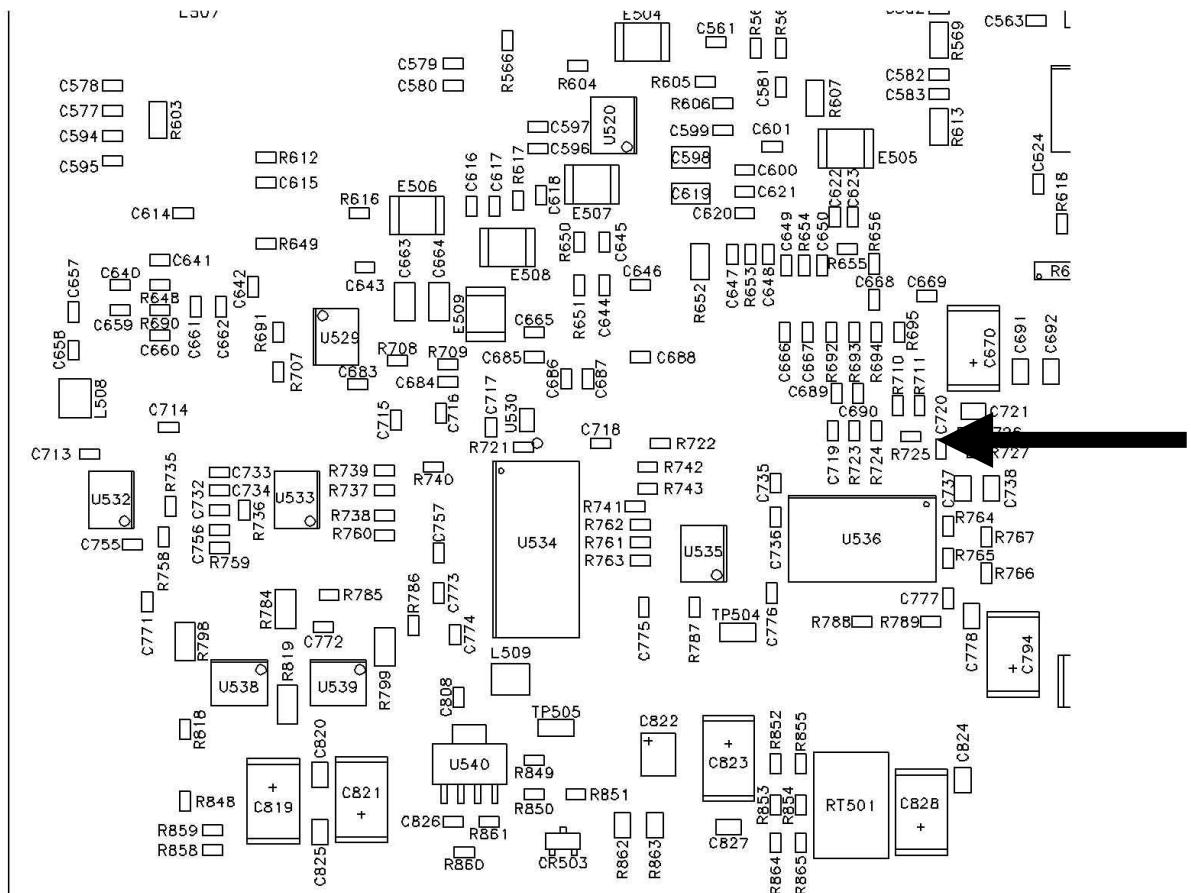
Location of R725 on J2125-63003 Board

A batch of instruments were shipped with the wrong value resistors fitted to the Digital Board (p/n J2125-63003). This causes incorrect operation of the instrument's Signal Wizard feature at the STM-0 signal rates. All other signal rates are unaffected.

5. Replace R725 with 100 ohm resistor 0699-3924 and resistor R797 with 0 ohm resistor 0699-3574.
6. Replace the Digital Board and instrument covers by performing the reverse of steps 1 to 3. Ensure the screws on the cover are tightened to a torque of 0.15Nm maximum. Ensure the screws securing the instrument top cover are tightened to a torque of 2.8Nm
7. End of procedure.
