S E R V I C E N O T E

E1401A VXI C-Size High-Power Mainframe

Serial Numbers: 3227A00101 / 3227A00267

Modification to prevent random system resets.

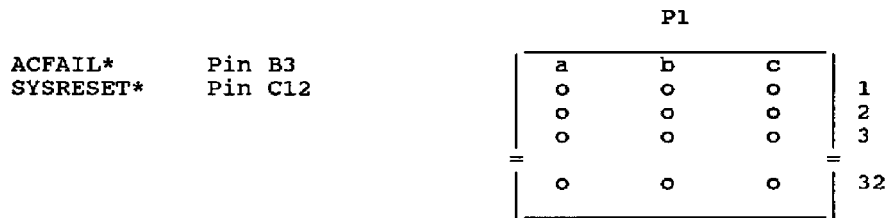
The cause of these random apparent failures may be noise on the system reset line (SYSRESET*) and/or the AC fail line (ACFAIL*) on the VXI backplane caused by inductive coupling in these signal lines from the fan power supply cable. These TTL lines are tied high (about +4 vdc), and are pulled low (< +1 vdc) when true. Noise spikes may drop the level low enough to cause reset to occur. The noise may be observed by monitoring these two signal lines on the 25-pin Sub-D connector on the rear panel of the E1401A (pin #10 is SYSRESET* and pin #23 is ACFAIL*). The signals can also be monitored on the front side of any one of the P1 (upper row) backplane 96-pin slot connectors:
