## S E R V I C E N O T E

**8751A Network Analyzer**

**Modification to fix the intermittent lock up/PRESET operation**

DATE: 16 December 1991

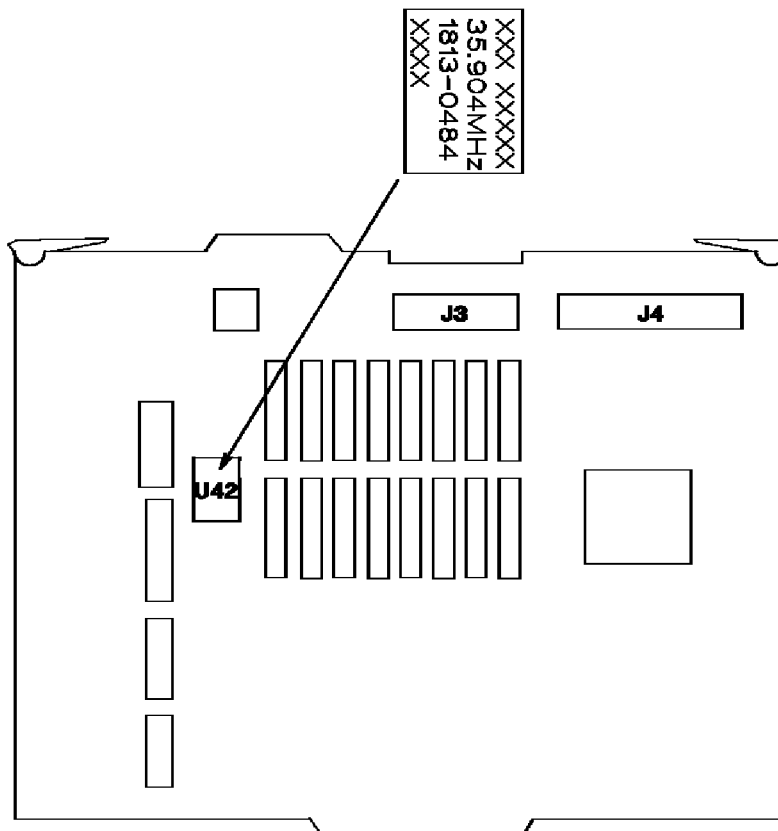
Figure 1. A51U42 Location

8751As may intermittently lock up, or perform unexpected PRESET operations suddenly, if a X'tal OSC (pn 1813-0484) is used at A51U42 on the 8751A A51 GSP board.

This will be caused by the A51U42 X'tal OSC which does not oscillate properly.

1. Remove the top cover from the 8751A.
2. Remove two screws restraining a plate over the A51 assembly, and remove the plate.
3. Disconnect all cables from the A51 assembly.
4. Remove A51 assembly from the 8751A.
5. Check if "1813-0484" is tagged on the A51U42 X'tal OSC component as shown in Figure 1. If it's written, replace the A51 board.

Perform the following procedure to check if the X'tal OSC (pn 1813-0484) is used at A51U41. If the X'tal OSC (pn 1813-0484) is used, replace the A51 board with new one.

6. Reassemble the 8751A.
7. After the A51 assembly is replaced, perform the display background adjustment.  
The adjustment procedure is provided in Chapter 2 of the 8751A Service Manual (pn 08751-90031). No performance test is required after the A51 replacement.
