S E R V I C E N O T E

87510A Gain-Phase Analyzer

Modification prevents the 87510A from hanging up or generating an unexpected reset**To Be Performed By:** Agilent-Qualified Personnel**Parts Required:**

DATE: 13 June 1994

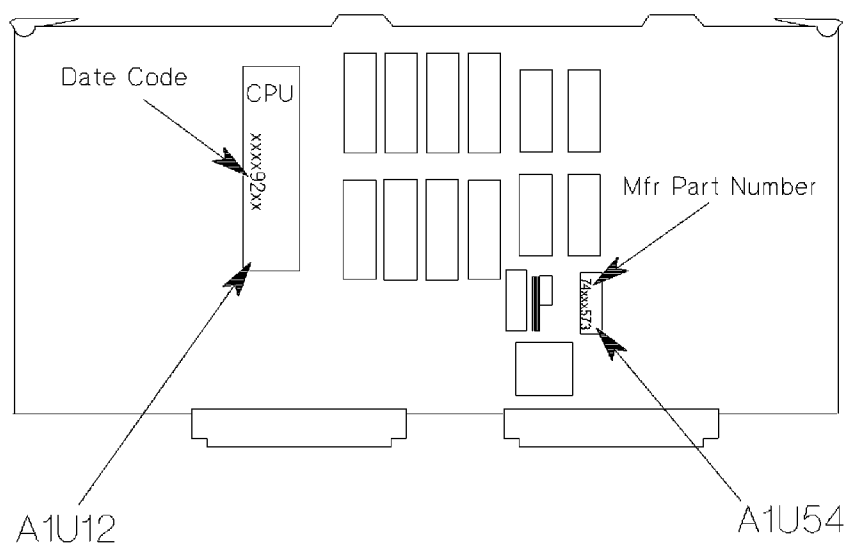
Figure 1. A1 Board Parts Location

If the Date Code of the A1U12 is "92xx" and the Mfr Part Number of the A1U54 is "74F573" or "74BCT573", the address error may occur, which hangs up the 87510A or generates an unexpected reset.

1. Disconnect the power cable from the 87510A.
2. Remove the top cover and the shield plate from the 87510A.
3. Remove the A1 board from the 87510A.
4. Check the Date Code of the A1U12 and the Mfr Part Number of the A1U54.
(The Date Code and the Mfr Part Number are printed on each part. See Figure 1.)

Replace the A1U54 with the new one (Mfr Part Number: 74ABT573, Part Number: 1820-8885).

5. Remove the old A1U54 (Mfr Part Number: 74F573 or 74BCT573).

6. Install the new A1U54 (Mfr Part Number: 74ABT573, Part Number 1820-8885)
7. Reinstall the A1 board in the 87510A.
8. Turn the 87510A ON and confirm the “POWER ON TEST FAILED” message is NOT displayed.
9. Turn the 87510A OFF.
10. Reinstall the shield plate and the top cover on the 87510A.
