E8363A-03

S E R V I C E N O T E

E8363A PNA Microwave Network Analyzers

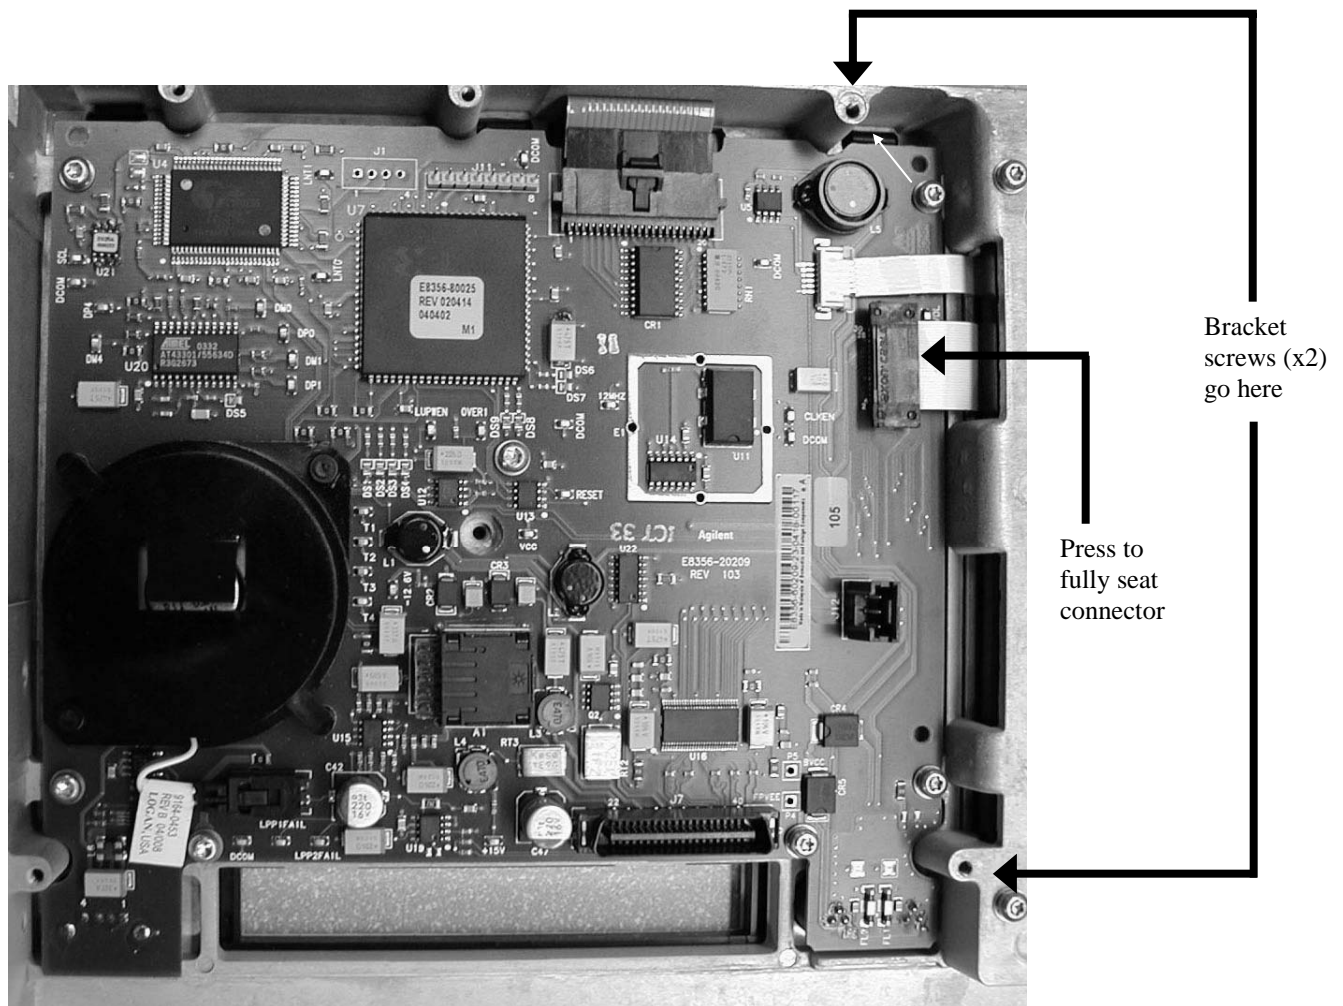
Figure 1: A3 Front Panel Interface Board Assy without the Bracket

A connector of the ribbon cable (Agilent part number 8120-8409) that joins the front panel display to the front panel interface board can loosen, causing a display failure, unless a new bracket is installed. Because the failure rate has been very low, it is recommended that the bracket be installed only when there is an additional reason to remove the PNA front panel.

1. Refer to Figure 1 in this document:
 - Press down firmly on the ribbon cable's black connector.
 - Locate the two tapped holes for the bracket screws.
2. As shown in Figure 2 in this document, position the bracket so that its holes line-up with the two holes you located in the previous step.
3. Hand-start the two screws, and then torque both to 9 in-lbs.
4. Reinstall the PNA Front Panel by following the Service Guide instructions in the "Replacement Procedure." This is located on the same page as the "Removal Procedure" used previously in step 7.
