E8364A-01C**S E R V I C E****N O T E**Supersedes:
E8364A-01B**E8364A PNA Series RF Network Analyzers**

Serial Numbers: 00000000 thru 46999999

December 6, 2007

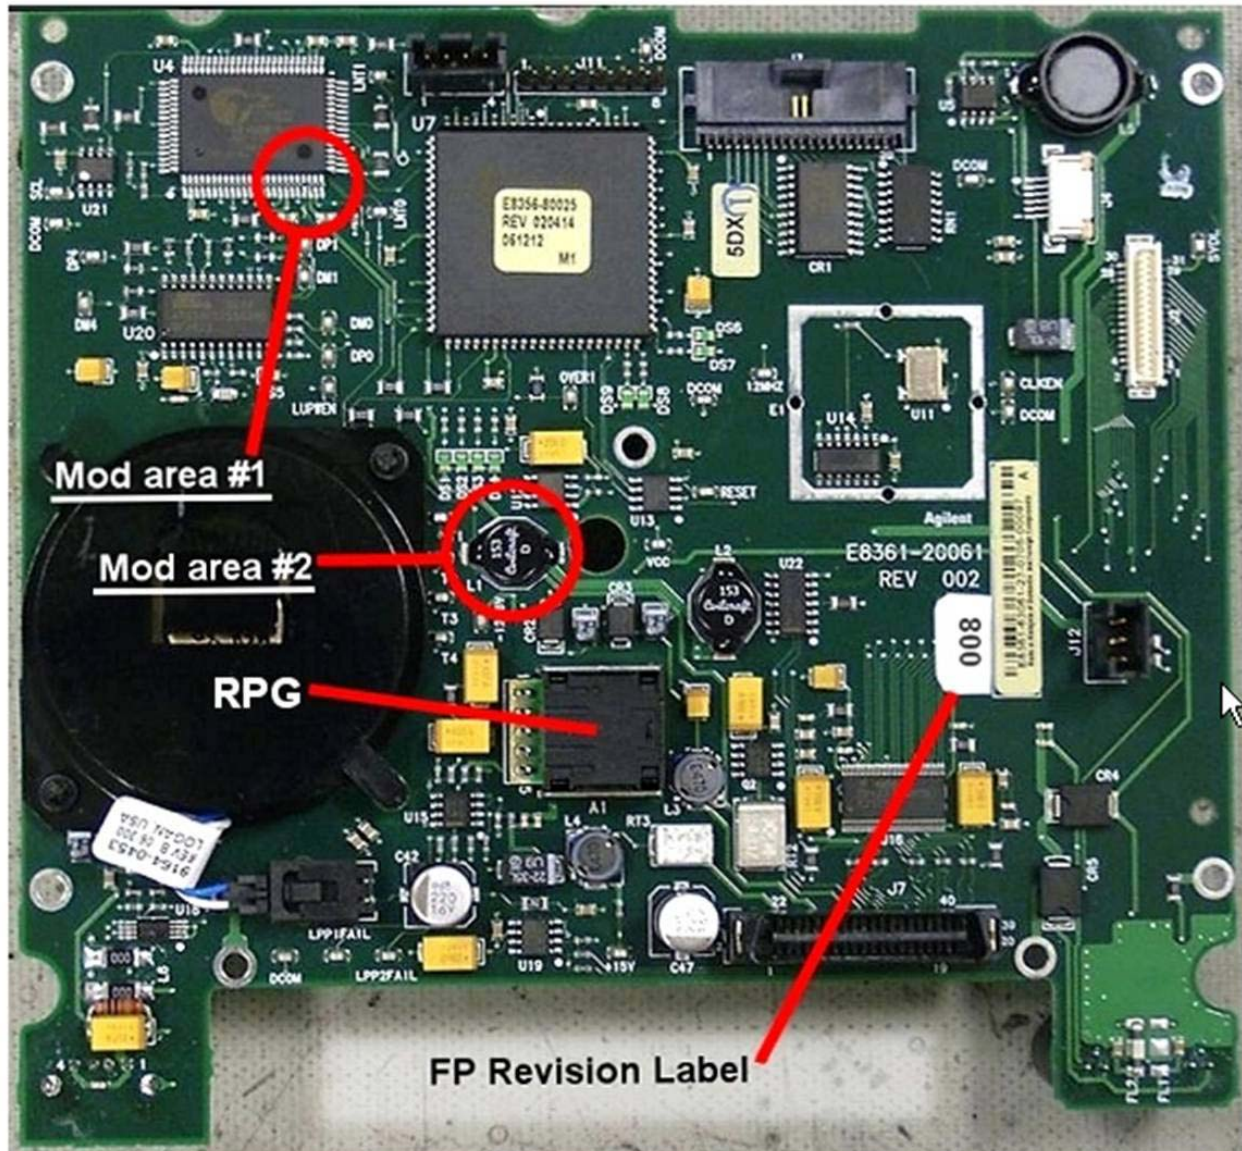
Refer to Figure 1 for the two modification areas to be addressed. Note that while this picture happens to show the FPI board completely removed from the front frame assembly, this is not necessary to perform the required modifications.

- Modification #1 consists of shorting two pins of U4 together with a small amount of solder.
- Modification #2 consist of removing L1.

Carefully solder pins 21 and 22 together on U4. Refer to Figure 2 for the exact location. Use care so that no other pins are shorted. Use of a very fine tip soldering iron is recommended and a large work-task magnifying glass is very helpful.

Unsolder and completely remove the black surface mount inductor L1 from the front panel assembly board. This is no longer needed and can be discarded.

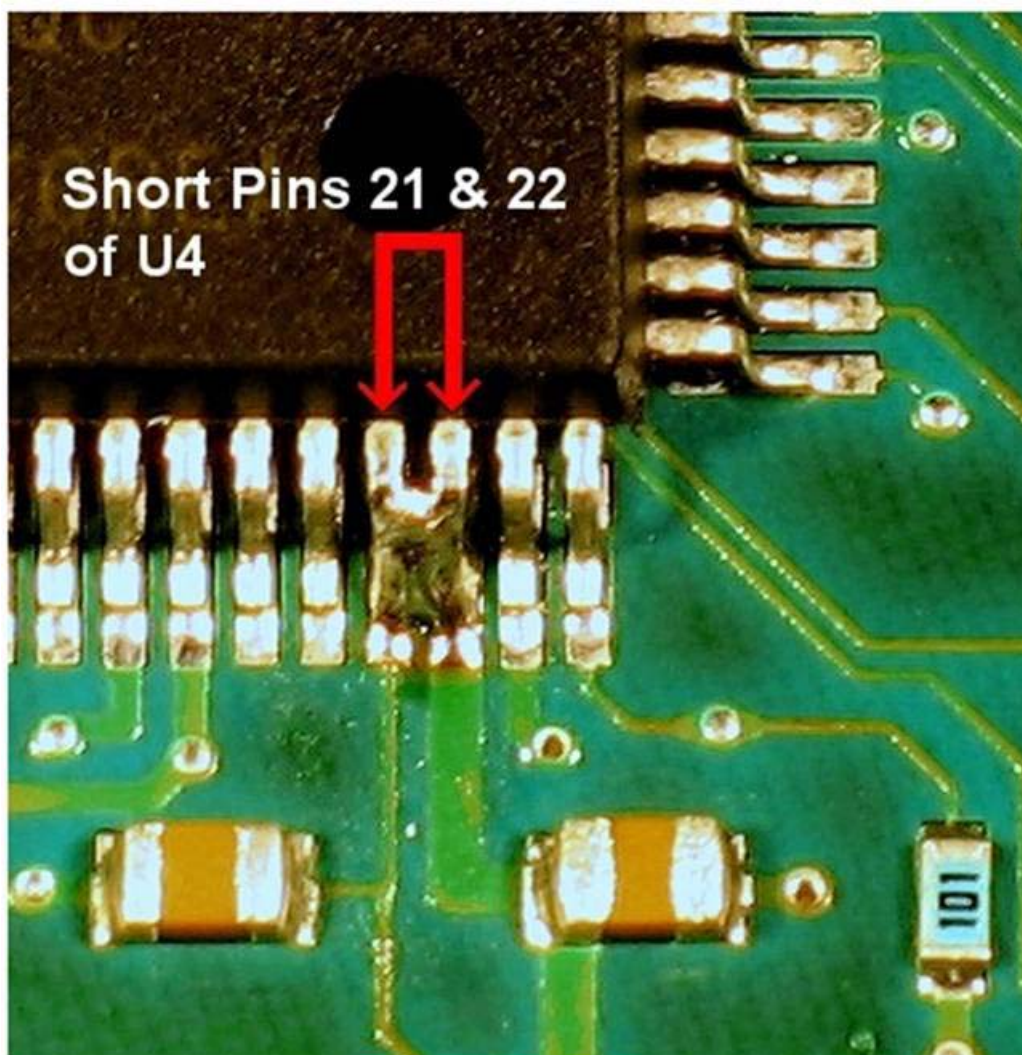
Figure 2

Both intermittent problems have been traced to an incorrect voltage applied to a pin on the U4 IC.
