E8364A-03

S E R V I C E N O T E

E8364A PNA Microwave Network Analyzers

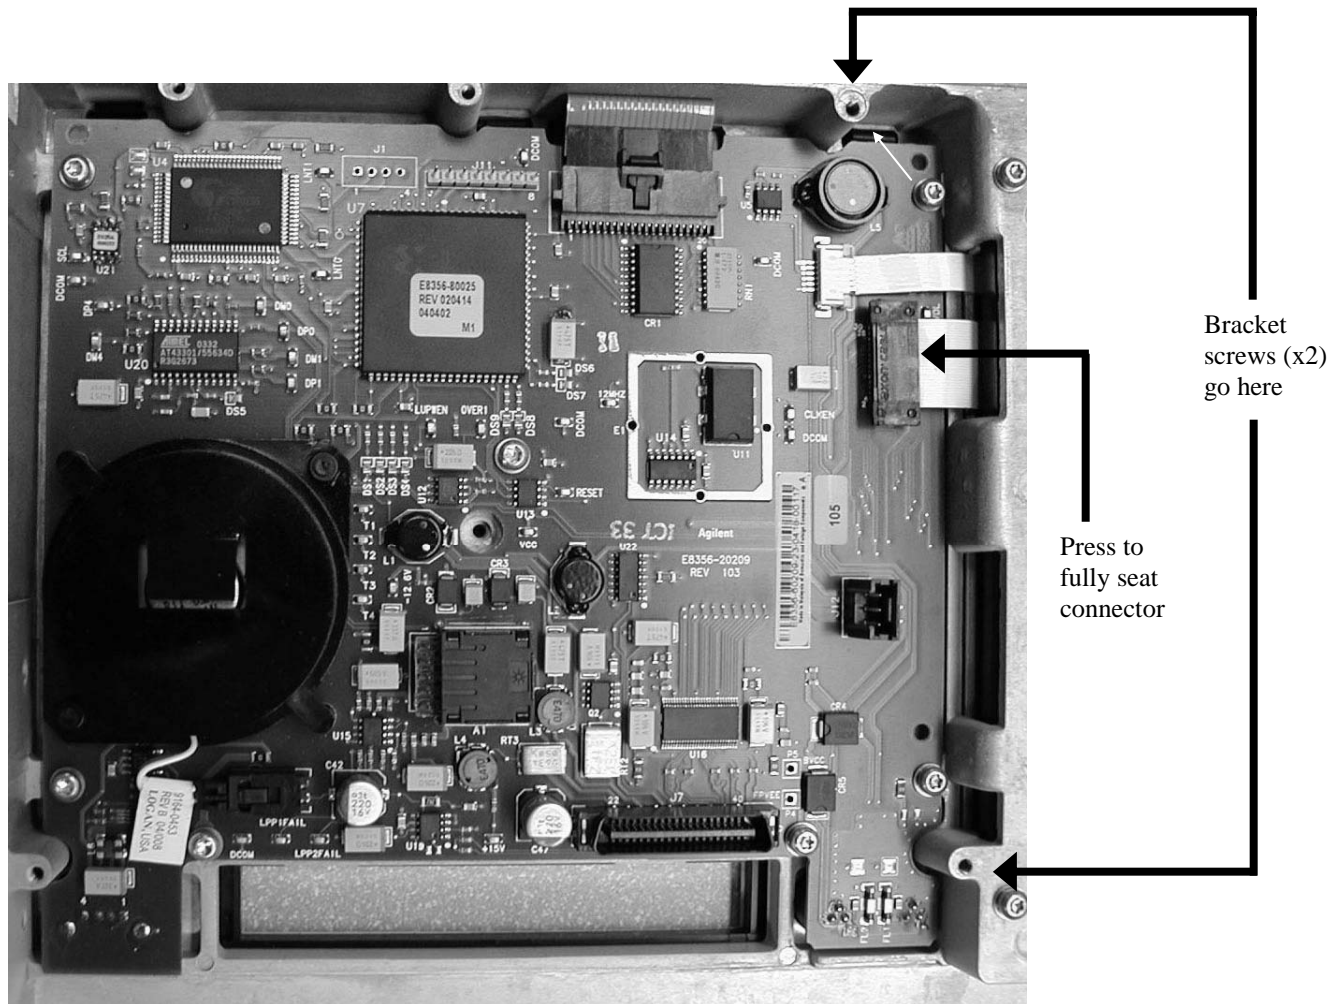
Figure 1: A3 Front Panel Interface Board Assy without the Bracket

A connector of the ribbon cable (Agilent part number 8120-8409) that joins the front panel display to the front panel interface board can loosen, causing a display failure, unless a new bracket is installed. Because the failure rate has been very low, it is recommended that the bracket be installed only when there is an additional reason to remove the PNA front panel.

1. Refer to Figure 1 in this document:
 - Press down firmly on the ribbon cable's black connector.
 - Locate the two tapped holes for the bracket screws.
2. As shown in Figure 2 in this document, position the bracket so that its holes line-up with the two holes you located in the previous step.
3. Hand-start the two screws, and then torque both to 9 in-lbs.
4. Reinstall the PNA Front Panel by following the Service Guide instructions in the "Replacement Procedure." This is located on the same page as the "Removal Procedure" used previously in step 7.
