E8801A-05**S E R V I C E N O T E**Supersedes:
NONE**E8801A PNA Series RF Network Analyzers****Serial Numbers: 0000A00000/9999Z99999 [All]****Replace Inverter board (0950-3379) due to faulty component.****To Be Performed By: Agilent-qualified personnel or customer with
specific product repair knowledge - requires
instrument disassembly and component replacement.****Parts Required:**

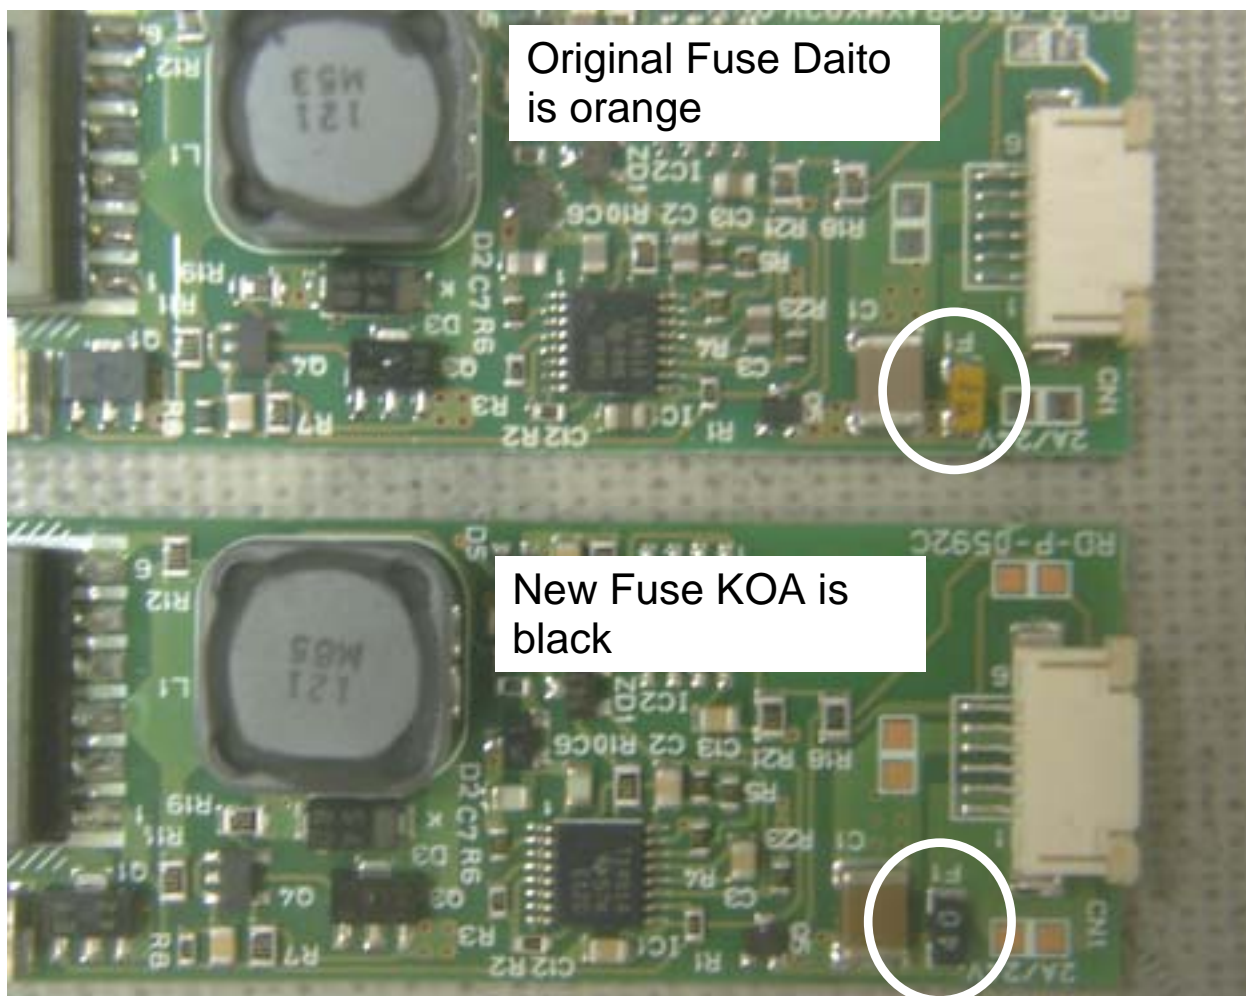
The original fuse (see photo) in the DC/AC Inverter board (p/n 0950-3379) is prone to failure in normal use.

Replace the Inverter board with a board containing the new fuse (see photo).
