HIOKI 8855 Firmware and optional 9549 Software Defect Details

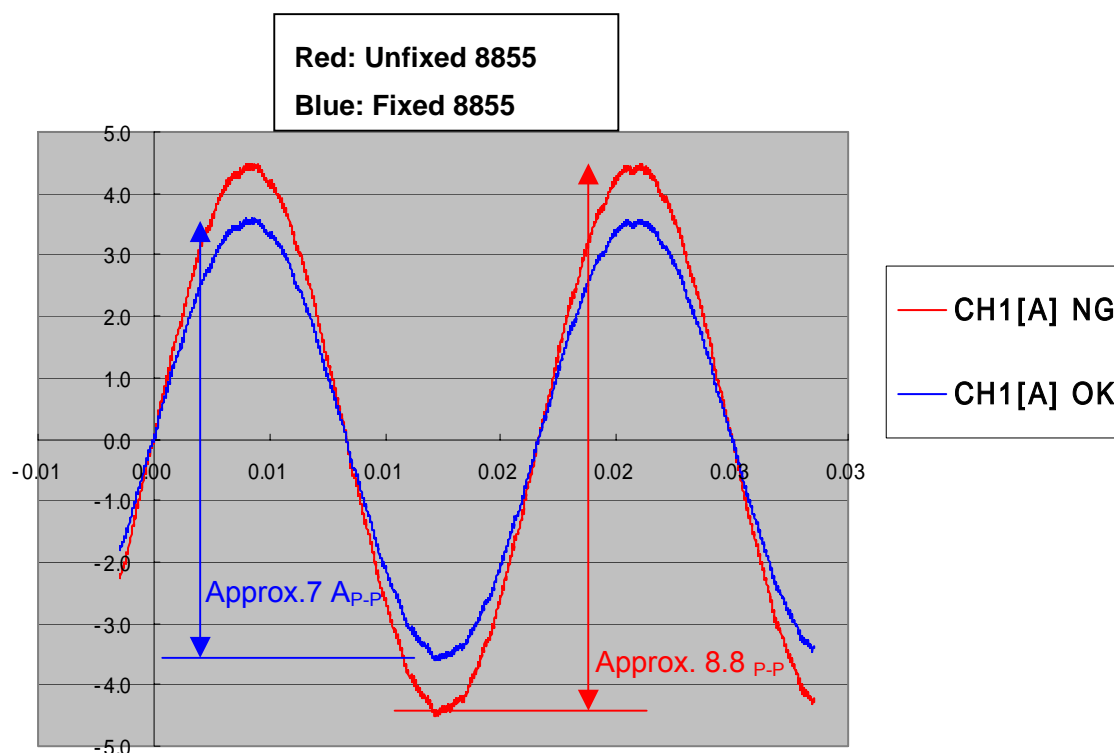
1. Erroneous current measurement with the Hioki 8855 and 9279, and PC application enhancements

- When measuring current with **the combination of Model 8951 Voltage and Current Unit and the 9279 Current Probe**, after acquired waveform data has been saved as a binary format file, data values will be 1.25 times larger than their initially measured values when the file is subsequently loaded by the Model 9335 Waveform Processor or the WV Wave Viewer. The measurement ranges producing erroneous values are **500 mA/div, 1 A/div, 10 A/div and 20 A/div**.
- As a result, if the waveform data file is converted to CSV format by the Hioki 9335 or WV software application and displayed graphically in Excel, its amplitude will be 1.25 times the measured level.
- However, the waveform displayed on the 8855 is unaffected.

500 mA/div range: with 2.5 A (rms) input data converted to CSV format and displayed in Excel

→ Measured values of about 7 A_{P-P} are erroneously displayed as about 8.8 A_{P-P}.

Improved functions of the Hioki 9333, 9335 and WV software applications - Waveform files that were saved before the 8855 was fixed can be read properly by calculating a new conversion factor using the 8855 range information and according to whether or not the Model 9279 was used, without using the conversion factor saved with the (binary format) waveform files.

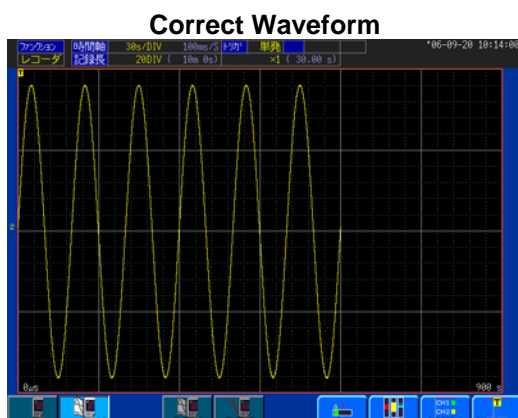
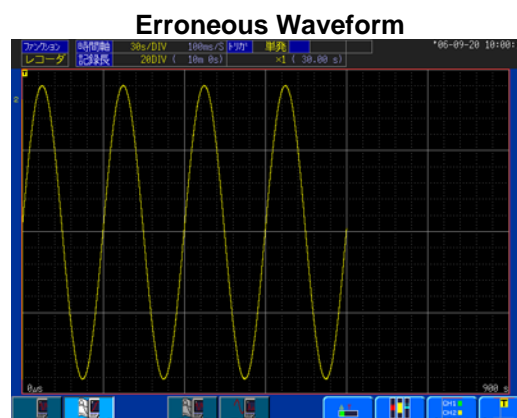
2. Erroneous timebase settings with the Recorder Function of the Hioki 8855

- Depending on the combination of the timebase and sampling settings, actual recording length may be shorter than the set time. Particularly when the timebase is set to 30 s/div, actual recording occurs at 20 s/div, so the time axis is erroneously lengthened and recording time is only 2/3 of the correct length.

With the instrument timebase set to 30 s/div, monitoring a sine wave with a 100-second period for 20 divisions should capture six cycles of the waveform. However, because of the defect, only four cycles are captured, as the actual timebase is 20 s/div.

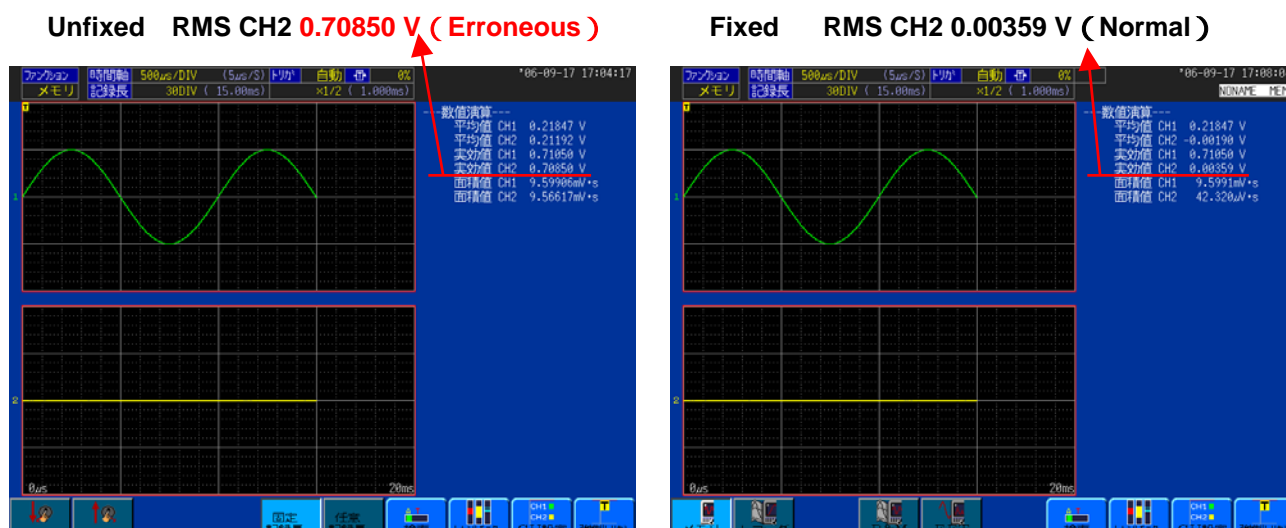
3. Erroneous Numerical Value Calculation (Average, RMS and Area)

- When performing numerical calculation on lower-numbered channels using the Memory function, calculation results for Average, RMS and Area values on channels other than CH1 are incorrect (calculated results are completely unrelated to measured values).

- In this case, the Use Channels setting is CH1-2, with a 2 Vp-p sine wave applied to CH1 and no signal applied to CH2. Average, RMS and Area values are calculated after measurement.
- Although the calculation results for CH2 should be near zero, before the fix is applied (left figure), they are almost the same as the values for CH1(!). After the fix is applied (right figure), the calculated values for CH2 are near zero. (This is only one example of the defect: the erroneous values are not always near those of CH1.)
