IBM 8260 Multiprotocol Intelligent Switching Hub Ethernet 10-Port 10BASE-FB Module Release Note

IBM Corporation • IBM Part Number 29H4248 • August 25, 1995

This release note applies to the IBM 8260 Ethernet 10-port 10BASE-FB Module (Model Number E10PS-FB) at software Version 1.0 of the boot code and Version 1.05 of the operational code.

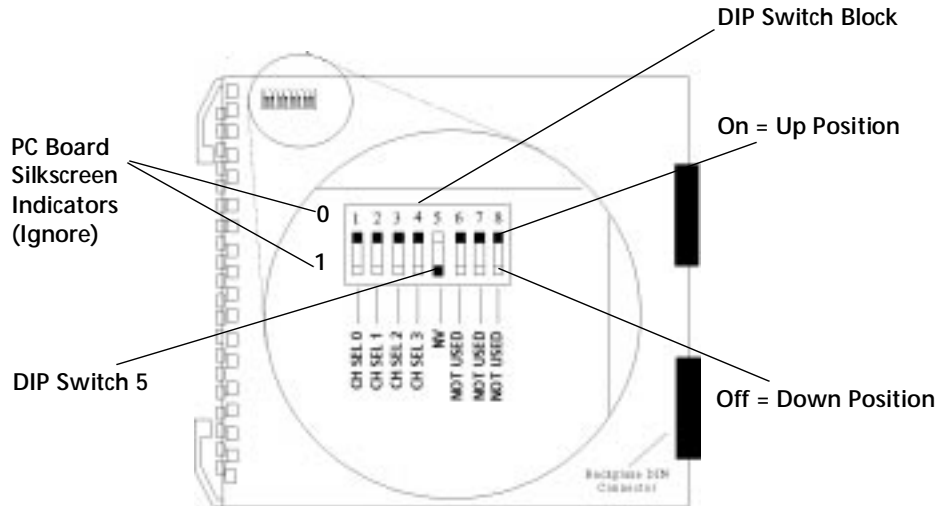
Figure 1. 10-Port Module and DIP Switch Location

Figure 3-1 on page 3-6 of the *8260 Ethernet 10-Port 10BASE-FB Module User's Guide* displays an incorrect DIP switch illustration. Refer to the following figure and notes when setting DIP switches.

Note: Ignore the **0** and **1** PC board silkscreen position indicators on the left side of the DIP switch block. This is a hardware issue *only*.

Note: **DIP Switch 5** must be set to the positions listed below when configuring network assignments using:

- NVRAM in OFF (down) position
- DIP switch in ON (Up) position
