Icom IC-765 Notes

Don Stalkowski, VE3HUR

March 30, 2005

Version 1.07

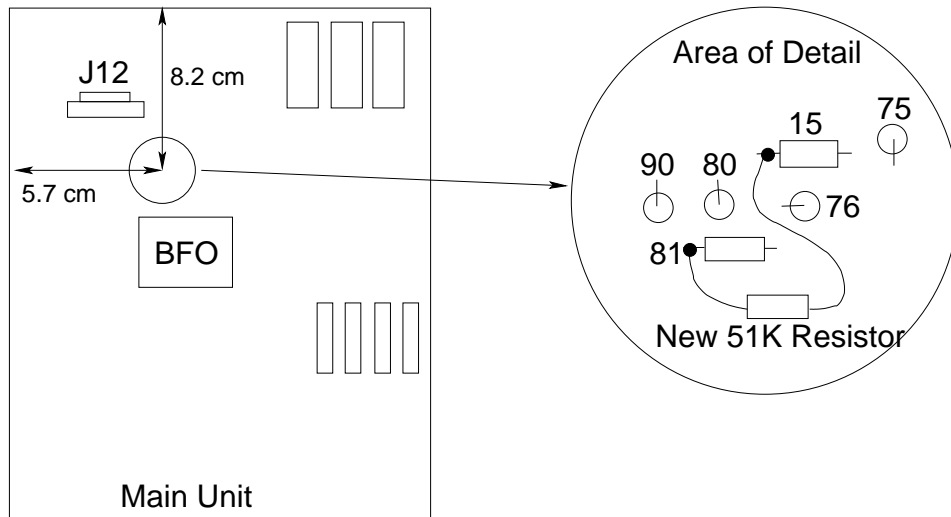
Figure 8: QSK Sidetone Modification

The second modification reduces the delay from key down to sidetone output from 10 to 3 milliseconds and increases the delay from key up to side tone off from 2 to 3 milliseconds. This improves the sidetone sound significantly.

To improve the sidetone, remove the bottom cover and locate the area on the Main Unit shown in Figure 8. Solder a $51\text{k}\Omega$ $\frac{1}{4}$ watt resistor between the left ends of components labeled 15 and 81. Use an iron with a *small* tip.
