Jitter Effects On 100BASE-T Timing

Time Interval Error Detects Excessive Phase Jitter

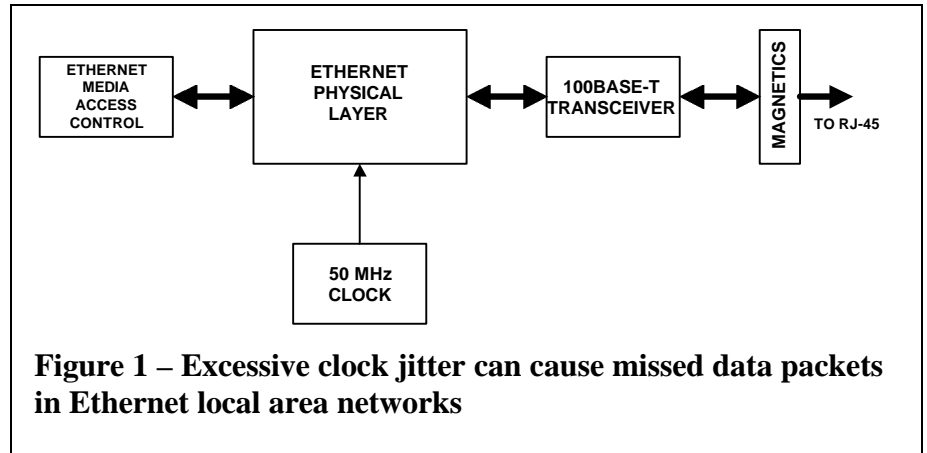
Figure 1 – Excessive clock jitter can cause missed data packets in Ethernet local area networks

being missed. A measurement of the 50 MHz oscillator frequency and the 25 MHz transmit (Tx) clock did not reveal any change. The 50 MHz oscillator was a phase locked loop (PLL) based device which did not have a jitter specification. Looking at the clock signal with analog persistence led the engineer to suspect that this oscillator was

the source of the problem. Subsequent measurements using TIE quantified the jitter. The designers replaced the PLL with a crystal oscillator and the problem disappeared.

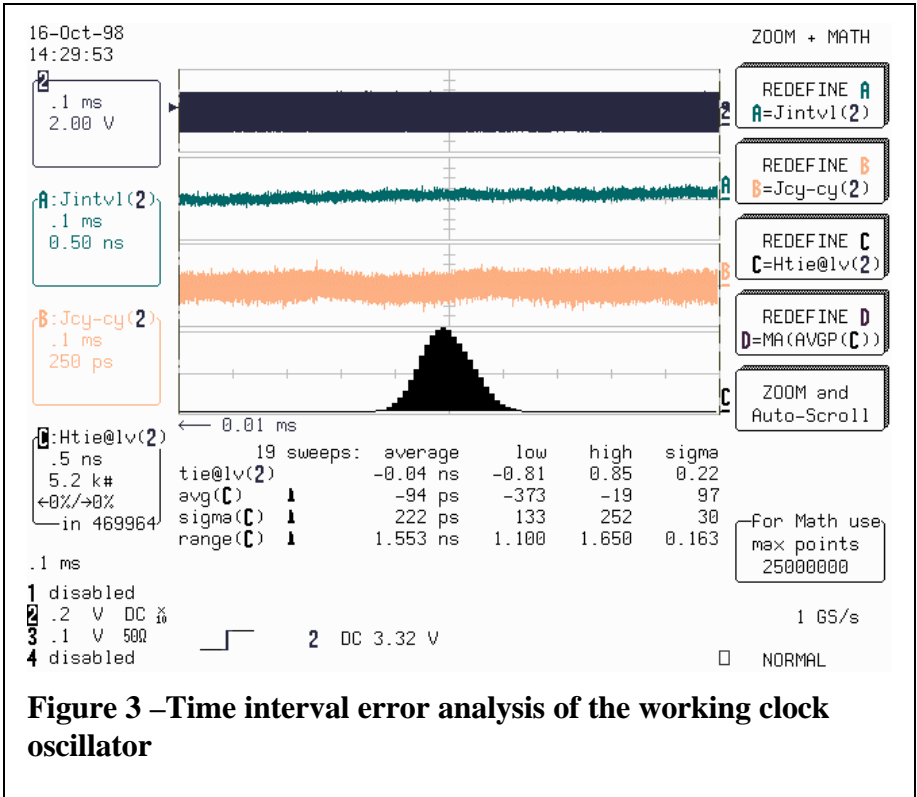
The acquired clock shown in the top waveform (channel 2). Time interval error (trace A) and cycle to cycle period jitter (trace B) are computed for 1 ms (50,000 cycles) of the 50 MHz clock. In addition the histogram of the time interval error at level (tie@lv) parameter is shown in trace C. The histogram parameters avg, sigma and range read the mean, standard deviation or rms jitter, and peak to peak jitter of the interval error. Note that the range or peak to peak jitter is 1.553 ns.

Figure 3 –Time interval error analysis of the working clock oscillator

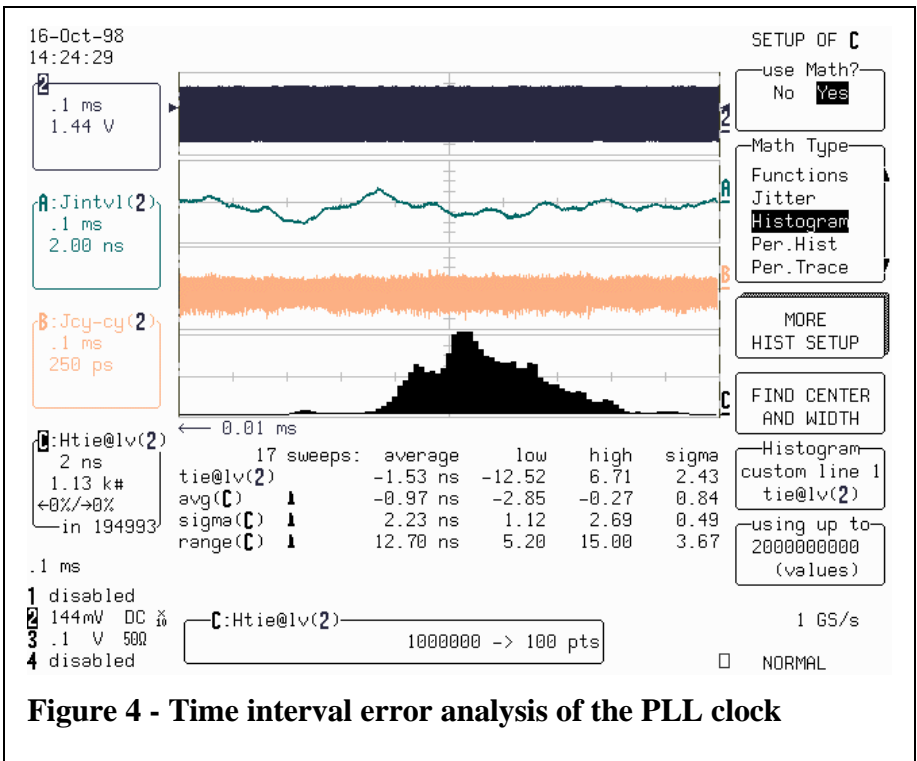
Compare this value with the jitter analysis of the original 50 MHz PLL based clock shown in figure 4. This is the oscillator associated with the dropped data packets. Note that the cycle to cycle variation in period (trace B) has not changed appreciably. The time interval error function and the related histogram parameters show a large increase in TIE. In particular the peak to peak phase jitter has increased to 12.7 ns

Figure 4 - Time interval error analysis of the PLL clock
