Repairhints

Communicator 9000/9000i RAE/K-1/4

The purpose of this document is to provide some further service information for NOKIA Communicator 9000/I. It contains a lot of collected tips and hints to find failures and repair solutions easily.

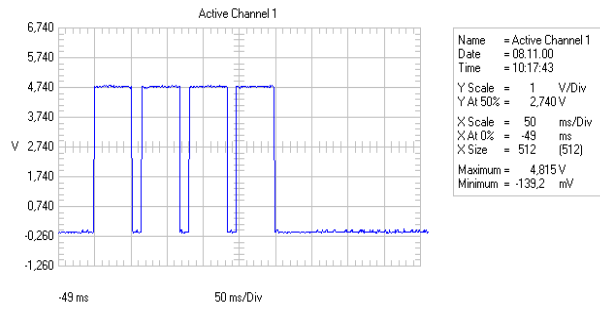
VSIM after switching on the phone without SIMcard. E 400 pulses up VSIM four times to an amplitude of 5 Volt.

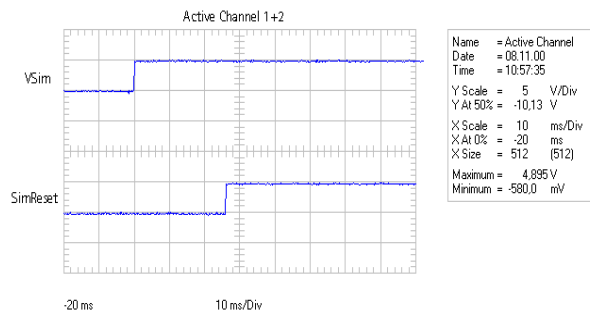
SIMReset is low-active, that means that the Simcard will be reseted when SIMReset is 0 Volt. This is the case after switching on the phone. While VSIM is already high, SIMReset keeps low for a few milliseconds – in this time the card will be reseted.

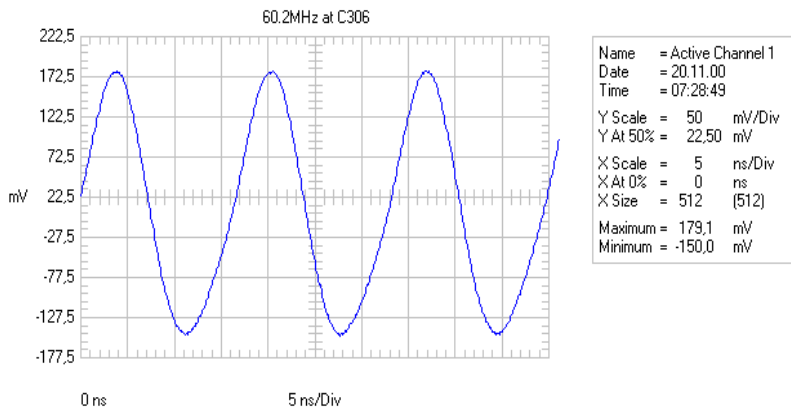
In case of Selftest failures which appears from time to time check DSP-oscillator. It is enabled by ASIC (Check E400 pin 88, 4.8V DC).
Critical parts are the crystal G300, coil L300 and transformer T300. If it is necessary to change the crystal, take care not to destroy L300, which is thermal sensitive!

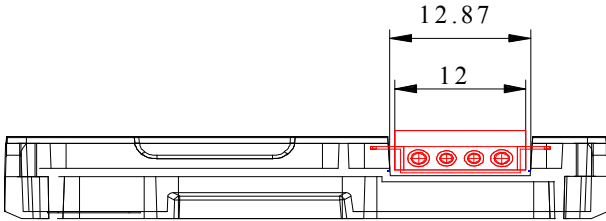
If the communicator intermittent switches off itself and the symptom can be reproduced by moving the battery sideways, check that the space between the right edge of connector X202 and the chassis is 0.5mm. If distance is not ok, try to correct it by opening screws of shield and chassis and push CMT-module to the left, check gap after tightening the screws. If this does not work, replace connector X202.

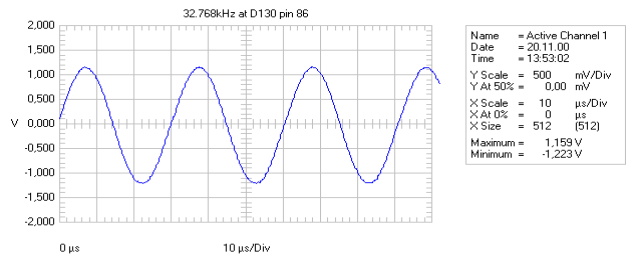
Check 32.768kHz sinewave at D130 pin 86. In most cases the crystal B130 is defect if signal is not ok.
