# Service Hints

Video Cassette Recorder

**Z-MECHANISM CHASSIS**

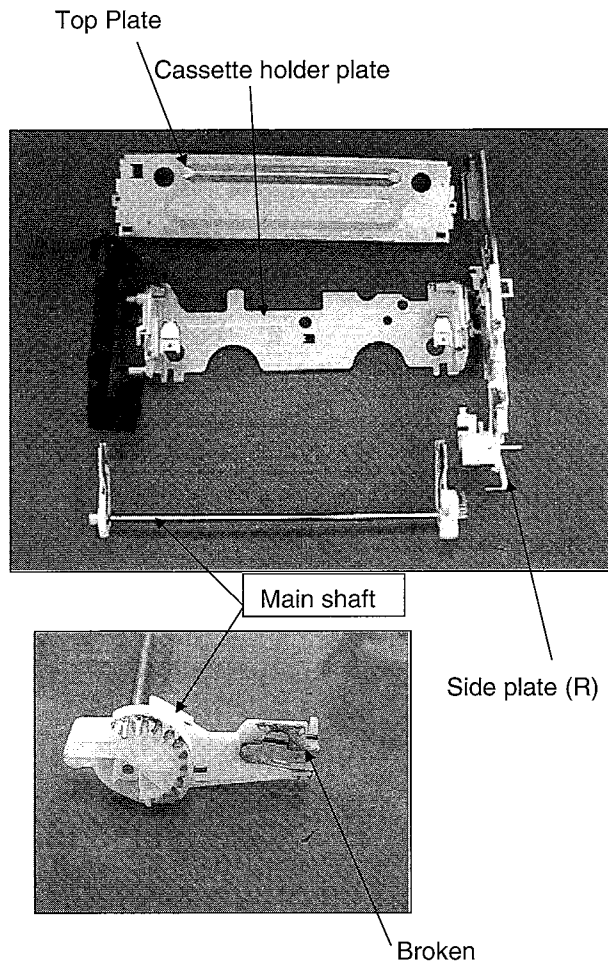
Break-down of the plastic portion in Main shaft  
Deformation of Side plate or out of gear phase alignment in Wiper arm and Drive rack

The plastic portion in Main shaft is broken so that Cassette holder unit can not advance.

Replacement of Main shaft (VXP1730)  
Replacement of Side plate (R) unit (VXA5740)

1. Remove Top Panel and Front panel unit.  
Remove 2 screws located at both left and right side of Top Panel and Top Panel.  
Unlock 4 tabs located at the top of Front panel unit and 3 tabs located at the bottom of Front panel unit. Remove Front panel unit.
2. Remove Top plate.  
Unlock 4 tabs located at both left and right side of Top plate softly and remove Top plate.
3. Remove Cassette holder plate.  
Keep pressing 2 stoppers on Cassette holder plate and press Cassette holder plate to the rear of VTR and remove it from left and right side plate unit.
4. Remove Left and Right side plate unit.  
Remove Connection spring of Drive gear and remove 3 red screws and remove Left and right side plate unit.
5. Remove Main shaft and replace it.

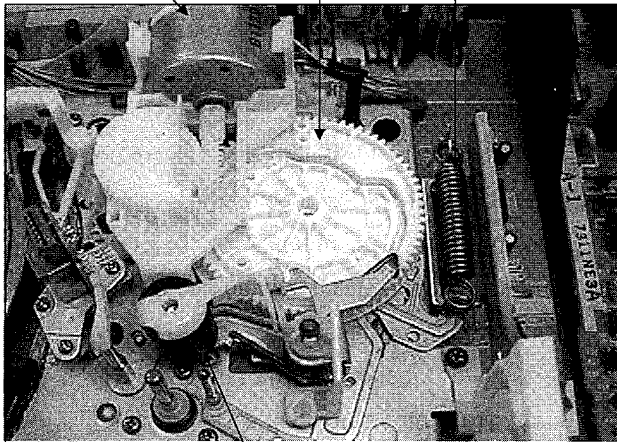
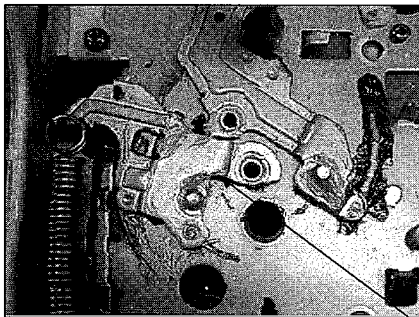
Deformation of Drive rack arm located under Main cam gear

Replacement of Drive rack arm (VML3165)

1. Remove Mechanism unit.
  - Remove 5 screws that fix Mechanism unit.
  - Disconnect some connectors.
  - Remove Mechanism unit.
2. Remove Pinch arm unit.
  - Unlock the tab of Opener piece and remove Opener piece.
  - Remove Pinch arm unit.
3. Remove Loading motor unit.
  - Unlock 3 tabs of Loading motor unit and remove Loading motor unit.
4. Remove Main cam gear.
  - Remove Snap washer located at the bottom of Mechanism chassis and remove main cam gear.
5. Remove Drive rack arm.
  - Rotate Drive rack arm to the counterclockwise and remove Drive rack arm.
  - Then replace Drive rack arm.

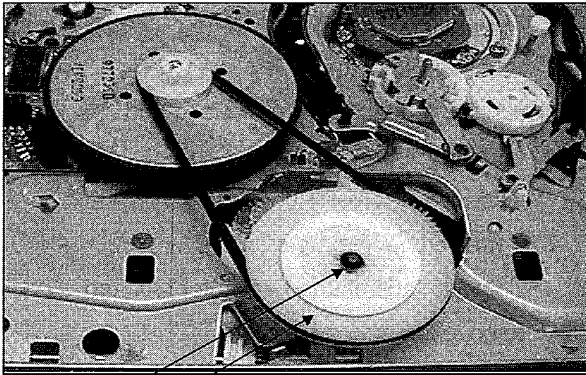
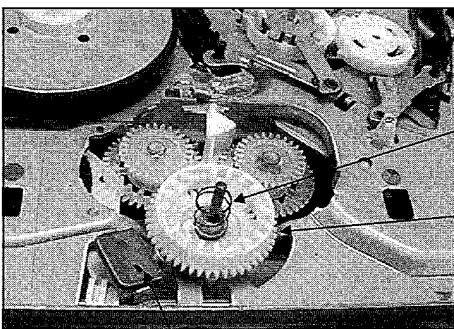
The rotation of Centre clutch unit is heavy

Centre clutch unit failure is thought. When rotate Centre clutch unit individually, the rotation of Centre clutch unit is uneven.

Replacement of Centre clutch unit (VXP1850 or VXP1732) No. of Centre clutch unit is different depend on the model No.

1. Remove Mechanism unit.
  - Remove 5 screws that fix Mechanism unit.
  - Disconnect some connectors.
  - Remove Mechanism unit.
2. Remove centre clutch located at the bottom of Mechanism chassis.
  - Remove Capstan belt and Washer and remove centre clutch unit while pressing conversion lever B to the bottom.After confirming the rotation of Centre clutch unit individually, replace it.

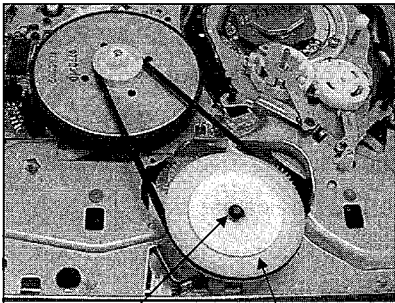
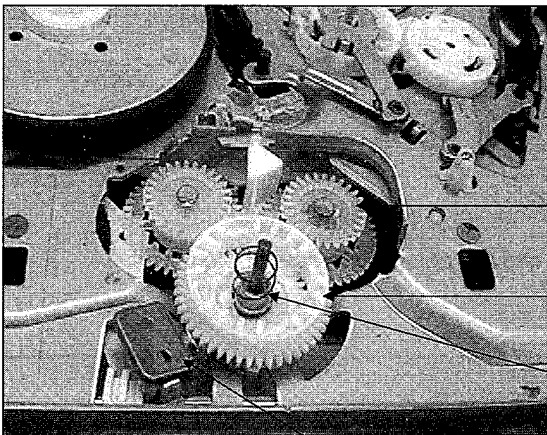
Engagement between  
Idler arm unit and Centre  
clutch unit is not so good.

Engagement of gear of Idler arm unit is bad.

Replacement of Idler arm  
unit (VXL2792)

1. Remove Mechanism unit.
  - Remove 5 screws that fix Mechanism unit.
  - Disconnect some connectors.
  - Remove Mechanism unit.
2. Remove Centre clutch unit located at the bottom of Mechanism chassis.
  - Remove Capstan belt and Washer.
  - Remove Centre clutch unit while pressing Conversion lever B to the bottom.
3. Remove Idler arm unit.
  - Remove Conversion gear and Conversion gear spring and remove Idler arm unit.

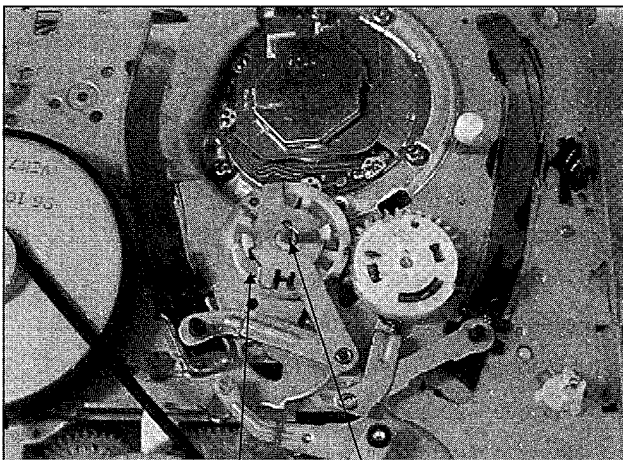
-Roller post is not fixed  
-Take up loading arm is out of position

The tab of Take up loading arm loosens and Take up loading arm is not fixed to the pin so that Take up loading arm get out of position.

Replacement of Take up loading arm (VXL2670)

1. Remove Mechanism unit.
  - Remove 5 screws that fix Mechanism unit.
  - Disconnect some connectors.
  - Remove Mechanism unit.
2. Replacement of Take up loading arm.
  - Unlock the tab of Take up loading arm located at the bottom of Mechanism chassis and remove Take up loading arm.
  - Replace Take up loading arm. When mount Take up loading arm, the arrow mark mentioned on the gear of Take up loading arm has to be adjusted to the gear of Supply loading arm.

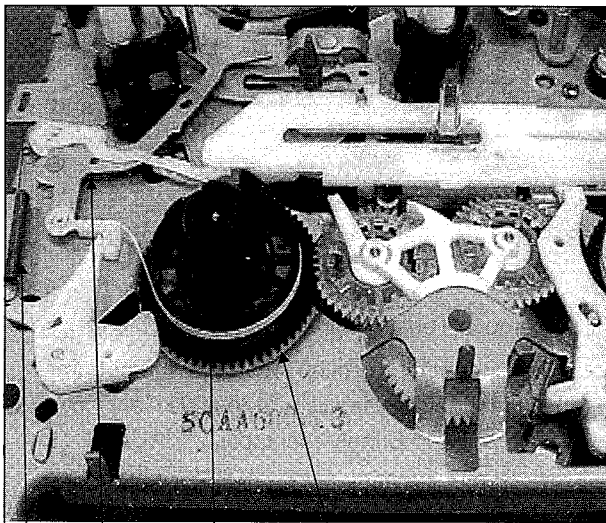
Cassette tape is not  
engaged with Supply reel  
table (Engagement of  
cassette tape with Supply  
reel table is bad)  
(Tape is not wound)

The engagement with gear portion of Supply reel table and cassette tape is bad so that cassette tape is not set to the regular position.

Replacement of Supply  
reel table (VDR0346)

1. Remove Mechanism unit.
  - Remove 5 screws that fix Mechanism unit.
  - Disconnect some connectors.
  - Remove Mechanism unit.
2. Remove Cassette holder unit.
  - Remove Connection spring of Drive gear and remove 3 red screws and then remove Cassette holder unit.
3. Remove Tension arm unit and Supply reel table
  - Remove Tension spring. Unlock the tab of Tension arm projection located at the bottom of Mechanism chassis and remove Tension arm unit and Supply reel table.
  - Then replace Tension arm unit and Supply reel table.

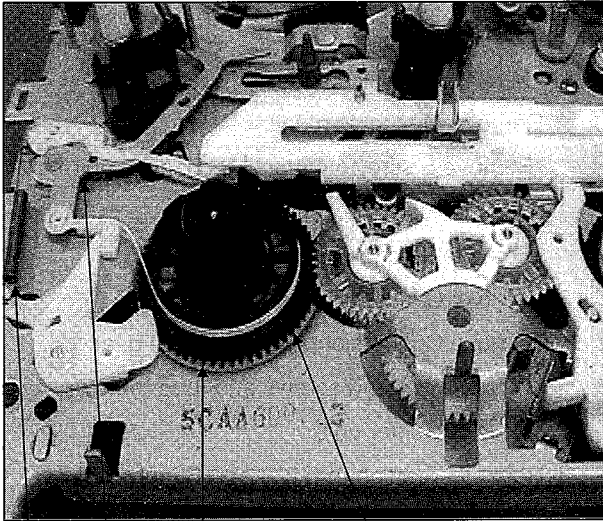
Tension band comes off Supply reel table and tape is not wound.

1. Remove Mechanism unit.
  - Remove 5 screws that fix mechanism unit.
  - Disconnect some connectors.
  - Remove Mechanism unit.
2. Remove Cassette holder unit.

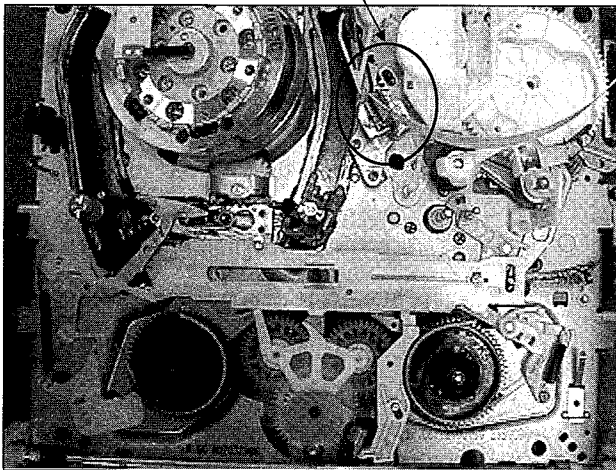
Clog of A/C Head or  
A/C Head failure

Since A/C Head is clogged and control signal is not detected, above phenomenon appears.

Cleaning of A/C Head or  
replacement of A/C Head  
(VED0412)

2. Clean the surface of A/C Head.

Remove 1 screw that fix A/C Head and replace A/C Head.

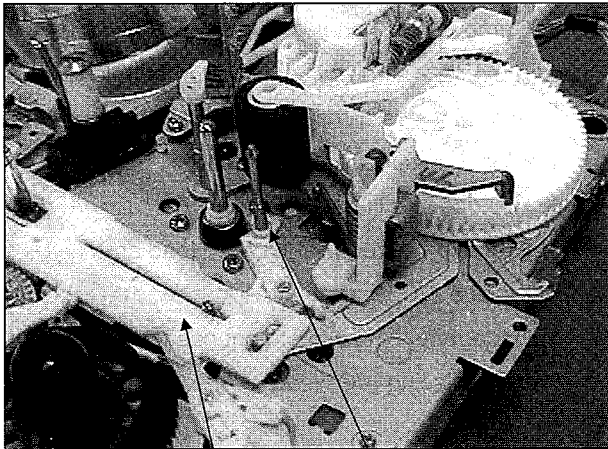
Bend of P5 arm

The plastic portion of P5 arm is broken or P5 arm is bent.

Replacement of P5 arm (VXL2677)

1. Remove mechanism unit.
  - Remove 5 screws that fix Mechanism unit.
  - Disconnect some connectors.
  - Remove Mechanism unit.
2. Remove Main lever and P5 arm.

Unlock 2 tabs that fix LED prism and 1 tab that fix the projection on Mechanism chassis while lifting the left side of Main lever a little and remove Main lever and P5 arm. Then replace Main lever and P5 arm.

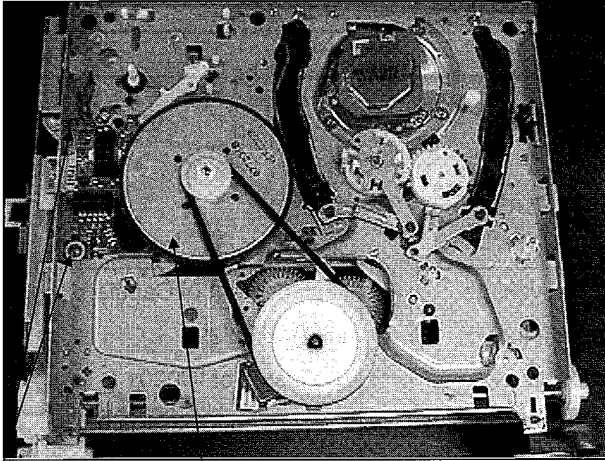
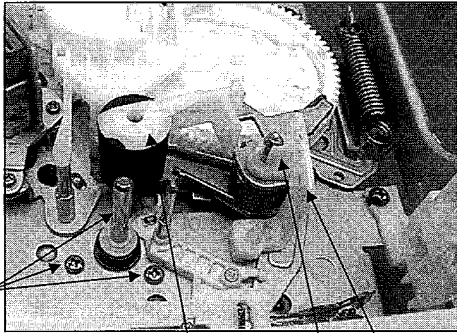
Replacement of Capstan unit (VEK8239)  
The inside of IC0201 is broken and IC0201 is being supplied with Capstan unit as one unit

Capstan runs away so that cassette tape can not be ejected or VTR is placed to CUE mode even though VTR is set in SP playback mode.

1. Remove Top Panel and Front Panel unit.
  - Remove 2 screws located at both left and right side of Top Panel and Top Panel.
  - Remove 7 tabs located at top and bottom of Front Panel unit and Front Panel unit.
2. Remove Mechanism unit.
  - Remove 5 screws that fix Mechanism unit.
  - Disconnect some connectors.
  - Remove Mechanism unit.
3. Replacement of Capstan unit.
  - Unlock the tab of Opener piece and remove Opener piece. Remove Pinch arm unit.
  - Remove 3 screws that mount Capstan unit at the top of Mechanism unit.
  - Remove 2 screws that mount Capstan unit at the bottom of Mechanism unit.
  - Remove Capstan unit and replace capstan unit.
