Model: Kaiser1	Date: 29-Feb-00	No.: RH306001a
----------------	-----------------	----------------

Subject: ROM History (Kaiser 1)		Prepared by: M. Mano	
From: Technical Services Dept., GTS Division			
Classification:	<input type="checkbox"/> Troubleshooting	<input type="checkbox"/> Part information	<input type="checkbox"/> Action required
	<input type="checkbox"/> Mechanical	<input type="checkbox"/> Electrical	<input type="checkbox"/> Service manual revision
	<input type="checkbox"/> Paper path	<input type="checkbox"/> Transmit/receive	<input checked="" type="checkbox"/> Retrofit information
	<input type="checkbox"/> Other ( )

Model: Kaiser1		Date: 29-Feb-00	No.: RH306002
Subject: Note on the PIF's grounding plate attachment		Prepared by: M. Mano	
From: Technical Services Dept., GTS Division			
Classification:	<input type="checkbox"/> Troubleshooting	<input type="checkbox"/> Part information	<input type="checkbox"/> Action required
	<input checked="" type="checkbox"/> Mechanical	<input type="checkbox"/> Electrical	<input type="checkbox"/> Service manual revision
	<input type="checkbox"/> Paper path	<input type="checkbox"/> Transmit/receive	<input type="checkbox"/> Retrofit inform

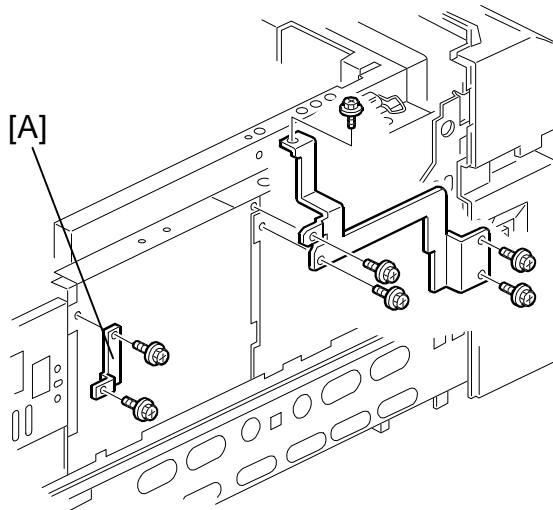
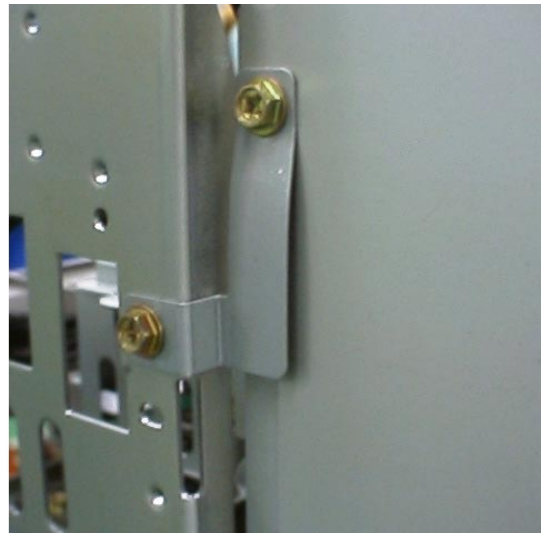
The PIF option grounding plate [A] (P/N: H3064662) in the following 15 units will bend slightly when you attach it, as shown in figure 2.

However, the plate will function normally and the slight bending will not affect the operations of the printer unit or mainframe in any way.

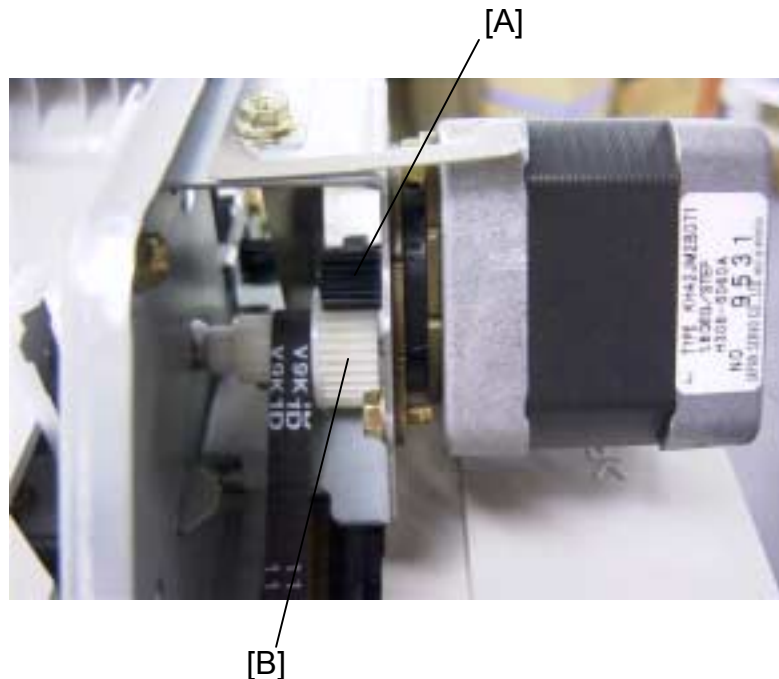
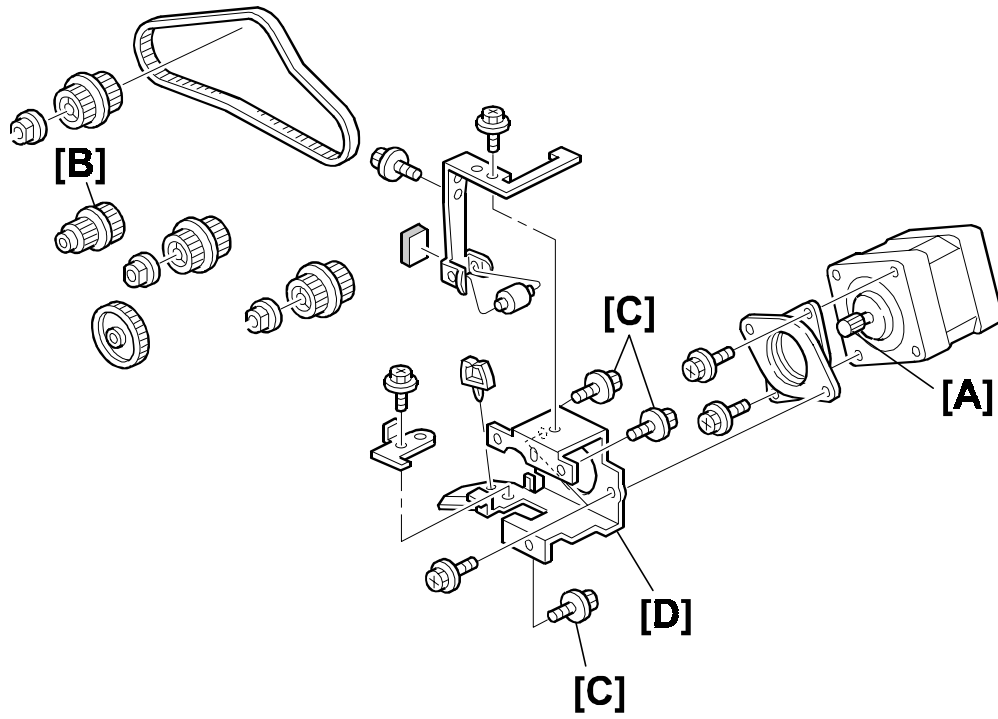
A squeaking sound can be heard coming from the ADF unit.

Vibration of the ADF motor gear [A] and ADF rear slow down gear [B] as shown below.

In the field, please re-tighten the 3 screws [C] (see the next page) that secure the ADF motor bracket [D] to the ADF unit. This will ensure that the 2 gear shafts are parallel.

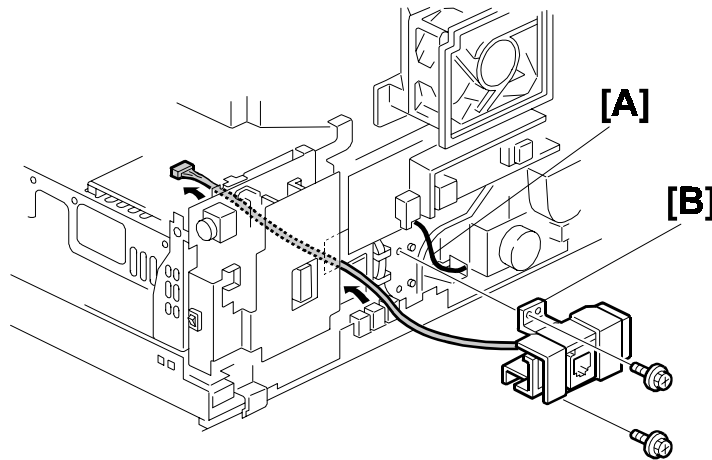
When the following option(s) are installed, the paper end sensor harness [A] may be pinched between the mainframe and the bracket [B].

If the harness [A] is pinched, a number of symptoms can occur such as:

- Power LED is not lit
- Operation panel is not lit
- Other

When installing the bracket for the options mentioned above, please make sure that the harness remains to the right of the bracket and does not get pinched.

For the N. America model, the routing of the harness has been changed from the beginning of March 2000 production.
