Model: Schmidt3		Date: 31-Oct-99	No.: RH547001
Subject: New Functions in the Schmidt3 G4 Unit		Prepared by: K. Misugi	
From: Technical Service Dept., GTS Division			
Classification:	<input checked="" type="checkbox"/> Troubleshooting	<input type="checkbox"/> Part information	<input type="checkbox"/> Action required
	<input type="checkbox"/> Mechanical	<input type="checkbox"/> Electrical	<input checked="" type="checkbox"/> Service manual revision
	<input type="checkbox"/> Paper path	<input type="checkbox"/> Transmit/receive	<input type="checkbox"/> Retrofit information
	<input type="checkbox"/> Other ()

Model: Schmidt 3		Date: 31-Oct-99	No.: RH547002
Subject: Group dials display on RDS		Prepared by: K. Moriizumi	
From: Technical Service Dept., GTS Division			
Classification:	<input checked="" type="checkbox"/> Troubleshooting	<input type="checkbox"/> Part information	<input type="checkbox"/> Action required
	<input type="checkbox"/> Mechanical	<input type="checkbox"/> Electrical	<input type="checkbox"/> Service manual revision
	<input type="checkbox"/> Paper path	<input type="checkbox"/> Transmit/receive	<input type="checkbox"/> Retrofit information
	<input type="checkbox"/> Other

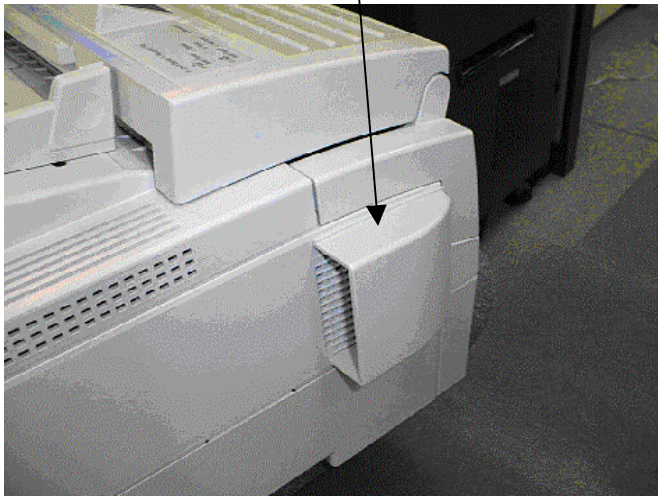
The noise level of the machine is within standard parameters. However, some customers do not like the noise generated by the fan, as the machine is sometimes installed on or by a desk.

We will provide a special part called a "Silencer" which can be set at the air exit near the fan by the customer. (See below)

This will reduce the noise from the fan.

The part number of the Silencer is H5459500. This part will be available soon at SPC.
