SUBJECT: Operation Procedures for the transmission of fax messages  
while making memory copies.

AD-1

SUBJECT: ROM History (AD1-FAX option)

We inform you of the firmware history for the AD1-Fax option.  
(For the USA Model)

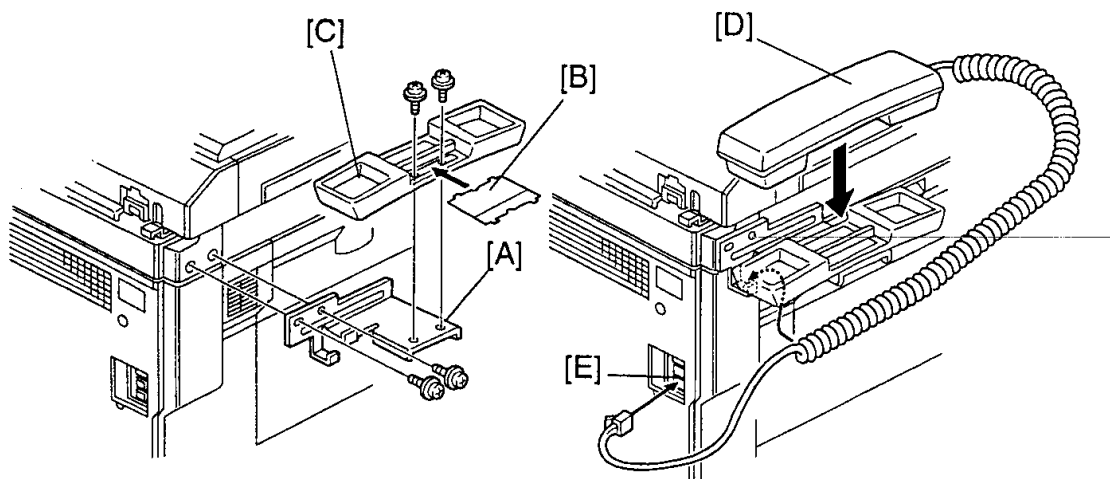
## 4.HANDSET

In some countries, the optional handset is available for the Aficio 200. To install the optional handset, use the bracket which is included in the Fax Unit Option, Type 250. Also, correct the installation procedure in the Service Manual on page 3-12 as follows.

1. Install the bracket [A] ( 2 screws ), as shown.

\* The bracket [A] in the carton box of the Fax Unit Option Type 250 must be used.

2. Remove the label [B] from the handset cradle [C]. Install the cradle on the bracket [A] ( 2 screws ), then replace the label [B].

3. Install the handset [D] as shown. Connect the handset cord to the " TEL " jack [E] on the machine.
