Model: AD1-E (Printer Controller)		Date: 30-Jun-97	No: 33
Subject: AD1-E Printer Controller Launching		Prepared by: A.Nakajima	
From: QAC 2nd Field Information Dept.			
Classification:	<input type="checkbox"/> Troubleshooting	<input type="checkbox"/> Part information	<input type="checkbox"/> Action required
	<input type="checkbox"/> Mechanical	<input type="checkbox"/> Electrical	<input type="checkbox"/> Service manual revision
	<input type="checkbox"/> Paper path	<input type="checkbox"/> Transmit/receive	<input type="checkbox"/> Retrofit information
	<input checked="" type="checkbox"/> Other (Launching Information)

Model: AD1-Printer Type 250		Date: 23-Jul-97	No: 35B
Subject: Firmware and Software History		Prepared by: K.Ugaeri	
From: QAC Field Information Dept.			
Classification:	<input type="checkbox"/> Troubleshooting	<input type="checkbox"/> Part information	<input type="checkbox"/> Action required
	<input type="checkbox"/> Mechanical	<input type="checkbox"/> Electrical	<input type="checkbox"/> Service manual revision
	<input type="checkbox"/> Paper path	<input type="checkbox"/> Transmit/receive	<input checked="" type="checkbox"/> Retrofit information
	<input type="checkbox"/>

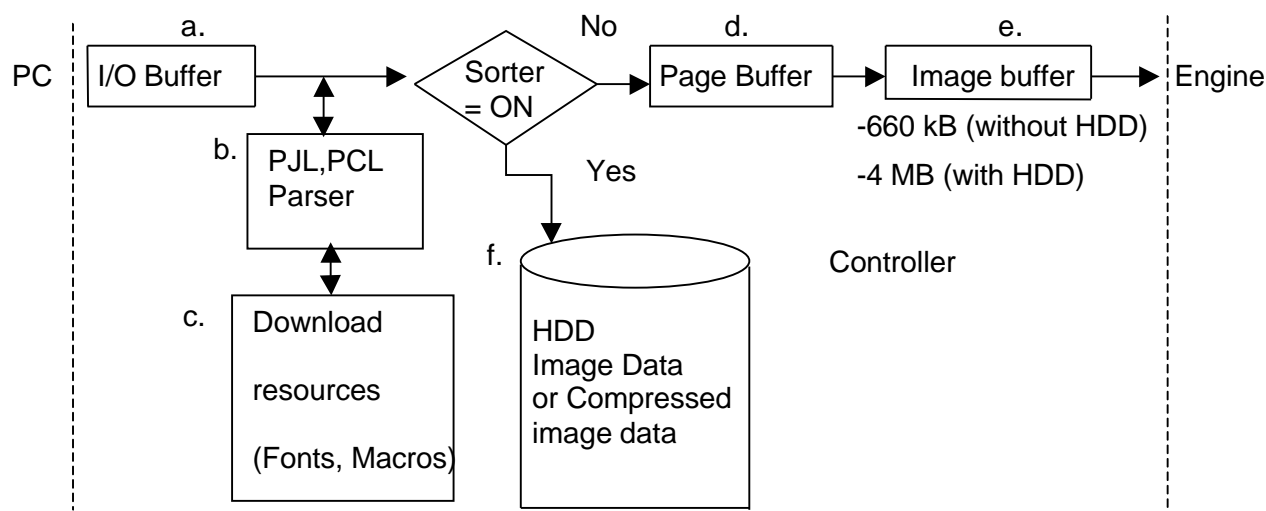
1. Data flow in the controller unit

a. I/O Buffer for receiving and sending data.

b. Stores the operation language software (such as PCL and PJP).

c. Manages downloaded resources (such as Fonts and Macros).

d. Holds and processes data from incoming print jobs.

e. Image video buffer for sending video data to the engine to print.

f. *When the HDD is installed, it is used only for the sorting function.

If the user sends a print job which will use lots of memory, it might cause a memory overflow. Memory overflow might happen at points b, c, and d above. When memory overflow happens and the user presses the continue key, the printer prints only part of the page. This problem can be solved by adding SIMM memory (8 MB or more).

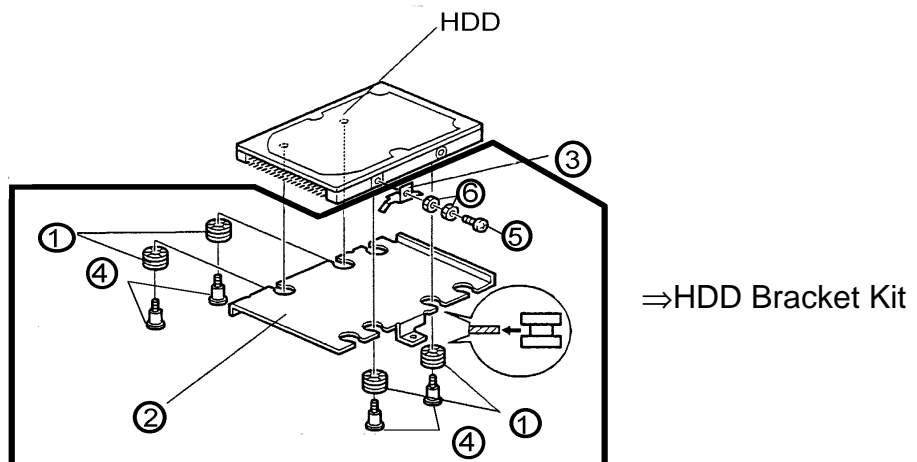
The HDD bracket has been modified for the print-overflow problem caused by vibration from the duplex unit (refer to RTB37). These new brackets have been available from June production in 1997 (the cut-in serial number is A7327060001-)

If you have the print overrun problem on an AD1 with a duplex unit or when you visit a customer whose machine has the old HDD bracket, please change the bracket to a new type.

This kit consists of the following parts.
