Model: K-P1, A-C2, J-P1		Date: 03-Jul-01	No.: RB003008
Subject: Slow Printing from Macintosh		Prepared by: K. Misugi	
From: Technical Services Dept., GTS Division			
Classification:	<input checked="" type="checkbox"/> Troubleshooting	<input type="checkbox"/> Part information	<input type="checkbox"/> Action required
	<input type="checkbox"/> Mechanical	<input type="checkbox"/> Electrical	<input type="checkbox"/> Service manual revision
	<input type="checkbox"/> Paper path	<input type="checkbox"/> Transmit/receive	<input type="checkbox"/> Retrofit information
	<input type="checkbox"/> Other ()

Model: Model Adonis-C2		Date: 09-Aug-01	No.: RB003010
Subject: Printer Firmware Release History		Prepared by: K. Takagi	
From: Technical Services Dept., GTS Division			
Classification:	<input type="checkbox"/> Troubleshooting	<input type="checkbox"/> Part information	<input checked="" type="checkbox"/> Action required
	<input type="checkbox"/> Mechanical	<input type="checkbox"/> Electrical	<input type="checkbox"/> Service manual revision
	<input type="checkbox"/> Paper path	<input type="checkbox"/> Transmit/receive	<input type="checkbox"/> Retrofit information
	<input checked="" type="checkbox

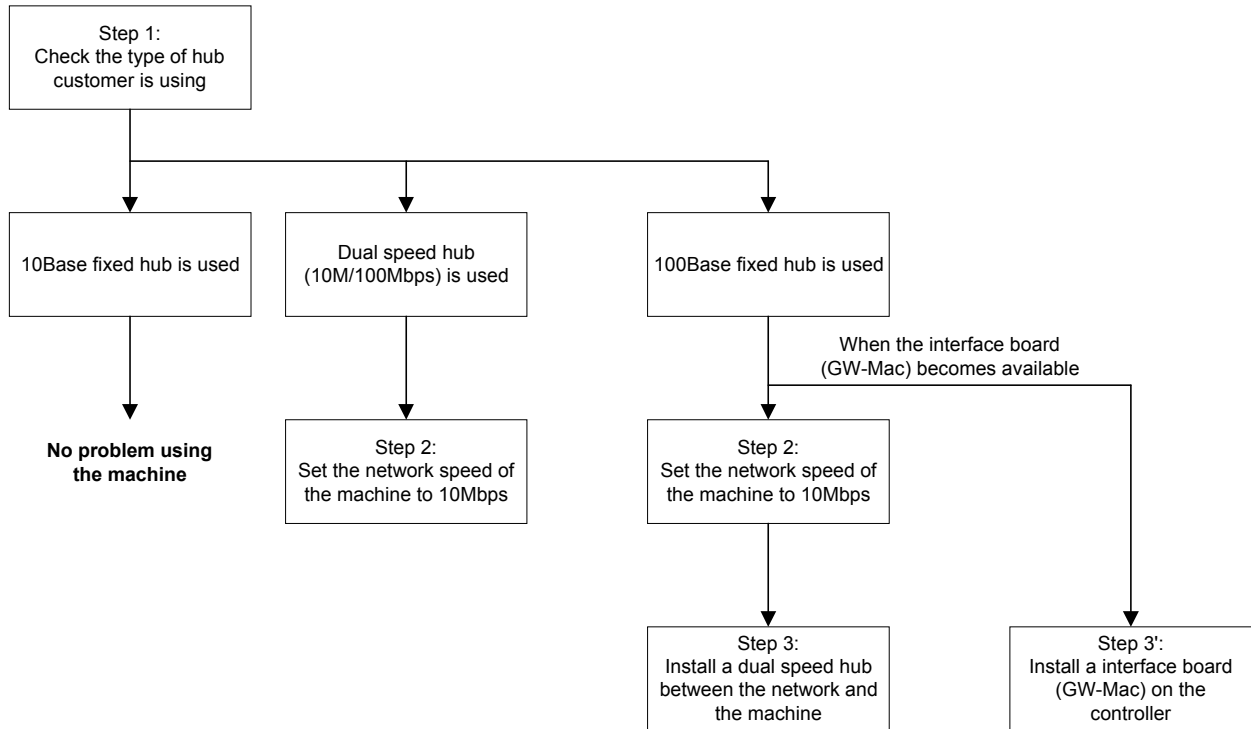
Flow Chart:

When machines are being connected to Macintosh with PowerPC G3/G4 processors with Apple Talk, check the type of hub being used and follow the steps explained below.

- 1) Check what type of hub the customer is using.
If the customer is using a dual speed (10M/100Mbps) hub, go to step 2.
If the customer is using a 100Base fixed (100Mbps only) hub, go to step 3.
- 2) For the customer using a dual speed hub:
Set the network (ethernet) speed of the machine to 10Mbps.
The default setting of the machine is "Auto." This setting can be changed in the "Network Setup" in the user mode "Host Interface" ("Interface Settings" in the "System Settings" for the Model A-C2).

- a) Set the network (ethernet) speed of the machine to 10Mbps.
The default setting of the machine is "Auto." This setting can be changed in the "Network Setup" in the user mode "Host Interface" ("Interface Settings" in the "System Settings" for the Model A-C2).
- b) Install a dual speed hub between the 100Base fixed hub and the machine.

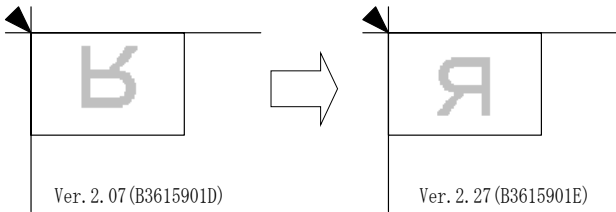
Descriptions	Version
<p><i>Firmware modified to correct the following:</i></p> <ol style="list-style-type: none"> Software changed so that the original can be placed on the exposure glass just as with copying, i.e. there is no need to turn the original upside-down (for <u>both</u> directions).

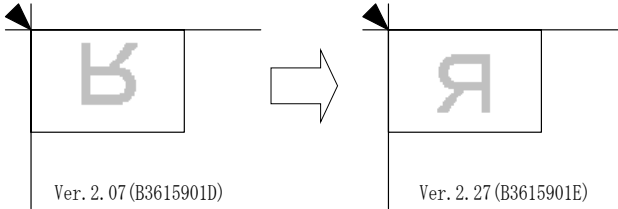
Descriptions	Version
<p><i>Firmware modified to correct the following:</i></p> <ol style="list-style-type: none"> Software changed so that the original can be placed on the exposure glass just as with copying, i.e. there is no need to turn the original upside-down (for <u>both</u> directions).
