Model: Mojito		Date: 10-Nov-00	No.: RA293015
Subject: Printer Controller (B337) System Firmware Histories		Prepared by: A. Sasaki	
From: Technical Service Dept., GTS Division			
Classification:	<input type="checkbox"/> Troubleshooting	<input type="checkbox"/> Part information	<input type="checkbox"/> Action required
	<input type="checkbox"/> Mechanical	<input type="checkbox"/> Electrical	<input type="checkbox"/> Service manual revision
	<input type="checkbox"/> Paper path	<input type="checkbox"/> Transmit/receive	<input type="checkbox"/> Retrofit information
	<input checked="" type="checkbox"/> Other (Information)

This is to inform about the modification histories of the system firmware of Printer Controller Type 700 (B337).

Model: Bellini		Date: 23-Aug-00	No.: RA294030
Subject: Interface Board Installation		Prepared by: A. Sasaki	
From: Technical Services Dept., GTS Division			
Classification:	<input checked="" type="checkbox"/> Troubleshooting	<input type="checkbox"/> Part information	<input type="checkbox"/> Action required
	<input type="checkbox"/> Mechanical	<input type="checkbox"/> Electrical	<input type="checkbox"/> Service manual revision
	<input type="checkbox"/> Paper p

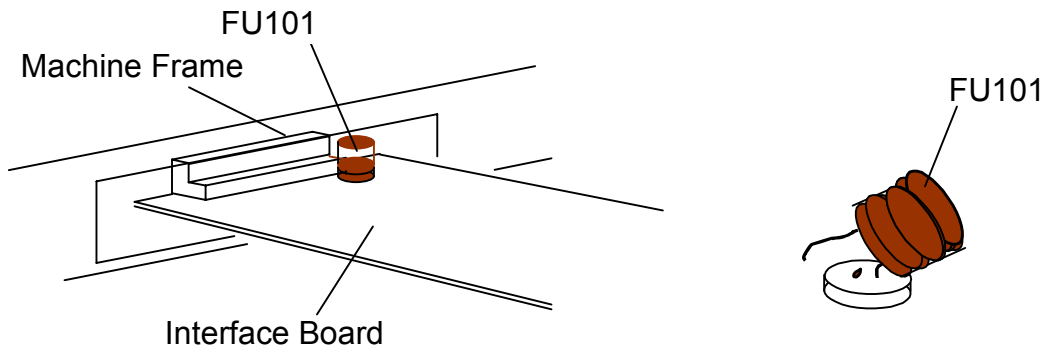
The fuse FU101 on the interface board is damaged.

When the interface board is inserted, the top part of the fuse brushes against the machine frame and a leg of the fuse comes loose.

Please make sure that the fuse on the interface board does not touch the machine frame when you insert the interface board.
