Model: Model-J CF		Date: 4-Mar-02	No.: RG570001
Subject: Language Software History		Prepared by: H. Someya	
From: Technical Services Dept., GTS Division			
Classification:	<input type="checkbox"/> Troubleshooting	<input type="checkbox"/> Part information	<input type="checkbox"/> Action required
	<input type="checkbox"/> Mechanical	<input type="checkbox"/> Electrical	<input type="checkbox"/> Service manual revision
	<input type="checkbox"/> Paper path	<input type="checkbox"/> Transmit/receive	<input type="checkbox"/> Retrofit information
	<input checked="" type="checkbox"/> Other ()

Model: Model-J CF		Date: 15-Mar-02	No.: RG570002
Subject: Remarks at firmware update		Prepared by: T. Itoh	
From: Technical Services Dept., GTS Division			
Classification:	<input type="checkbox"/> Troubleshooting	<input type="checkbox"/> Part information	<input checked="" type="checkbox"/> Action required
	<input type="checkbox"/> Mechanical	<input type="checkbox"/> Electrical	<input type="checkbox"/> Service manual revision
	<input type="checkbox"/> Paper path	<input type="checkbox"/> Transmit/receive	<input type="checkbox"/> Retrofit information
	<input type="checkbox"/> Other ()

Model: Model-J CF		D

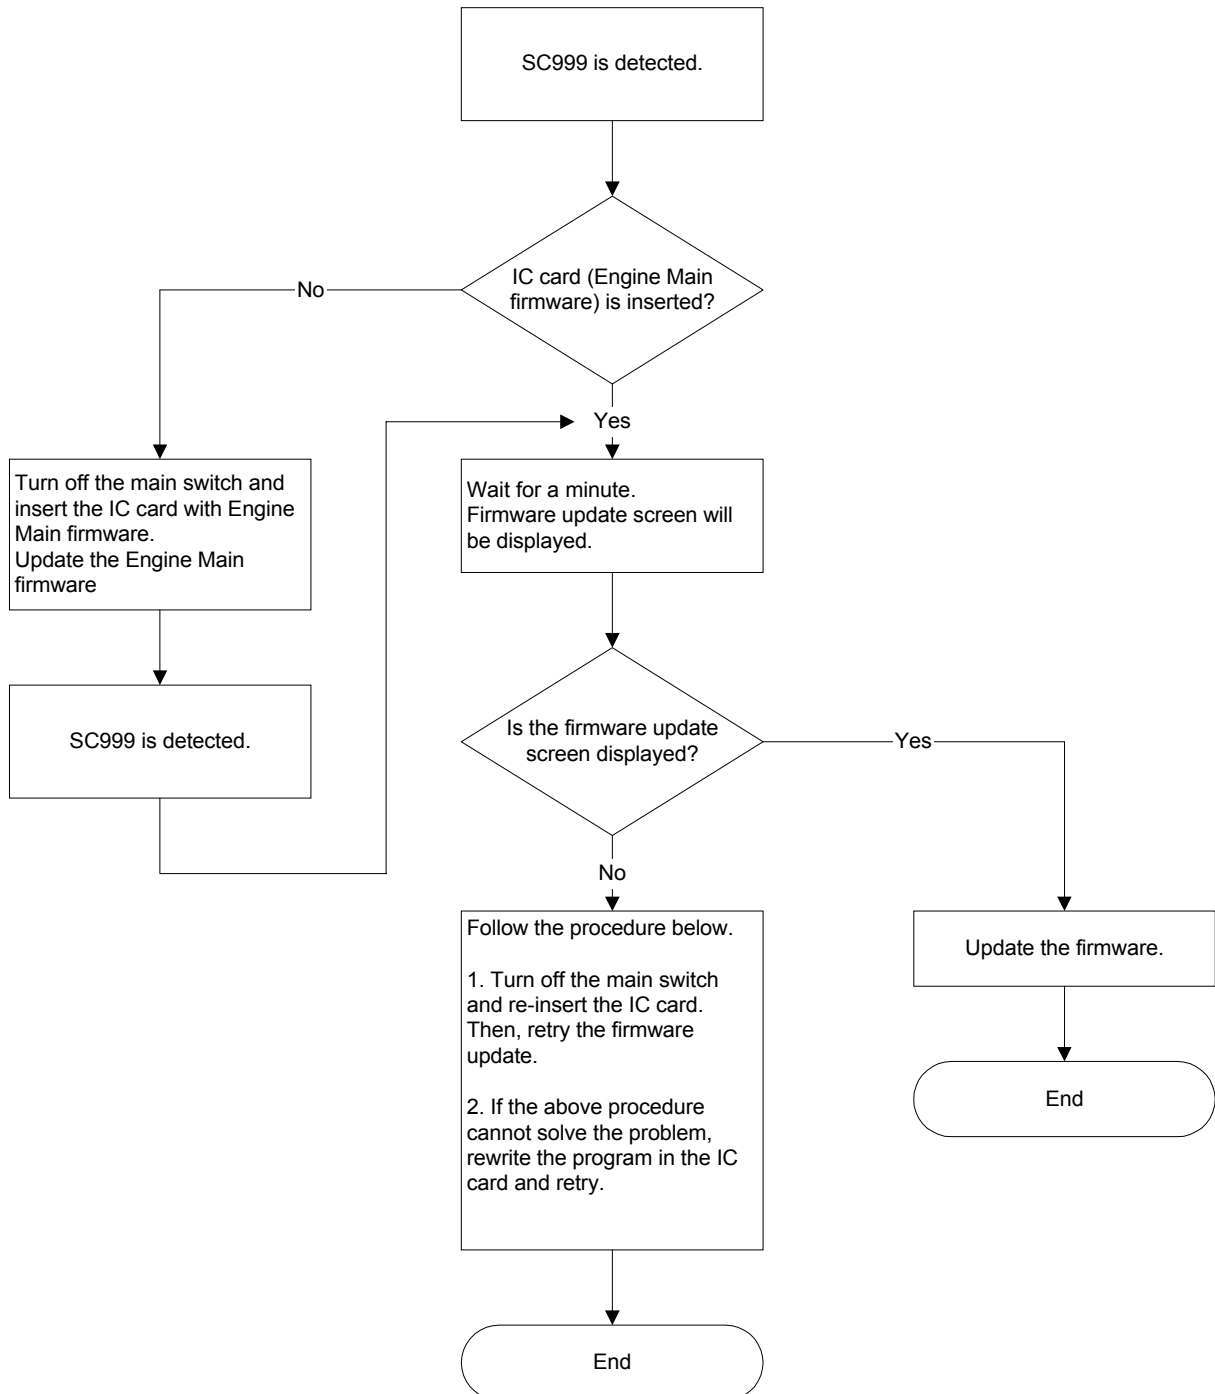
If for some reason NOTES 2 and 3 above are not followed, and SC999 occurs at power up when trying to update the system firmware to V1.07, please use the following flowchart to clear the condition.

NOTE 2: To prevent SC999 occurring at power up, whenever updating the system firmware to V1.07 or newer, make sure to install engine main firmware 1.17C or newer first.

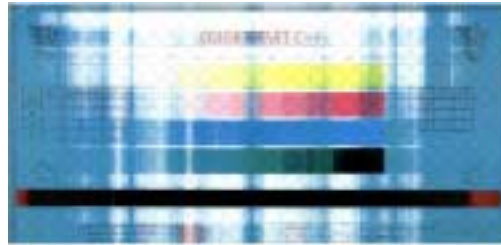
- SC142 (White Level Detection Error)
- SC101 (Exposure Lamp Error)
- Colored vertical lines/bands/background (see photo).

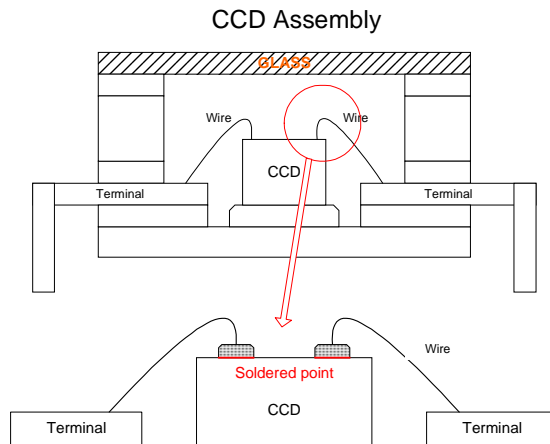
The adhesive used to attach the glass to the CCD assembly was changed. However, it generated a gas when exposed to the heat from the PCB during machine operation. The gas caused the soldered points of wires on the CCD to oxidize and deteriorate, resulting in poor contact.

Retrofit parts (lens block assemblies) will be provided to the field FOC for all affected units. Therefore, at the next service visit or when the issue is reported, please replace with P/N B1169455.

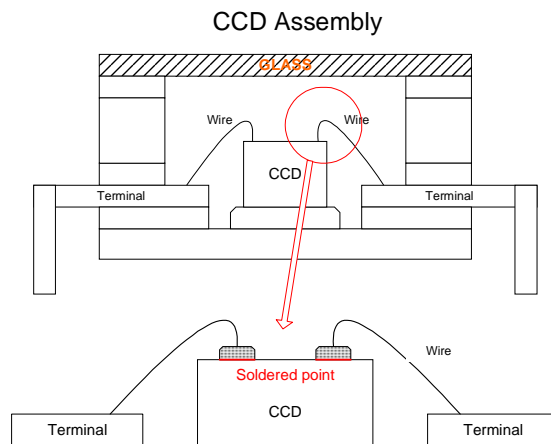
The adhesive used to attach the glass to the CCD assembly was changed, but it generated a gas when exposed to the heat from the PCB during machine operation. The gas caused the soldered points of wires on the CCD to oxidize and deteriorate, resulting in poor contact.

Retrofit parts (lens block assemblies) will be provided to the field FOC for all affected units. Therefore, at the next service visit or when the issue is reported, please replace with P/N B1169455.
