Model: General RTB	Date: 4-Feb-03	No.: RGene013b
--------------------	----------------	----------------

Model: Model J-P2CF		Date: 30-Apr-03	No.: RG367001
Subject: Firmware Modification		Prepared by: H. Someya	
From: 1st Tech. Support Sec. Service Support Dept.			
Classification:	<input type="checkbox"/> Troubleshooting <input type="checkbox"/> Mechanical <input type="checkbox"/> Paper path <input type="checkbox"/> Other ()	<input checked="" type="checkbox"/> Part information <input type="checkbox"/> Electrical <input type="checkbox"/> Transmit/receive	<input type="checkbox"/> Action required <input type="checkbox"/> Service manual revision <input type="checkbox"/> Retrofit information

Model: Model J-P2 CF		Date: 24-Mar-04	No.: RG367004
Subject: SC142 due to defective CCD		Prepared by: H.Taguchi	
From: 1st Tech. Support Sec. Service Support Dept.			
Classification:	<input checked="" type="checkbox"/> Troubleshooting <input type="checkbox"/> Mechanical <input type="checkbox"/> Paper path <input type="checkbox"/> Other ()	<input type="checkbox"/> Part information <input type="checkbox"/> Electrical <input type="checkbox"/> Transmit/receive	<input type="checkbox"/> Action required <

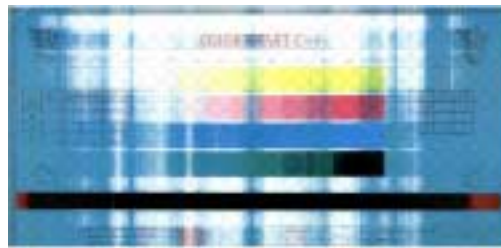
- SC142 (White Level Detection Error)
- SC101 (Exposure Lamp Error)
- Colored vertical lines/bands/background (see photo).

The adhesive used to attach the glass to the CCD assembly was changed, but it generated a gas when exposed to the heat from the PCB during machine operation. The gas caused the soldered points of wires on the CCD to oxidize and deteriorate, resulting in poor contact.

The adhesive has been changed back to the original type.

Retrofit parts (lens block assemblies) will be provided to the field FOC for all affected units. Therefore, at the next service visit or when the issue is reported, please replace with P/N B1169455.

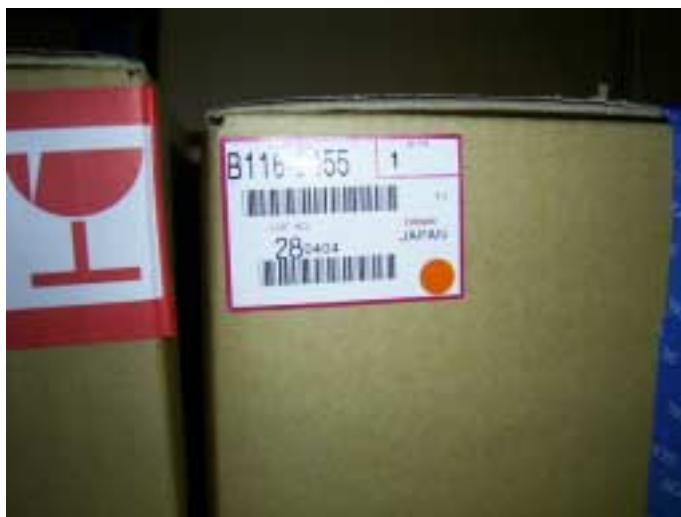
Step 7 on pg. 4 below, i.e. checking to make sure SP4-205 is at 70, is necessary due to a RAM data error with the retrofit lens block assemblies (#B1169455) discovered at the manufacturer's side. Specifically, one of the several special tools used by the manufacturer was defective, causing a limited amount of assembly RAMs to contain a value of 8 instead of the normal 70. Therefore, please ensure that this value is at 70 in Step 7 below, as dirty background in ADS mode may occur if this value is 8.

Please note that all boxes bearing the seal shown below contain lens block assemblies with the correct data (70).

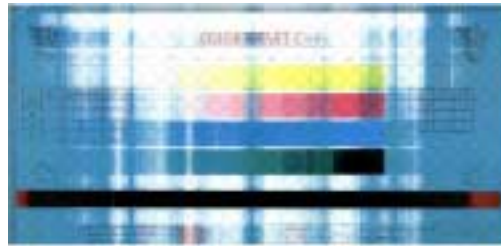
- SC142 (White Level Detection Error)
- SC101 (Exposure Lamp Error)
- Colored vertical lines/bands/background (see the photo).

The adhesive used to attach the glass to the CCD assembly was changed, but it generated a gas when exposed to the heat from the PCB during machine operation. The gas caused the soldered points of wires on the CCD to oxidize and deteriorate, resulting in poor contact.

Retrofit parts (lens block assemblies) will be provided to the field FOC for all affected units. Therefore, at the next service visit or when the issue is reported, please replace with P/N B1169455.
