SUBJECT: Caution about not mixing different size originals with DF-43

AD-1

AD-1 (DF43)

Model: AD1 (DF43)		Date: 28-Feb-97	No: 019	1/2
Subject: Black stripes			Prepared by: K. Ugaeri	
From: QAC 2nd Field Information Dept .			Checked by: S. Fujii <i>T. Inoue</i>	
Classification:	<input checked="" type="checkbox"/> Troubleshooting <input type="checkbox"/> Part information <input type="checkbox"/> Action required <input type="checkbox"/> Mechanical <input type="checkbox"/> Electrical <input type="checkbox"/> Service manual revision <input type="checkbox"/> Paper path <input type="checkbox"/> Transmit/receive <input type="checkbox"/> Retrofit information <input type="checkbox"/> Other ( )

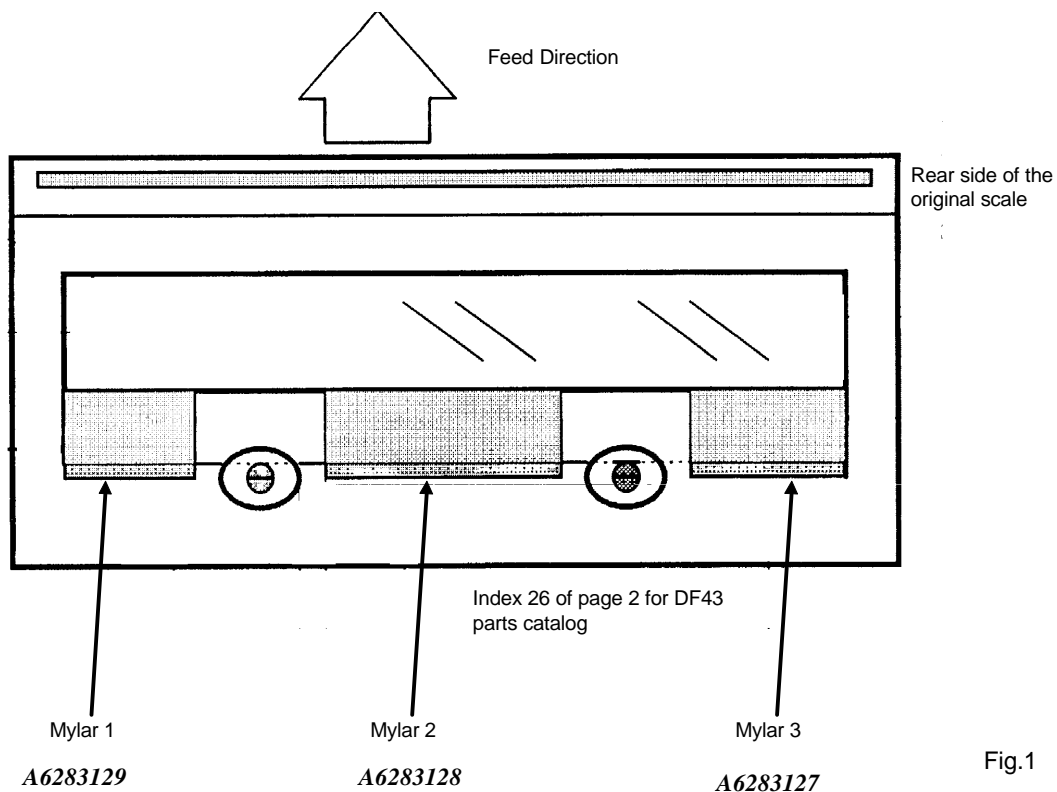
Fig.1

Black stripes when using the sheet scanner

Dust on the exposure glass.

1. The **three** mylars have been added on the original scale (A6283192) to prevent the scanning position on the exposure glass from becoming dirty.

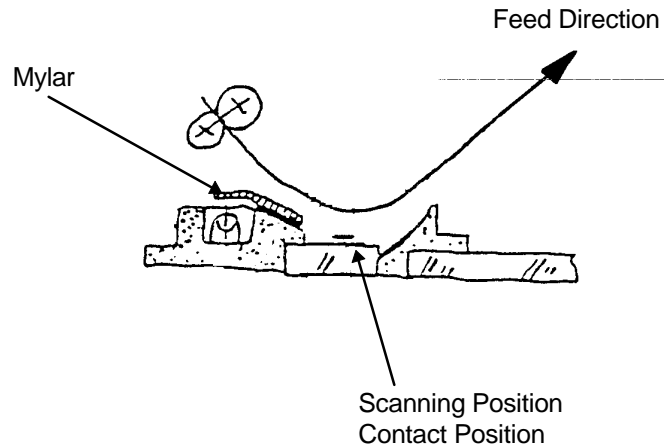
Fig. 2

Because the contact position of the original becomes dirty with paper dust, it has been moved from the scanning position by using mylars.

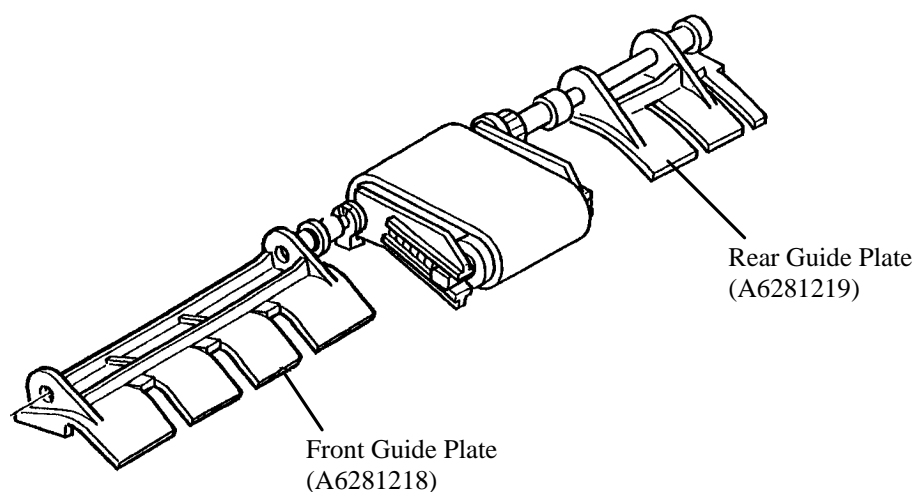
The left cover cannot be closed.

The Front or Rear Guide Plate was accidentally turned to the left when the operator removed a jammed original, because these plates are difficult to see.

The color of the Front and Rear Guide Plates has been changed from black to a clear color.

Current	New
Front Guide Plate	A628 1218B	A628 1218C
Rear Guide Plate	A628 1219B	A628 1219C
