SUBJECT: F400/F410 Dual Job Feeder separation belts
(manual correction)

FROM: Copier Technical Support Group

MODEL: F400/F410

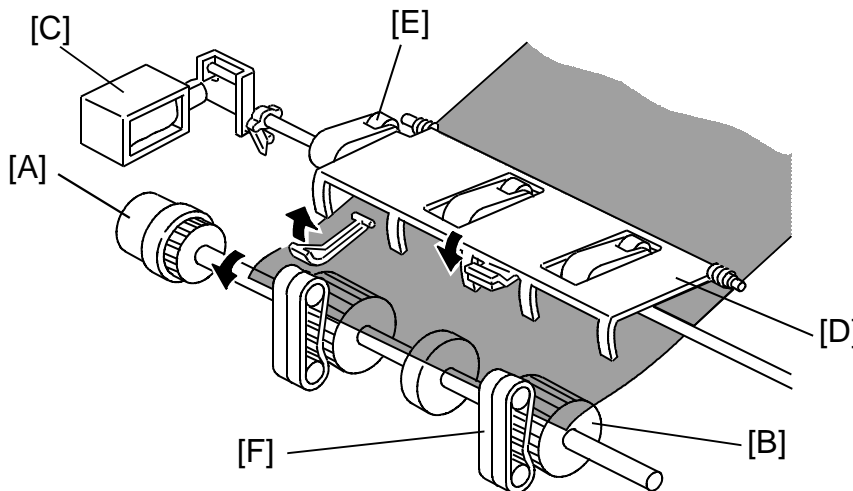
Page 7 - upper illustration

The quantity of the separation belt have been changed from two to four.

On the original printed by the laser printer, the toner may not be fused sufficiently and the image may smeared by the separation belts.

Because of this modification, the illustrations in page 7, 14, 15, 34 and 35 should be changed. The quantity of the separation belts should be doubled. There is no correction except illustrations.

To prevent this, two more separation belts are added to widen the contacting area between the separation belts and the original so that the separation pressure is not concentrated to the narrow area.

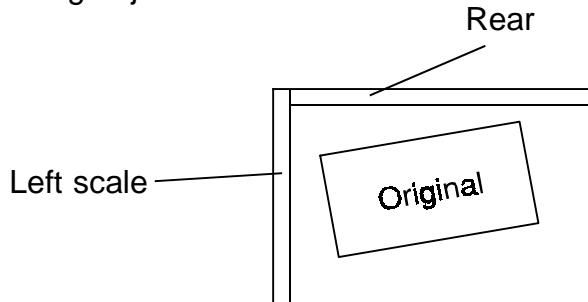
9. DJF Original Skew

If original skews occur as illustrated even if the DJF height is correctly adjusted, perform the following adjustment.

This skew is caused because the transport belt is faster than the feed-in motor speed, even if both motor speeds are within the specification.

1. Feed-in motor speed adjustment

Adjust the feed-in motor speed so that the motor speed becomes higher (within specification).

2. Transport belt motor speed adjustment

Adjust the transport belt motor speed so that the motor speed becomes lower (within specification).

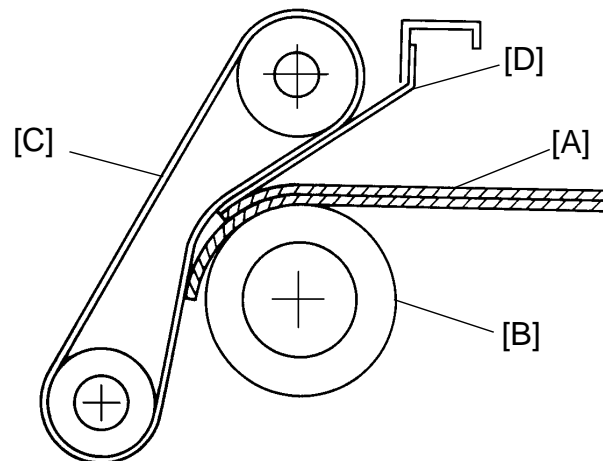
Original multiple feeding occurs when there is high friction between the originals. This tends to occur especially when the originals have staple holes, or computer forms with rough edges.

When the originals [A] comes between the feed rollers [B] and the separation belts [C], they meet the mylar [D] between them and the separation belts. This guide mylar transports the originals smoothly to the gap between the feed rollers and the separation belts. The mylar length determines the original separation force. If the mylar is longer, the area where the originals touch the separation belt becomes narrower, therefore the separation force become weaker. If the mylar is shorter, the separation force becomes stronger. (If it is too short, too much separation force stops original feed)
As a result of our investigation, we found that making the mylar 2mm shorter is the best condition (higher separation ability without feeding error).

Replace the original guide mylars (2 mylars per machine). New part is the assembled part of the mylar and the bracket. New part number is A3761254.

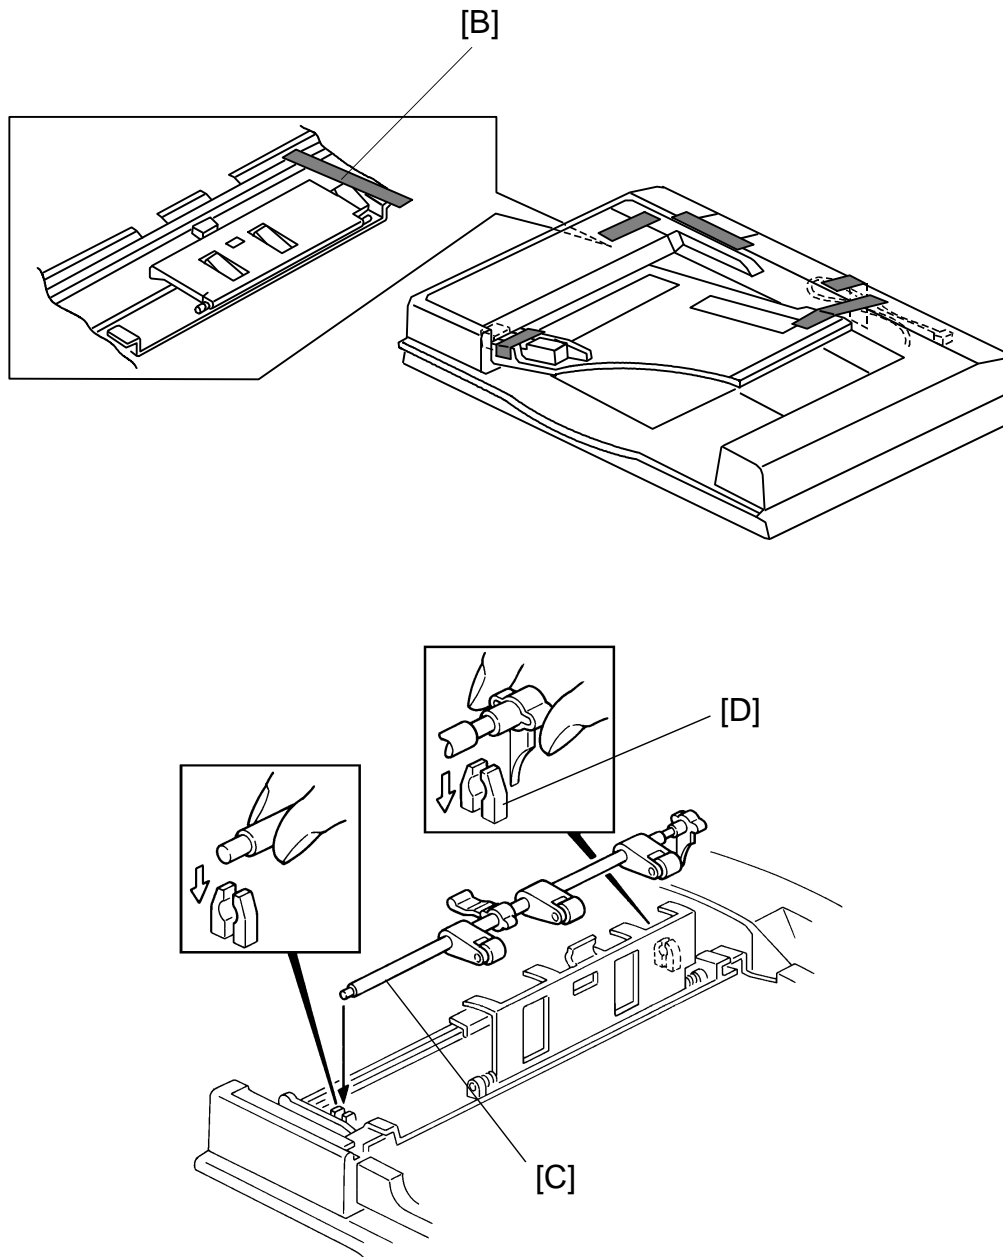
3. Caution for DJF shipping tape removal (dual job feeder service manual - installation procedure page, 24)

When removing the tape [B] fixing the original press roller shaft [C], be careful to confirm that the shaft is correctly in the holder [D]. It is possible that the shipping tape adheres strongly to the shaft. The shaft might be pulled out from the holder when the tape is removed.

If the shaft is out of position, the original will not feed.

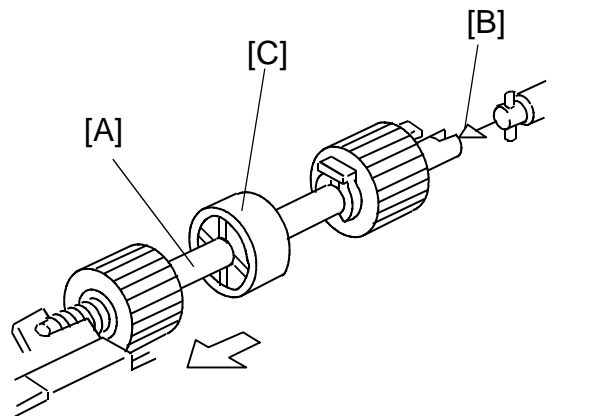
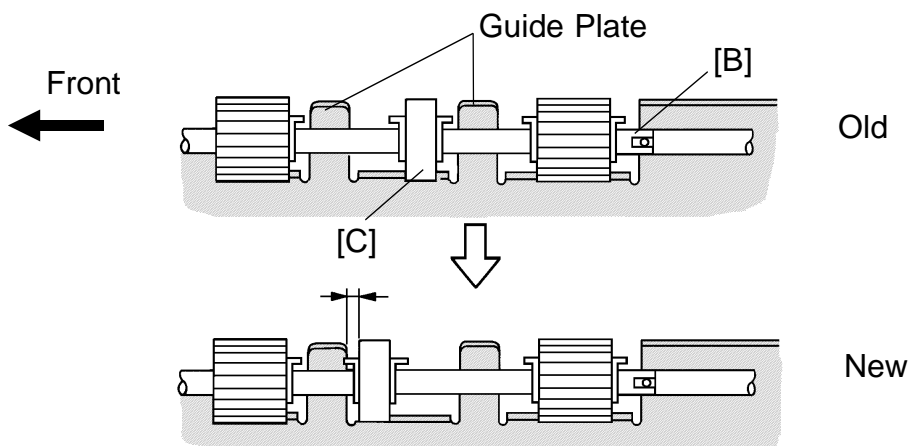
In the domestic market, we have experienced that the customer took off the feed roller assembly [A] when removing a jammed original. When the jammed original is pulled to the front, the feed rollers are pulled to the front and the joint part [B] comes out from the drive shaft. To prevent this, The middle roller [C] position has been changed (to the rear) as shown below.

Before the modification, the middle roller could be shifted to the front when the feed roller was pulled to the front. After the modification, when the feed roller is pulled to the front, the middle roller hits the guide plate and it cannot be moved to the front. This prevents the joint part from being separated by mistake.

To replace the feed roller assembly, the following procedure is necessary before performing step 6 (slide the feed roller assembly to the front, then remove it).

- * Remove the guide mylars
- * Remove the snap ring.
- * Hold the feed roller.

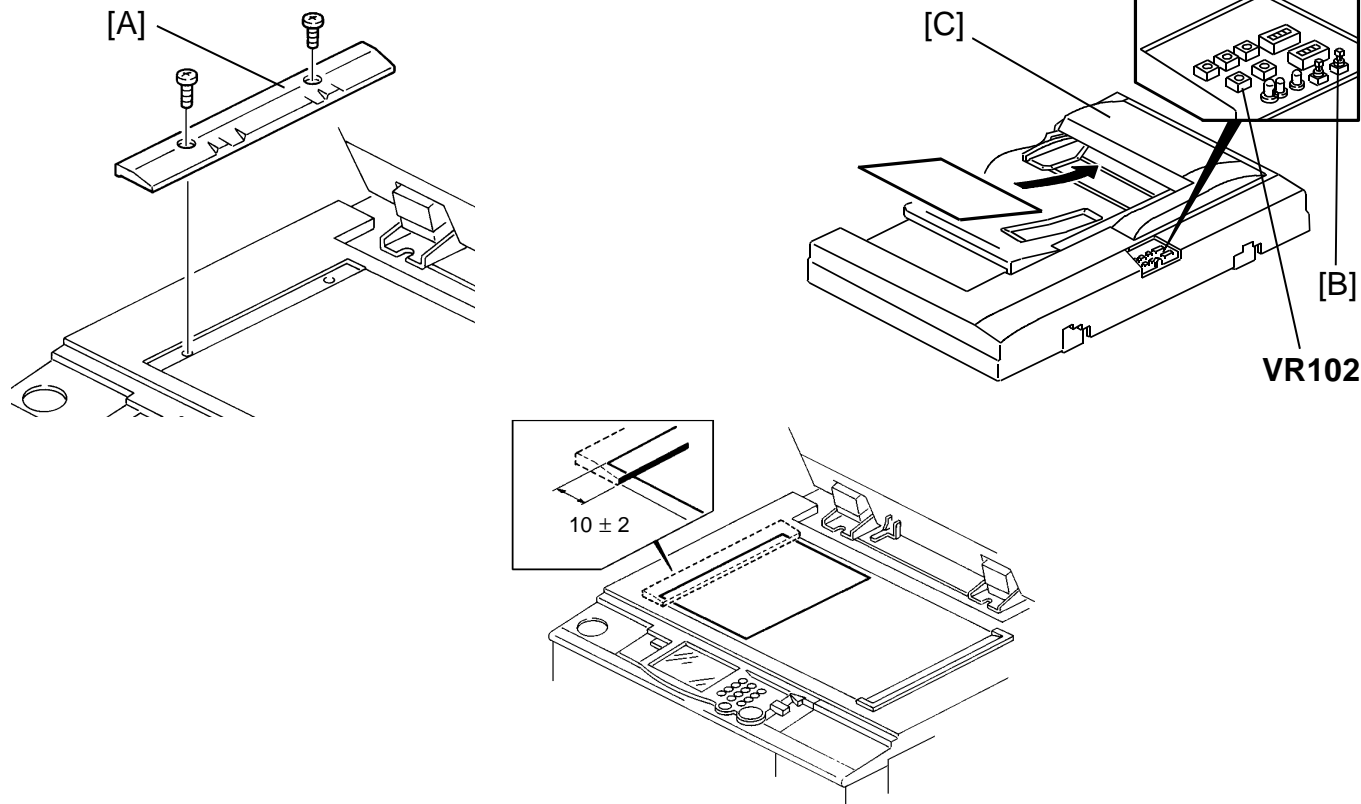
Two Sided Original Mode

Dual job feeders with the following serial numbers have the possibility that the vertical registration for two sided original mode is improper due to insufficient inspection during production.

1. Remove the copier's left scale [A] (2 screws).
2. Remove the small cover at the rear side on the upper DJF cover then turn on DIP SW 101-2, 101-4, and 102-1.
3. Set a sheet of A4 / 8 1/2" x 11" (53 ~ 80 g/m² / 14 ~ 22 lb) paper sideways on the original table.
4. Push SW 101 [B].
5. After the original stops on the exposure glass, gently raise the DJF (so that the original does not move).
6. Confirm that the gap between the trailing edge of the paper and the left edge [C] of the original rear scale is 10 ± 2 mm.
7. If the gap is not within specification, adjust the registration by using the copier SP mode (SP Adjustment - PAGE 6).

8. If the registration cannot be adjusted even though the SP data is changed to the maximum value, return the data to "00".
9. Adjust the vertical adjustment by turning VR102 on the DJF main board.

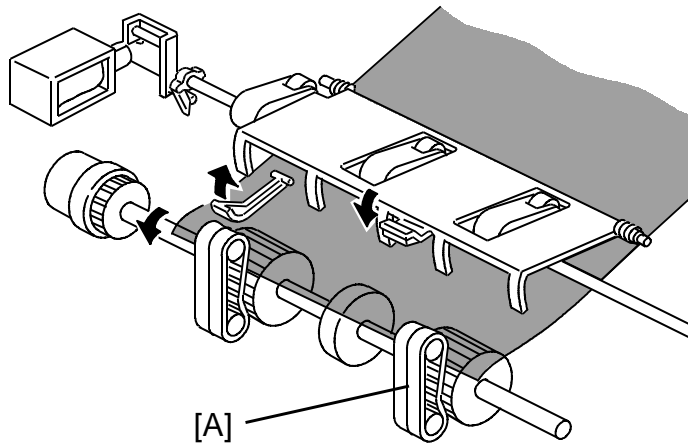
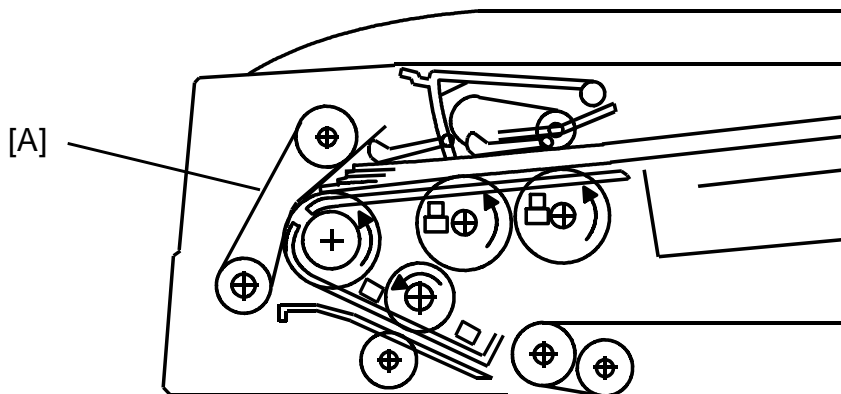
Original double feeding (two originals are fed at a time) tends to occur when the separation belts [A] become dirty with foreign matter which being transferred from the original surface.

When the separation belt surface is covered with foreign matter, the friction between the original and the separation belt decreases. This reduces the original separation ability.

Clean the separation belt surface with alcohol to recover the separation ability. We recommend to do this **at every customer visit** including at the installation to eliminate further EM calls.

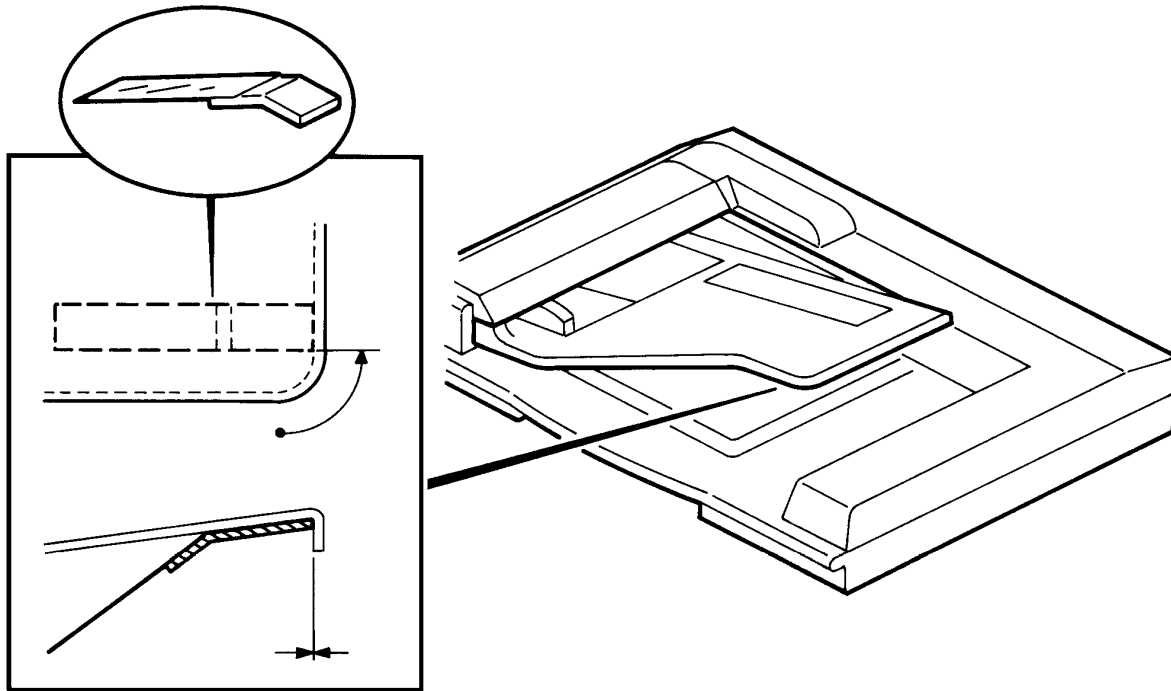
During auto counting mode, the original delivery speed varies. The original stack alignment become irregular, and in the worst case, the original order changes.

When the original is delivered in auto counting mode, the original exit motor changes its speed. Just before the trailing edge of the original passes through the exit roller, its speed decreases to correct the original stack. Normally the original exit motor changes to the quicker speed after completely feeding out the original. However, sometimes, the exit motor returns to the quicker speed before the original trailing edge passes through the exit roller. In this case, the original is pushed out quickly, resulting in the irregular original stack.

The original stack guide mylar is added. This mylar is attached to the DJF as an accessory. Please install the mylar at installation as shown in the illustration below.

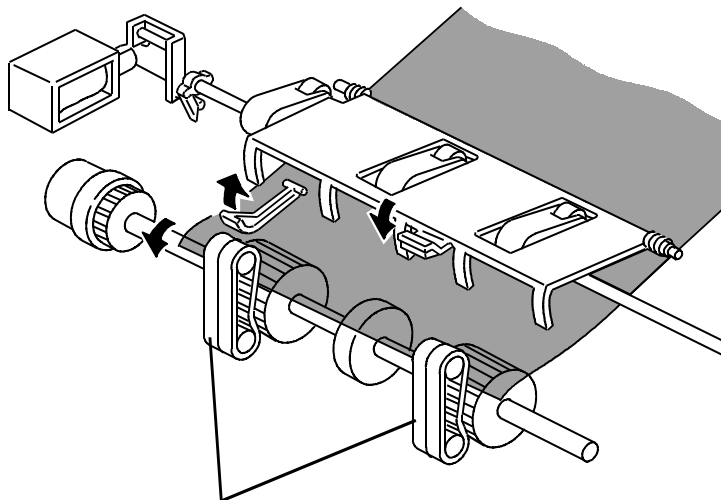
Separation Belts

Original double feeding (two or more sheets of the originals are fed at a time)

The separation belts become dirty with the toner, losing the friction to separate the originals.

This is especially true when the customer feeds lots of poorly fused originals such as laser output or cotton paper.

Replace the separation belts with the new parts. The new part number is A3769502.

The material of the separation belts has been changed to the one which less toner adheres to.

NOTE: Depending on the type of originals that the customer use, there is still a possibility that the separation belts become dirty. For those cases, cleaning the belts at every visits, which was introduced in the previous RTB, is recommended.

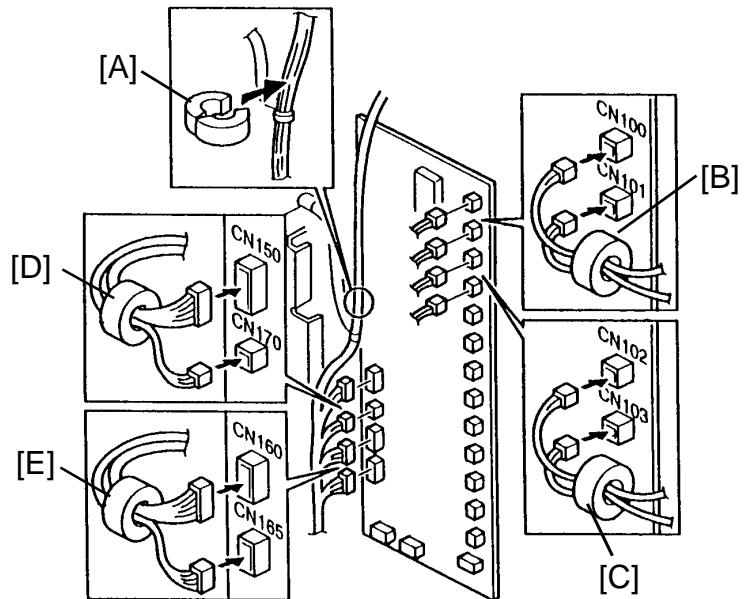
To comply with the CE mark, it is necessary to attach five ferrite cores when installing a sorter on DFC - α . The ferrite cores have been enclosed in the screw bag of the DFC - α from September production. Please refer to the following for the installation procedure of the ferrite cores.

1. Turn off the main switch and unplug the machine.
2. Remove the sorter top cover (3 screws).
3. Remove the sorter rear cover (4 screws).
4. Attach the ferrite core ([A] P/N 16070721) to the DC harness as shown.
