SUBJECT: DF61 Dirty Mark on Back-side of Original

Phoenix-series  
(DF61)

Model: DF61 (Phoenix series)		Date: 15-Aug-97	No: 20
Subject: Bent Original		Prepared by: S.Hizen	
From: QAC 1st Field Information Dept.			
Classification:	<input checked="" type="checkbox"/> Troubleshooting	<input type="checkbox"/> Part information	<input type="checkbox"/> Action required
	<input type="checkbox"/> Mechanical	<input type="checkbox"/> Electrical	<input type="checkbox"/> Service manual revision
	<input type="checkbox"/> Paper path	<input type="checkbox"/> Transmit/receive	<input type="checkbox"/> Retrofit information
	<input type="checkbox"/> Other (      )

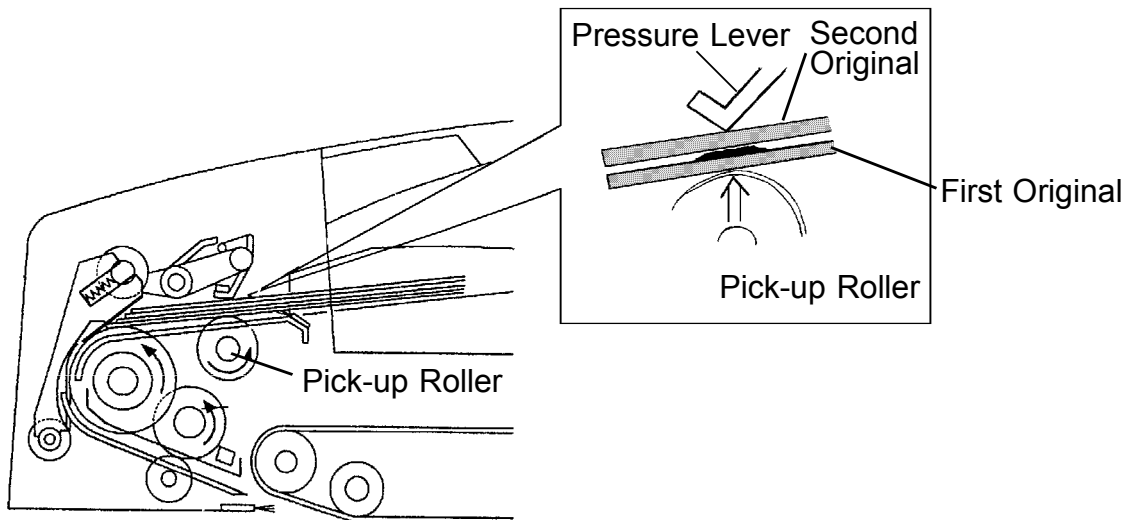
**Problem:** Three dirty marks on the back side of the original.

**Cause:** The toner on the first original is transferred to the back of the second original due to the pressure applied by the pressure lever and the pick-up roller.  
(See the illustration)

The dirty marks created are one of the limitations of the DF61. The degree to which the marks appear varies depending on how completely the image on the first original is fused, the type of image, and the type of paper used.

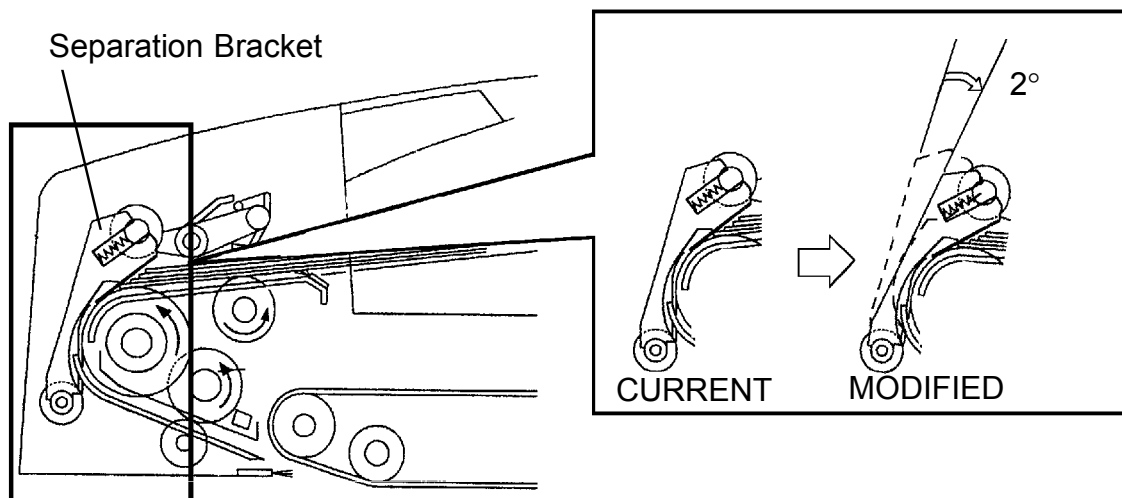
### Separation Bracket

The countermeasure for the dirty marks is designed to reduce the pressure applied to the originals by replacing the entrance guide stopper spring with a new one. This change also results in a decrease in the amount of force used to feed the original and may create an original non-feed problem. Therefore, the separation bracket has been modified to reduce the angle by 2 degrees.

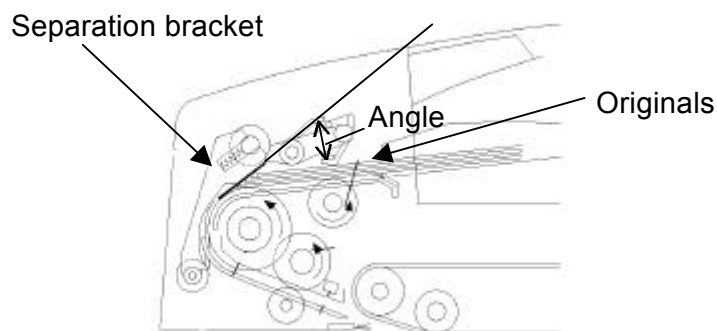
There is a bend (wrapping) on the leading edge of the original the same size as the width of the separation belt. If the bend in the original is large, dirty background may appear on the copy in the area that corresponds with that bend.

The problem occurs as a result of the contact between the edge of the original and the separation belt when the original is fed to the exposure glass. If the upward curl of the original is large or the cut in the leading edge of the paper is not smooth, this problem is more likely to occur.

The angle between the separation belt and the originals, and the symptoms caused by the angle.

Large: Good for separation, marginal for original leading edge bending

Small: Good for original leading edge bending, marginal for double-sheet feeds.

The Separation Belt Tension also affects the angle

Strong: If the tension is strong, the angle is relatively large.

Weak: If the tension is weak, the angle is relatively small

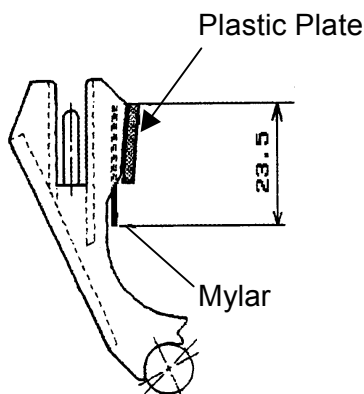
**Mass-production.**

A548-1291

Bracket Spring: AA06-3503

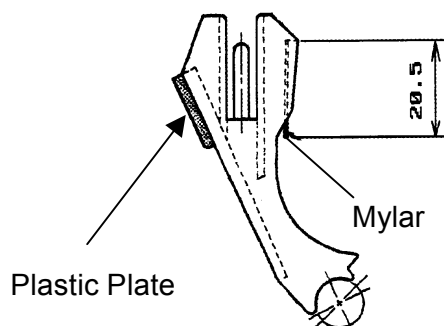
**RTB-11**

Bracket for the dirty mark on the back side of original.

A548-9502

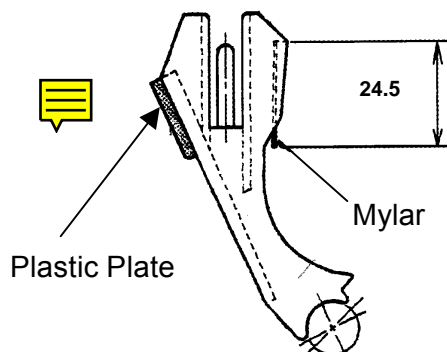
**RTB-20**

Bracket for the leading edge bend.

A548-9504

(This number is for the Bracket and the Spring)
