Model: Phoenix II /Cattleya/Iris/Lilac (ADF)		Date: 15-Sep-99	No.: RA204010
Subject: ADF Jam		Prepared by: H.Matsui	
From: Technical Service Dept., GTS Division			
Classification:	<input checked="" type="checkbox"/> Troubleshooting	<input type="checkbox"/> Part information	<input type="checkbox"/> Action required
	<input type="checkbox"/> Mechanical	<input type="checkbox"/> Electrical	<input type="checkbox"/> Service manual revision
	<input type="checkbox"/> Paper path	<input type="checkbox"/> Transmit/receive	<input type="checkbox"/> Retrofit information
	<input type="checkbox"/> Other (     )

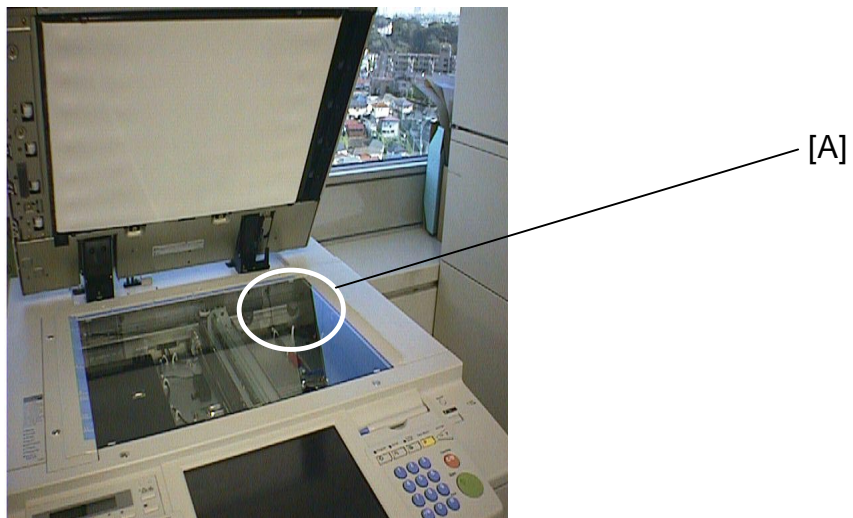
When feeding small size originals lengthwise, a original jam may occur in the area on the exposure glass where the original is to be fed out (position [A]).

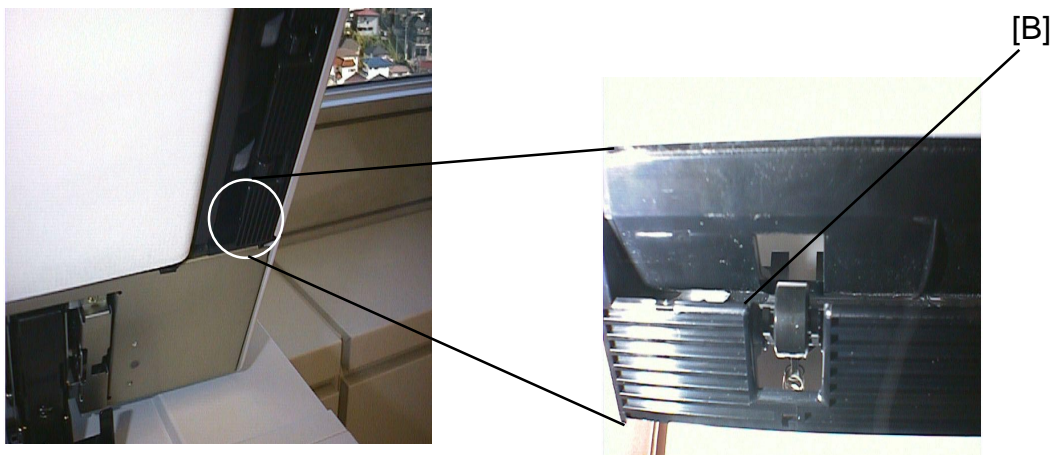
The rear side of the leading edge of the originals catches ridge [B] (this ridge was created during the molding process), near one of the ribs of the paper inverter guide plate (P/No. A5481210).

Until the permanent countermeasure is implemented, the ridge [B] should be smoothed down (remove if possible) with sandpaper.

From the serial numbers in the following table, a permanent countermeasure will be applied (the mold used to produce the inverter guide plate will be repaired). Therefore, the above action should not have to be done.
