| Model: NAD 30S/30/40 DF (DF67) | | Date: 15-Oct-98 | No.: 1 |
| Subject: Original MIsfeed | | Prepared by: S. Hizen | |
| From: GTS and S Field Information Dept. | | | |

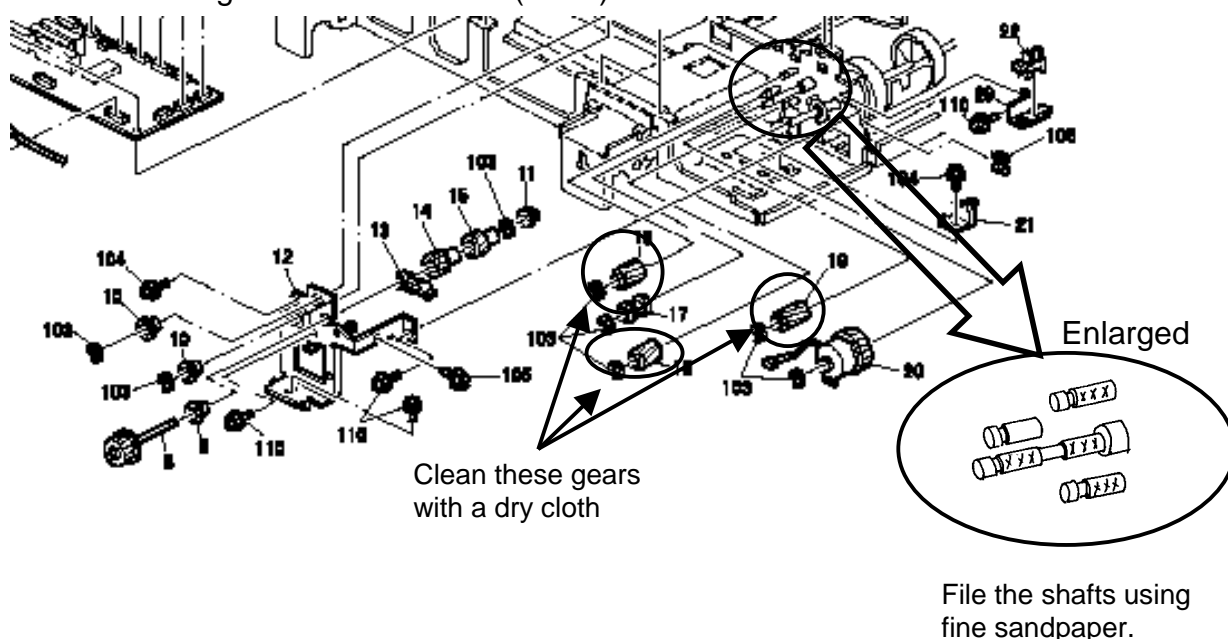
Original feed jam: The original is jammed just after the front edge is fed about 10 cm (A4/LT size) onto the exposure glass.

The friction between the 16Z gear and its shaft increases and exceeds the maximum torque of the feed motor. This is due to tiny burrs on the shaft.

The burrs on the shaft may be too tiny to be visible. You can check for burrs by removing the retaining rings and moving the 16Z gears back and forth slowly by hand. If the gear seems to be stuck, then burrs exist.

File off the tiny burrs on the shaft and lubricate as shown in the following procedure.

1. Take off the retaining rings for the 16Z gears.
  2. File the shafts using fine sandpaper. (Do not use a metal file to file the shaft because this will increase the friction.)
  3. Clean the shafts and the inside of the gears with a dry cloth.
  4. Lubricate the shafts and the inside of the gears with plastic grease (white resin based grease for plastic parts).
  5. Reassemble the gears and the rings.
- Parts Catalog: 7. Drive Section 2 (A680) -
