SUBJECT: F410 RDH Finisher system duplex method change  
(manual corrections)

SUBJECT: RDH Original Size Misdetection

SUBJECT: USER REMARKS WHILE SETTING THE ORIGINAL ON  
THE RDH

SUBJECT: SOFTWARE MODIFICATION

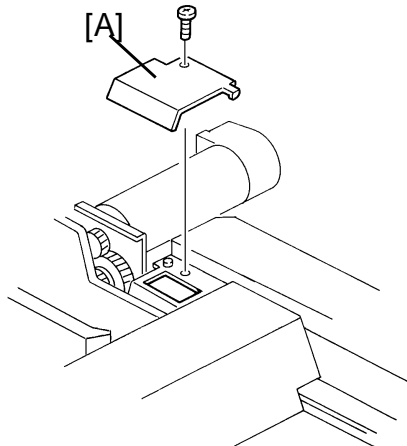
## Page 35 of RDH step #2

Since there is no LED cover, delete the cover [A] from the illustration and correct the following sentence.

- Incorrect  
Close the RDH and remove the LED cover [A] (1 screw).
- Correct  
Close the RDH.

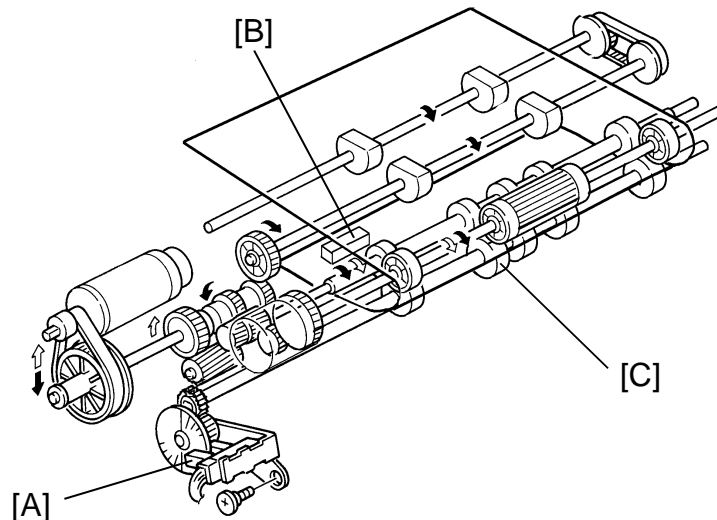
Original length is detected by the pulse generator sensor [A]. the RDH counts pulses from the point where the leading edge of the original activates the registration sensor [B] until the trailing edge of the original de-activates the registration sensor. The pulse count is compared with the reference data which is stored in the ROM to judge the original size.

The pulse generator wheel is driven by the driven pull-out roller [C].

From October to November 1993 production, grease was applied to the four driven roller shaft holders. When this grease on the shaft holders is contaminated with paper dust, it increases the mechanical load to the driven pull- out roller shaft resulting in the slippage between this roller and the original.

Due to the slippage, the pulse count varies. Because of this pulse variation, it is possible that the RDH detect the original length incorrectly.

To reduce the pulse count variation, four holders of driven pull out roller have been modified. To reduce the friction between the roller shaft and the holders, the inner diameter of the holders has been widened.

The grease is not applied.

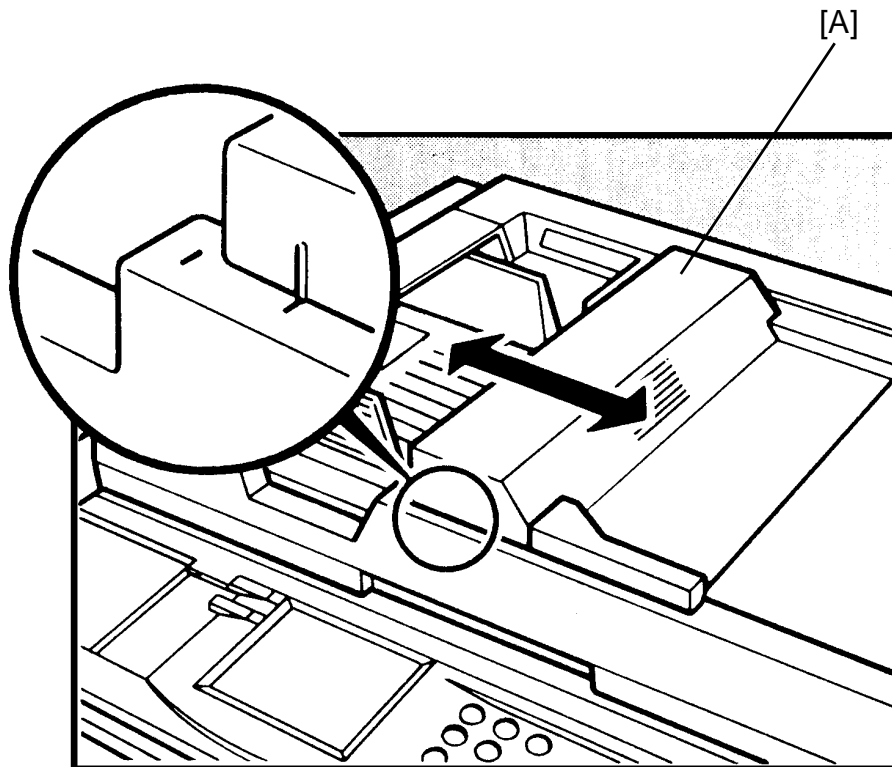
During field survey, we found cases that an incorrect feed out unit position created original jams.

*To prevent original jams,  
slide the feed-out unit [A] to match the size marks on  
the front of the recirculating document handler (RDH).*
