Model: Cattleya2 Controller E-710		Date: 15-Nov-01	No.: RG939001
Subject: "Please Wait", White Line Scans, etc.		Prepared by: Chisato Tsuji	
From: Technical Services Dept., GTS Division			
Classification:	<input checked="" type="checkbox"/> Troubleshooting	<input type="checkbox"/> Part information	<input type="checkbox"/> Action required
	<input type="checkbox"/> Mechanical	<input type="checkbox"/> Electrical	<input type="checkbox"/> Service manual revision
	<input type="checkbox"/> Paper path	<input type="checkbox"/> Transmit/receive	<input type="checkbox"/> Retrofit information
	<input type="checkbox"/> Other (      )

Model: Cattleya2		Date: 19-Jul-02	No.: RG939002
Subject: E-710 System Version 1.01 Release Information		Prepared by: Chisato Tsuji	
From: Technical Services sec. Service Planning Dept.			
Classification:	<input type="checkbox"/> Troubleshooting	<input type="checkbox"/> Part information	<input checked="" type="checkbox"/> Action required
	<input type="checkbox"/> Mechanical	<input type="checkbox"/> Electrical	<input type="checkbox"/> Service manual revision
	<input type="checkbox"/> Paper path	<input type="checkbox"/> Transmit/receive	<input type="checkbox"/> Retrof

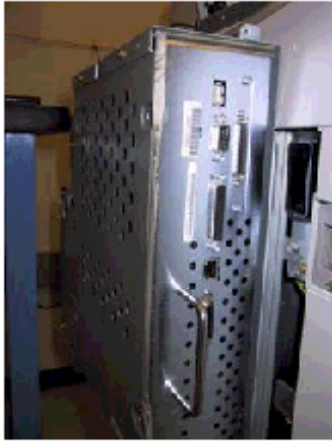
1. Some units were shipped from the factory with the connector in the condition shown in Fig. A below, i.e. the connector was not sticking out at least 4.2mm from the unit (as it should).
2. The connector clears the unit side face by at least 4.2mm, but the controller unit was not inserted far enough into the interface unit at installation (Fig. 1-4 below).

Figure 1 Front view – not fully seated

1. Shut down the Fiery system and turn off the copier main power.
2. Pull out the Fiery controller unit and check to see if the video interface connector sticks out from the unit 4.2mm or more (Fig. A). If not, then follow the instructions in Fig. B below.
3. Fully reseat the controller all the way into the interface unit until the connector fully engages (Fig. 5, 6).
4. Turn on the copier main power.

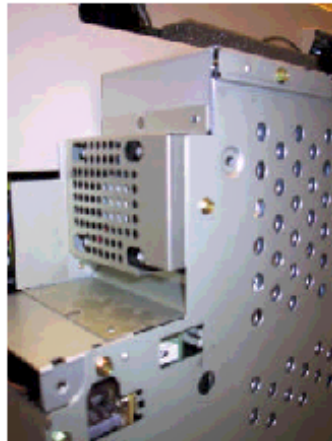
Figure 2 Rear view – not fully seated

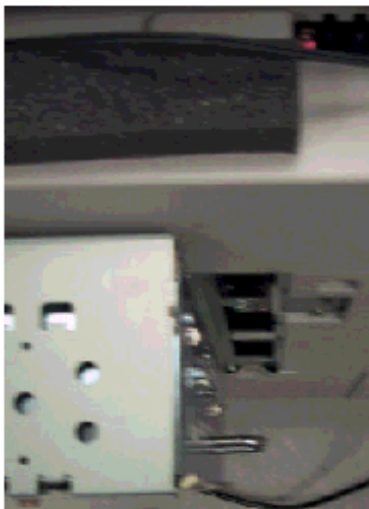
Figure 3 Top view – not fully seated

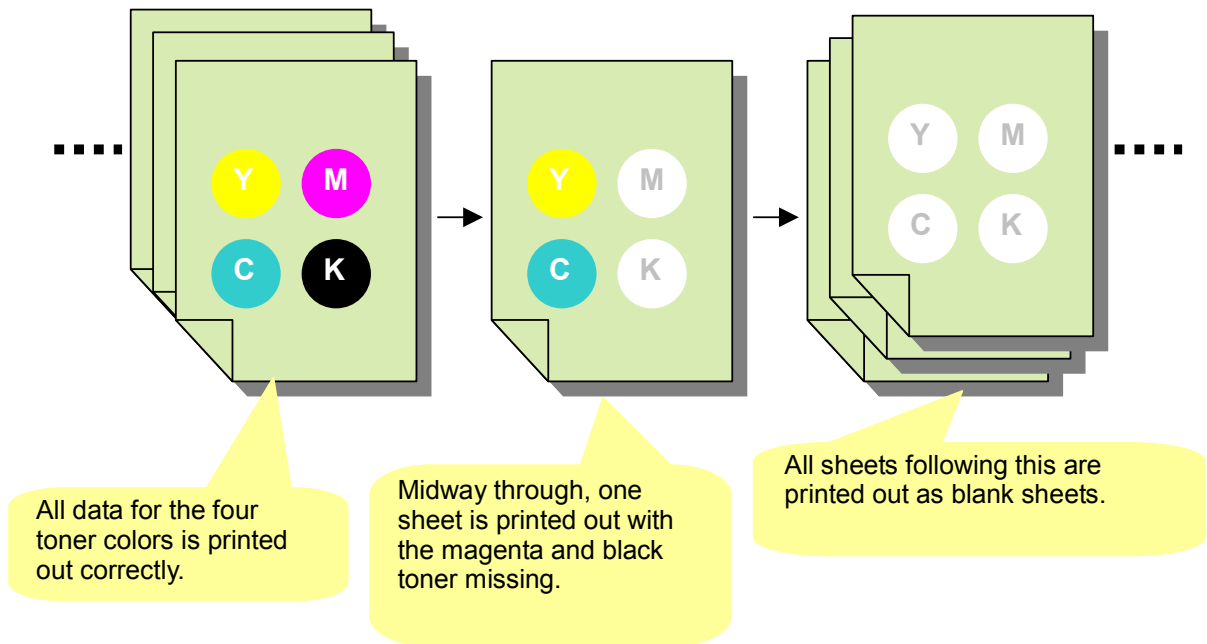
Symptom A

Midway through a job set for a large number of prints, one sheet is missing both magenta and black toner. Following this sheet, the machine prints out blank sheets until the job is reset, completed, or resumed after being interrupted (e.g. after toner/paper replenishment).

When the following two events occur simultaneously, a bug in the controller software disrupts the timing of the color plate data transmission to the engine.

- A software setup event for transferring image data for a color plate to the copier engine
- The arrival of a serial protocol data communication packet between the copier engine and the controller

Install patch file: 1-8RD6Y.ps

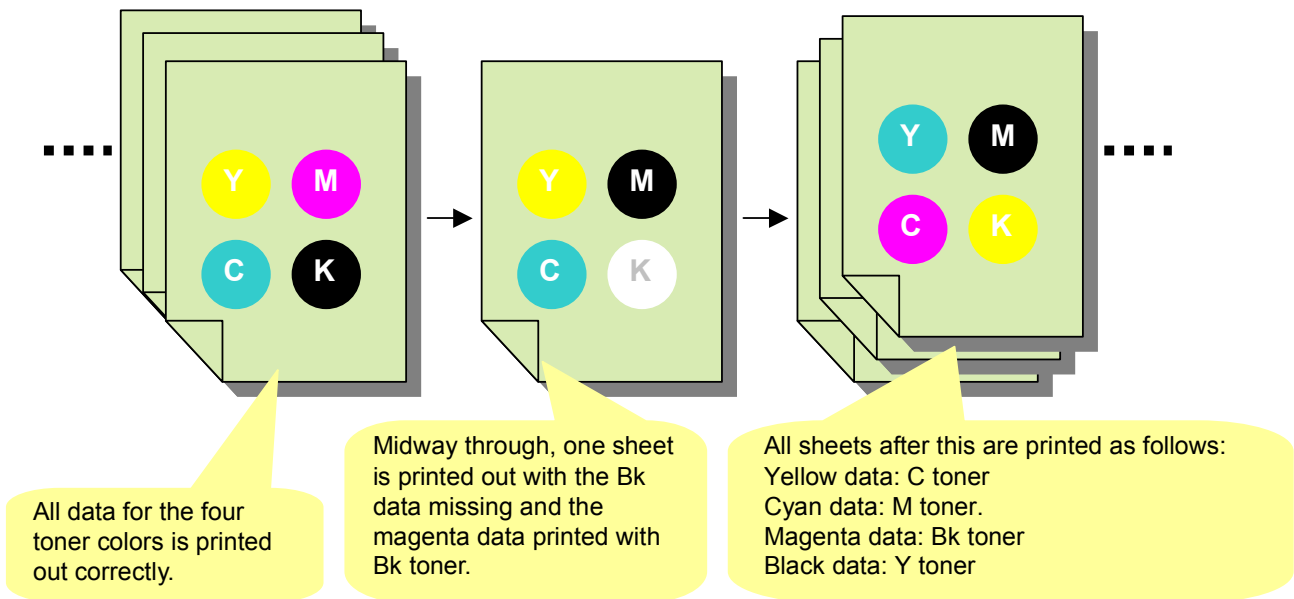
Symptom B

Midway through a job set for a large number of prints, one sheet has the magenta data printed out with black toner, and the black data missing. All sheets are then printed out as shown in the bottom right illustration (i.e. Y→C, C→M, M→K, K→Y) until the job is reset, completed or resumed after being interrupted.

With Symptom B, a delay in the transmission of the magenta color plate causes the engine to receive this data while performing black toner development. All color plate data is then shifted by one, resulting in the pattern shown in the far right illustration.
