Model: Adonis-C2		Date: 20-Sep-01	No.: RB003020
Subject: NCS(NIB) Firmware History		Prepared by: K. Takagi	
From: Technical Services Dept., GTS Division			
Classification:	<input type="checkbox"/> Troubleshooting	<input type="checkbox"/> Part information	<input checked="" type="checkbox"/> Action required
	<input type="checkbox"/> Mechanical	<input type="checkbox"/> Electrical	<input type="checkbox"/> Service manual revision
	<input type="checkbox"/> Paper path	<input type="checkbox"/> Transmit/receive	<input type="checkbox"/> Retrofit information
	<input checked="" type="checkbox"/> Other ()

Model: Adonis-C2		Date: 22-Oct-01	No.: RB003025
Subject: Service Card Release History (MFP)		Prepared by: K. Takagi	
From: Technical Services Dept., GTS Division			
Classification:	<input type="checkbox"/> Troubleshooting	<input type="checkbox"/> Part information	<input type="checkbox"/> Action required
	<input type="checkbox"/> Mechanical	<input type="checkbox"/> Electrical	<input type="checkbox"/> Service manual revision
	<input type="checkbox"/> Paper path	<input type="checkbox"/> Transmit/receive	<input type="checkbox"/> Retrofit information
	<input checked="" type="checkbox"/> Other ()

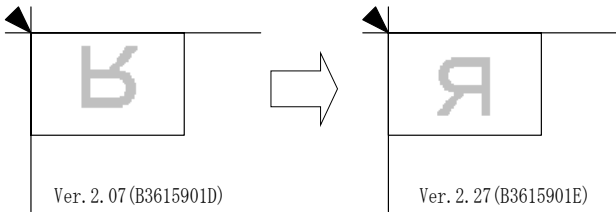
Descriptions	Version
<p><i>Firmware modified to correct the following:</i></p> <p>1. Software changed so that the original can be placed on the exposure glass just as with copying, i.e. there is no need to turn the original upside-down (for <u>both</u> directions).</p>
