SUBJECT: Rubber Feet on Copier Base Plate

DATE: Mar. 15, '93
PAGE: 1 of 1

FROM: Copier Technical Support Section

**A7 Series
(A069/A073/A074)**

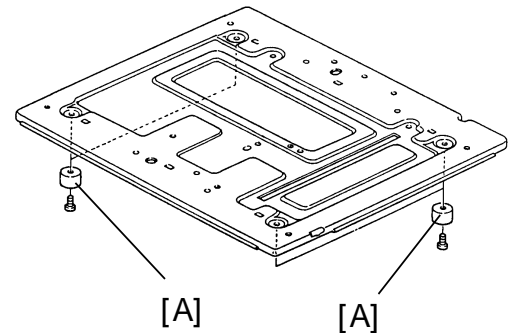
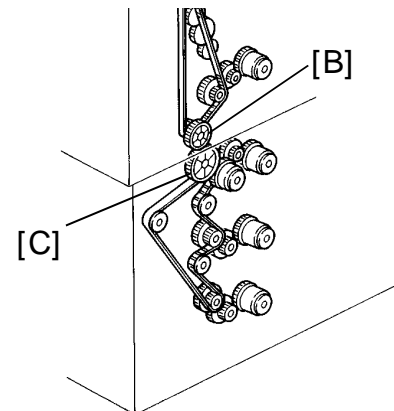
Please be informed that the material for rubber feet [A] on the copier base plate has been changed from hard rubber to molding since June, 1992.

When the copier is installed on the paper tray unit, the rubber feet are compressed by the copier's weight and they may be shortened.

When this occurs the gear mesh between the tray unit drive and driven gears [B,C] becomes tight, causing noise.

To prevent this, the material of the feet has been changed to a hard one. The part number has not been changed.

If the copier slips easily on the table, it is advised to stick rubber plates on the feet by glue or two sided tape for safety. You can use a commercial rubber plate and cut it for the feet.
