Model: Russian-C1		Date: 15-Feb-00	No.: RA265002
Subject: Service Manual Correciton		Prepared by: S. Tomoe	
From: Technical Services Dept., GTS Division			
Classification:	<input type="checkbox"/> Troubleshooting	<input type="checkbox"/> Part information	<input type="checkbox"/> Action required
	<input type="checkbox"/> Mechanical	<input type="checkbox"/> Electrical	<input type="checkbox"/> Service manual revision
	<input type="checkbox"/> Paper path	<input type="checkbox"/> Transmit/receive	<input type="checkbox"/> Retrofit information
	<input checked="" type="checkbox"/> Other ()

Please correct your service manuals as follows:

Technical Bulletin

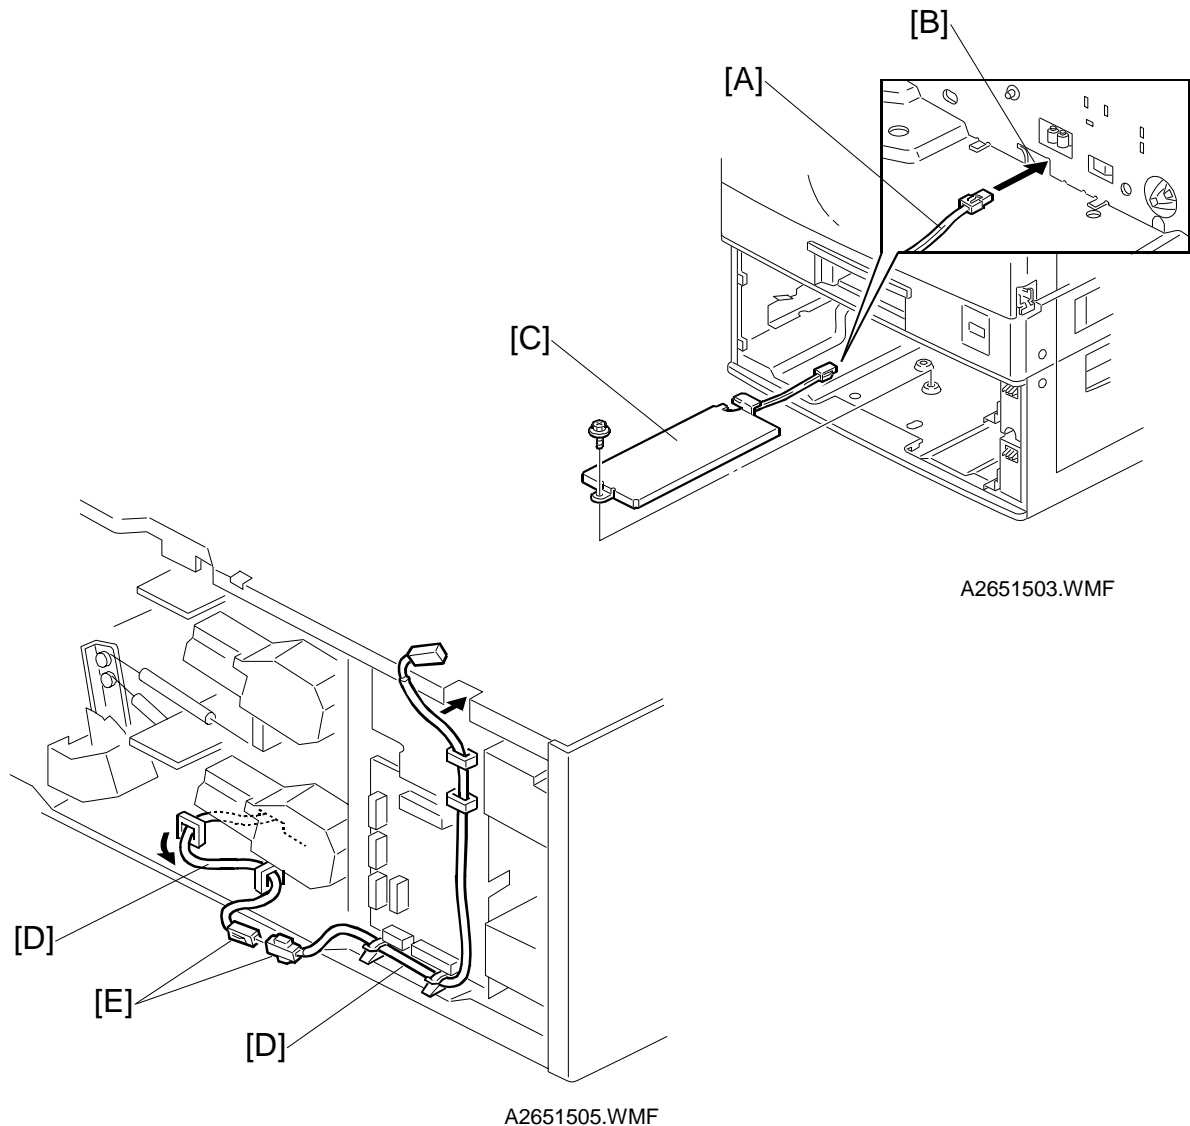
3. The call-outs and installation steps for the optional tray heater should be corrected as follows (P 3-46).

5. Slide out the two paper trays from the optional paper tray unit.
6. Pass the connector [A] through the opening [B].
7. Install the tray heater assembly [C] (1 screw).
8. Clamp the cables [D], as shown.
9. Join the connectors [E].
10. Reinstall the cable guide.
