# Scanner firmware history for the Russian-C1

Model: Russian-C1		Dat	e: 10-Mar-	-00	No.: RA265006	
Subject: Scale and edge of original is scanned (Scanner Option)				Prepared	d by: S. T	omoe
From: Technical	Services Dept., GTS Division					
Classification:	☐ Troubleshooting	☐ Part info	ormat	tion	Action	required
	☐ Mechanical	☐ Electrica	al		☐ Service	ce manual revision
	☐ Paper path	☐ Transm	it/rec	eive	Retrof	fit information
	Other ( )

<b>I</b> ecnn	ıcaı <b>B</b>	ull	etin	PAGE: 1/1
Model: Russian-	C1 (Scanner Option Type 270)	)	Dat	e: 24-Jan-01	No.: RA265021
Subject: Scanne	r controller does not connect to	o a hub		Prepared by: S. 7	Готое
From: Technical	Services Dept., GTS Division				
Classification:	☐ Troubleshooting	☐ Part info	orma	tion	n required
		☐ Electric	al	☐ Servi	ce manual revision
	☐ Paper path	Transm	ıit/rec	eive	fit information

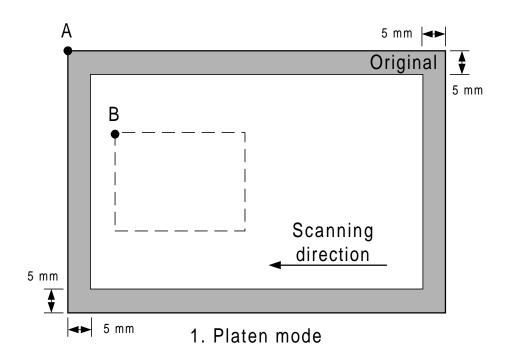
1. When the machine scans an A4 sized original in Platen Mode and the value of SP017 is 5 (illustration 1 below):

Since the scanning start position is at "A", margins will placed at 5 mm from the left and right edges (main scan) as well as from the leading and trailing edges (sub-scan). Any image within 5 mm of the four edges will be erased.

2. When scanning a selected area with the Preview function in Platen Mode and the value of SP017 is 5 (illustration 1):

Since scanning starts from point "B", the 5 mm margin is not applied to the selected area, and nothing in this area is erased along either scan direction.

A new scanner SP mode has been added (SP017, "Trimming") so that the scanning margin can be adjusted. This SP mode was made available with the release of scanner controller firmware version 4.0.0. After installing **this** firmware version, please make sure to perform SP006 to reset the UP and SP settings related to the scanner.

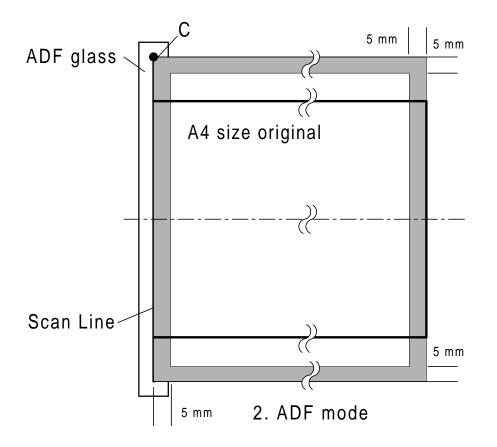
3. When the machine scans an A4 sized original in ADF mode and the value of SP017 is 5 (illustration 2):

In ADF mode, the original is <u>centered along the main scan direction</u>. Although the subscan direction margins are applied to the original (as in example 1), the main scan margins will not appear (left/right edges). This is because the machine applies the 5 mm main scan margin using reference point "C" (where scanning begins), and so the centered A4 original is too narrow for the main scan margin to appear.
