Model: Russian-C2		Date: 24-Oct-01	No.: RB022001
Subject: The fax function does not work		Prepared by: S. Tomoe	
From: Technical Services Dept., GTS Division			
Classification:	<input checked="" type="checkbox"/> Troubleshooting	<input type="checkbox"/> Part information	<input type="checkbox"/> Action required
	<input type="checkbox"/> Mechanical	<input type="checkbox"/> Electrical	<input type="checkbox"/> Service manual revision
	<input type="checkbox"/> Paper path	<input type="checkbox"/> Transmit/receive	<input type="checkbox"/> Retrofit information
	<input type="checkbox"/> Other ()

Model: Russian-C2		Date: 26-Oct-01	No.: RB022002
Subject: Major differences between Russian-C1 and Russian-C2	Prepared by: S. Tomoe		
	From: Technical Services Dept., GTS Division		
Classification:	<input type="checkbox"/> Troubleshooting	<input type="checkbox"/> Part information	<input type="checkbox"/> Action required
	<input type="checkbox"/> Mechanical	<input type="checkbox"/> Electrical	<input type="checkbox"/> Service manual revision
	<input type="checkbox"/> Paper path	<input type="checkbox"/> Transmit/receive	<input type="checkbox"/> Retrofit information
	<input checked="" type="checkbox"/>

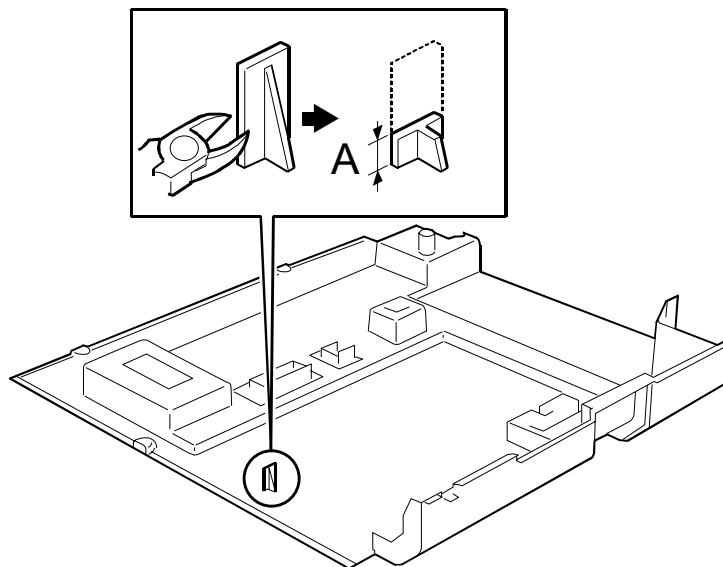
A rib on the Rear Covers produced at the factory in Korea (for machine code: B022-57) contacts the FCU bracket and prevents the cover from being installed.

The manufacturer had used the mold for the Russian-C1 to make the Rear Cover (which normally contains the rib).

A: 0 – 3 mm

Action in the field: When installing the optional fax unit, please cut the rib off as shown in the illustration below.
