SUBJECT: Installation procedure

SUBJECT: SC506

MODEL:3.5K LCT for
F400 series

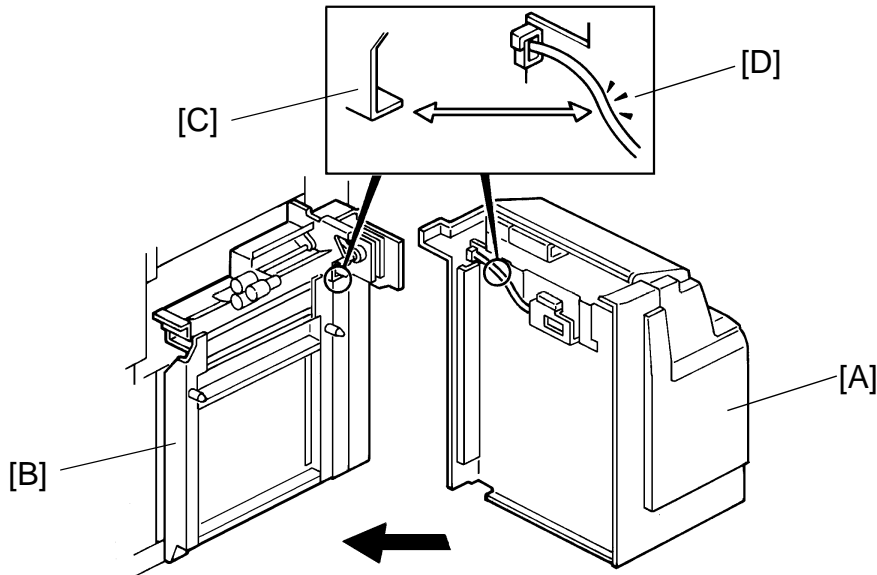
When installing the tray unit [A] to the LCT connector [B], be careful not to pinch the harness between the feed unit bracket [C] and the tray unit bracket [D], as shown.

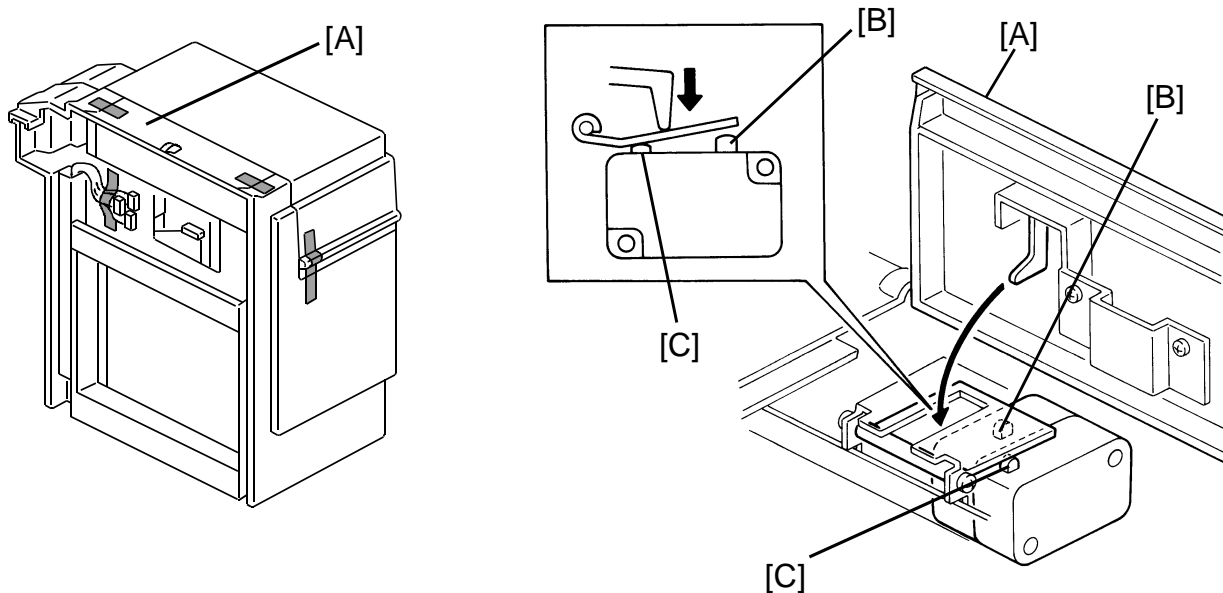
There are two micro switches detecting the 3.5K LCT small cover [A] open condition.

One switch [B] is a safety switch for cutting the power to the motors when the door is opened.

The other switch [C] sends a signal to the copier main control board. This cover open signal is used to indicate the cover open condition on the operation panel and prohibits the copying.

When the cover [A] is opened, both switches should be actuated.

When the door [A] is closed incompletely, it is possible that only the signal switch [C] is actuated. In this case, the operation panel does not indicate the door open condition and the print key is green. If the customer selects the 3.5K LCT and presses the print key, the LCT feed motor does not rotate and SC506 is displayed.

(If only the safety switch [B] is actuated, operation panel indicates the open condition correctly).

1. Instruct the customer to close the small cover then turn off and on the main switch.
2. The shape of the micro switch actuator plate has been changed as shown below so that the actuator plate [A] activates the switches securely. Replace the actuator.
