Technical Bulletin

Model: LCT for F401/411/421			Date: 15-Oct-97		No: 6
Subject: LCT Jam			Prepared by: M.Kitajima		
From: QAC Field	Information Dept.				
Classification:	 Troubleshooting Mechanical Paper path Other () 	Part info Electric	al	Servio	n required ce manual revision fit information

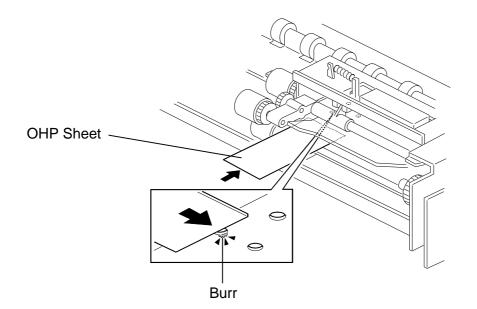
- 1. Constant jams from LCT installation onwards.
- 2. Non-paper feed jams.
- 3. Sometimes there is a crease in the central part of the leading edge of the paper, which results in skewing.

There is a burr in the welded area of the entrance guide plate in the LCT paper feed section.

- 1. Remove the paper feed unit of the LCT.
- 2. Carefully insert a piece of OHP sheet along the entrance guide plate as shown.

3. If the OHP gets scratched, the burr on the entrance guide plate should be filed away in the manner shown.
