Model: SP3		Date: 31-Oct-97	No: 4
Subject: Controller Board ROM Modification		Prepared by: A.Tokoyama	
From: QAC Field Information Dept.			
Classification:	<input type="checkbox"/> Troubleshooting <input checked="" type="checkbox"/> Part information <input type="checkbox"/> Action required <input type="checkbox"/> Mechanical <input type="checkbox"/> Electrical <input type="checkbox"/> Service manual revision <input type="checkbox"/> Paper path <input type="checkbox"/> Transmit/receive <input type="checkbox"/> Retrofit information <input type="checkbox"/> Other ()

Model: SP3		Date: 15-Jan-98	No: 5
Subject: Controller Error		Prepared by: E.Fukuyama	
From: QAC Field Information Dept.			
Classification:	<input checked="" type="checkbox"/> Troubleshooting	<input type="checkbox"/> Part information	<input type="checkbox"/> Action required
	<input type="checkbox"/> Mechanical	<input type="checkbox"/> Electrical	<input type="checkbox"/> Service manual revision
	<input type="checkbox"/> Paper path	<input type="checkbox"/> Transmit/receive	<input type="checkbox"/> Retrofit information
	<input type="checkbox"/> Other ()

Model: NIC Option for SP3		Date: 15-Mar-98	No: 9
Subject: The floppy dis

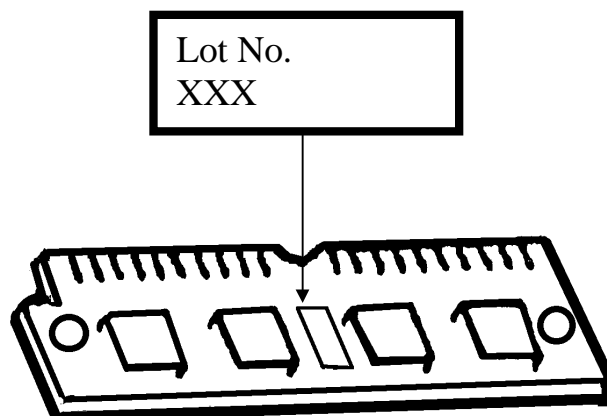
1. At installation, the PS2 board cannot be recognized.
2. New PS software cannot be reprogrammed into the PS2 board, because it is not possible to erase the programmed software before reprogramming it.

1. The program in some PS2 options was damaged due to noise on the cable between the PC and the checker in the factory which downloads the software.
2. The PS2 option uses flash ROMs from two vendors (Fujitsu and AMD). The AMD chips were used for the December production in 1997 and January production in 1998. These chips cannot be erased before programming new software.

- A. Stocked PS2 options in the warehouse
Please replace them with new ones and send back the old ones.
- B. PS2 options in the field
 1. When the PS2 board cannot be recognized after installing it, please replace it with a new one.
(Note) Before replacing it, please reinstall again and confirm that it can be recognized.
 2. Please replace all boards with the lot no. of 7Zxxx and 81xxx with new ones.
The lot no. is shown on the carton or on the label on the board as shown below.
