Technical Bulletin

Model: Finisher for the AD3			Date	e: 31-July-97	No: 1
Subject: ROM modification for Main Control Board				Prepared by: E.	Fukuyama
From: QAC 2nd I	Field Information Dept.				
Classification:	☐ Troubleshooting	☐ Part informat		tion	n required
	☐ Mechanical	☐ Electric	al	☐ Serv	ice manual revision
	☐ Paper path	☐ Transmit/rec		eive	ofit information
	Other ()

Model: Finisher for the AD3		Date: 30-Sep-97		97	No: 18	
Subject: SC101				Prepared by: E.Fukuyama		
From: QAC 2nd Field Information Dept.						
Classification:	☐ Troubleshooting	Part informat		_		•
	☐ Mechanical	Electrical		☐ Service r		ce manual revision
	☐ Paper path	☐ Transmit/rec		ceive Retrot		fit information
	Other ()

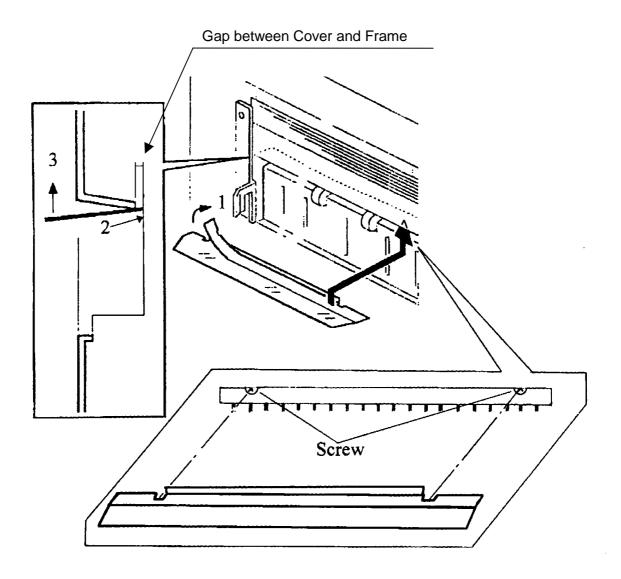
Entrance Guide Installation Procedure

If the Entrance Guide is not installed in the proper position, a gap may develop between the Cover and the Main Frame through which the heat and humidity generated by the paper may enter and lead to high temperature/high humidity around the lamp stabilizer.

New Entrance Guide

In the event of an SC101 on a Finisher manufactured before April 1997, please replace the Entrance Guide with part number A6122333.

- 1. Peel off the tape seal for the Entrance Guide
- 2. Place the Entrance Guide on the Main Frame.
- 3. Attach the Entrance Guide to the Cover
