Model: Bellini		Date: 30-May-00	No.: RA294014
Subject: Finisher ROM History		Prepared by: H.K.	
From: Technical Services Dept., GTS Division			
Classification:	<input type="checkbox"/> Troubleshooting	<input checked="" type="checkbox"/> Part information	<input type="checkbox"/> Action required
	<input type="checkbox"/> Mechanical	<input type="checkbox"/> Electrical	<input type="checkbox"/> Service manual revision
	<input type="checkbox"/> Paper path	<input type="checkbox"/> Transmit/receive	<input type="checkbox"/> Retrofit information
	<input type="checkbox"/> Other (      )

Model: Bellini		Date: 26-Jun-00	No.: RA294021
Subject: Finisher - Punch Waste Full Condition		Prepared by: H.K.	
From: Technical Services Dept., GTS Division			
Classification:	<input type="checkbox"/> Troubleshooting	<input type="checkbox"/> Part information	<input type="checkbox"/> Action required
	<input type="checkbox"/> Mechanical	<input type="checkbox"/> Electrical	<input checked="" type="checkbox"/> Service manual revision
	<input type="checkbox"/> Paper path	<input type="checkbox"/> Transmit/receive	<input type="checkbox"/> Retrofit information
	<input type="checkbox"/> Other ( )

Model: Bellini	Date:

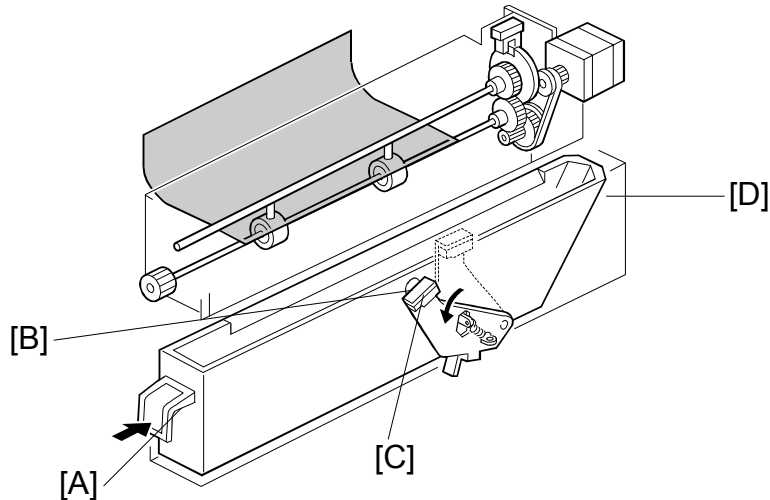
B302D002.WMF

The punch waste is collected in the punch waste hopper [A], which is under the punch unit.

*When the punch waste covers the hole [B] in the hopper, the punch waste hopper sensor [C] turns on and a message will be displayed after the copy job finishes.*

*When the punch waste covers the hole [B] in the hopper, the punch waste hopper sensor [C] turns on and a message will be displayed in the operation panel LCD. Then, the copy job will be stopped. After emptying the punch waste and returning the punch waste hopper [A] to the finisher, the copy job will be resumed.*

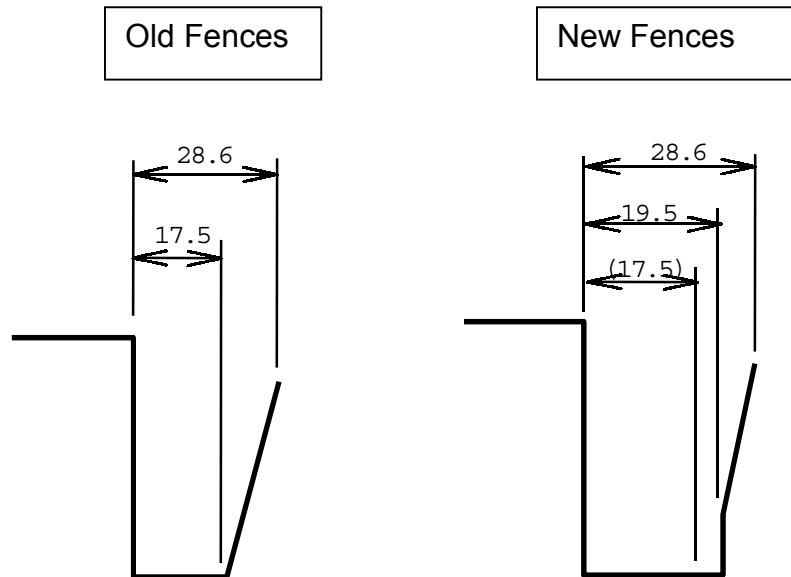
The widths of the positioning fences (front, middle and rear) have been increased as shown below.

Note 1: When replacing either of the old fences in the field, install all three new parts as a set.

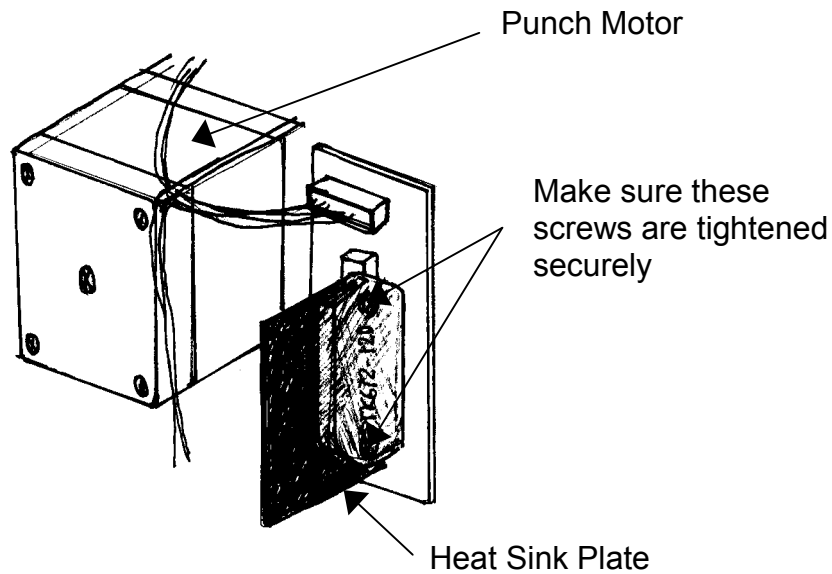
1. Electrical noise generated by the drive motor affects the initial check routine of the punch drive board firmware, so that the motor reset signal is constantly sent out. The only units on which the symptom may occur are the USA two-punch-hole and European fourpunch-hole units.
2. The two screws securing the heat resistor to the IC on the punch drive board come loose. As a result, the temperature of the IC becomes too high.

3-1 Please check the two heat resistor screws when visiting the machine site and tighten them if they are loose.
