Model: Martini-C1	Date: 13-Sep-02	No.: RB064002
-------------------	-----------------	---------------

Subject: Jogger Fence Adjustment		Prepared by: Y.Urushihara	
From: 1st Tech. Support Sec. Service Support Dept.			
Classification:	<input type="checkbox"/> Troubleshooting	<input type="checkbox"/> Part information	<input type="checkbox"/> Action required
	<input type="checkbox"/> Mechanical	<input type="checkbox"/> Electrical	<input checked="" type="checkbox"/> Service manual revision
	<input type="checkbox"/> Paper path	<input type="checkbox"/> Transmit/receive	<input type="checkbox"/> Retrofit information
	<input type="checkbox"/> Other ()

Model: Martini-C1		Date: 4-Oct-02	No.: RB064005
Subject: Finisher screw detaches from slide rail bracket		Prepared by: K. Miura	
From: Technical Services sec. Service Planning Dept.			
Classification:	<input checked="" type="checkbox"/> Troubleshooting	<input type="checkbox"/> Part information	<input type="checkbox"/> Action required
	<input type="checkbox"/> Mechanical	<input type="checkbox"/> Electrical	<input type="checkbox"/> Service manual revision
	<input type="checkbox"/> Paper path	<input type="checkbox"/> Transmit/receive	<input type

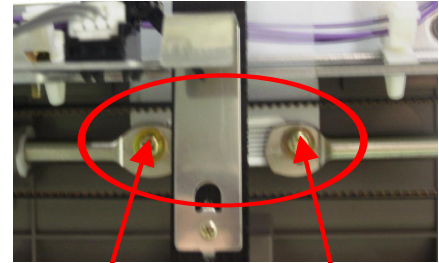
Left edge height + Right edge height = **0.5mm or less.**

8. Adjust the **rear** jogger shaft position until the top edge of the upper stay and upper edge of the board are parallel to one another.

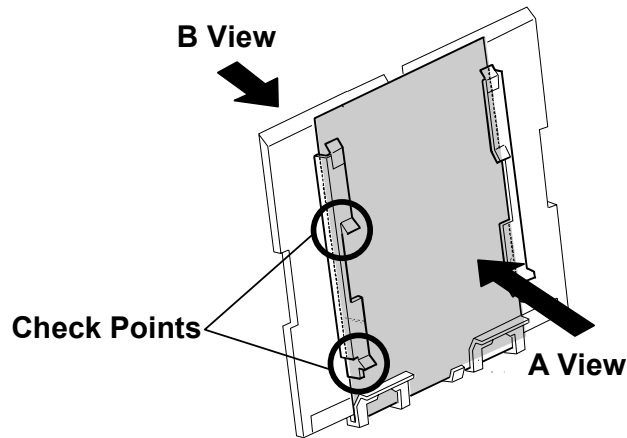
Board/fence gap (top + bottom) = **0 - 0.5mm**.

10. Bring the **front** jogger fence flush against the edge of the board, then adjust the front fence shaft until the board/fence gaps on both sides are:

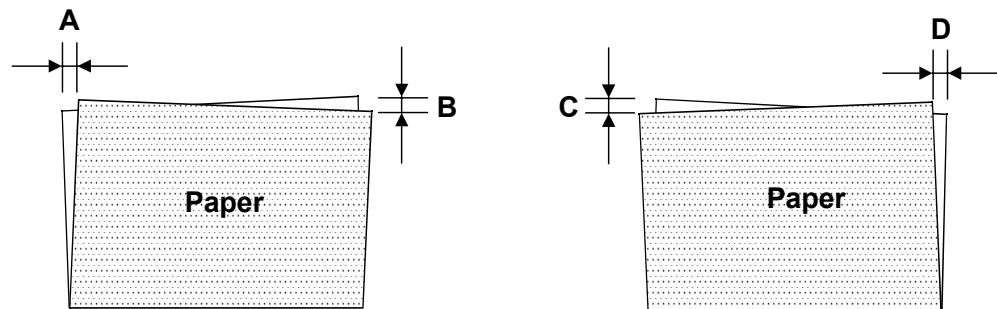
13.WMF

All distances shown below (A, B, C, D): **2mm or less**.

Note: As mentioned on pg. 1, measure this from the edges of the **innermost sheet**.

13. If A, B, C or D is **over 2mm**, perform the following.

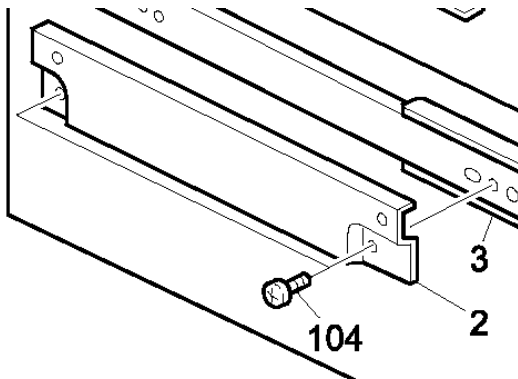
The screw shown below (Frame section 20, P/N #04533006B, pg. 45 #104) comes loose and detaches from the slide rail bracket.

Vibration during transport.

As a permanent solution, the screws have been equipped with spring-washers. As a temporary solution in the field, please perform the procedure below.
