SUBJECT: MATT20 (A374) TROUBLESHOOTING GUIDE

FROM: Copier Technical Support Section

To aid the technician in troubleshooting matt20 misfeeds we are issuing this troubleshooting guide. If the guide is used properly it will resolve the majority of misfeeding problems the field is experiencing.

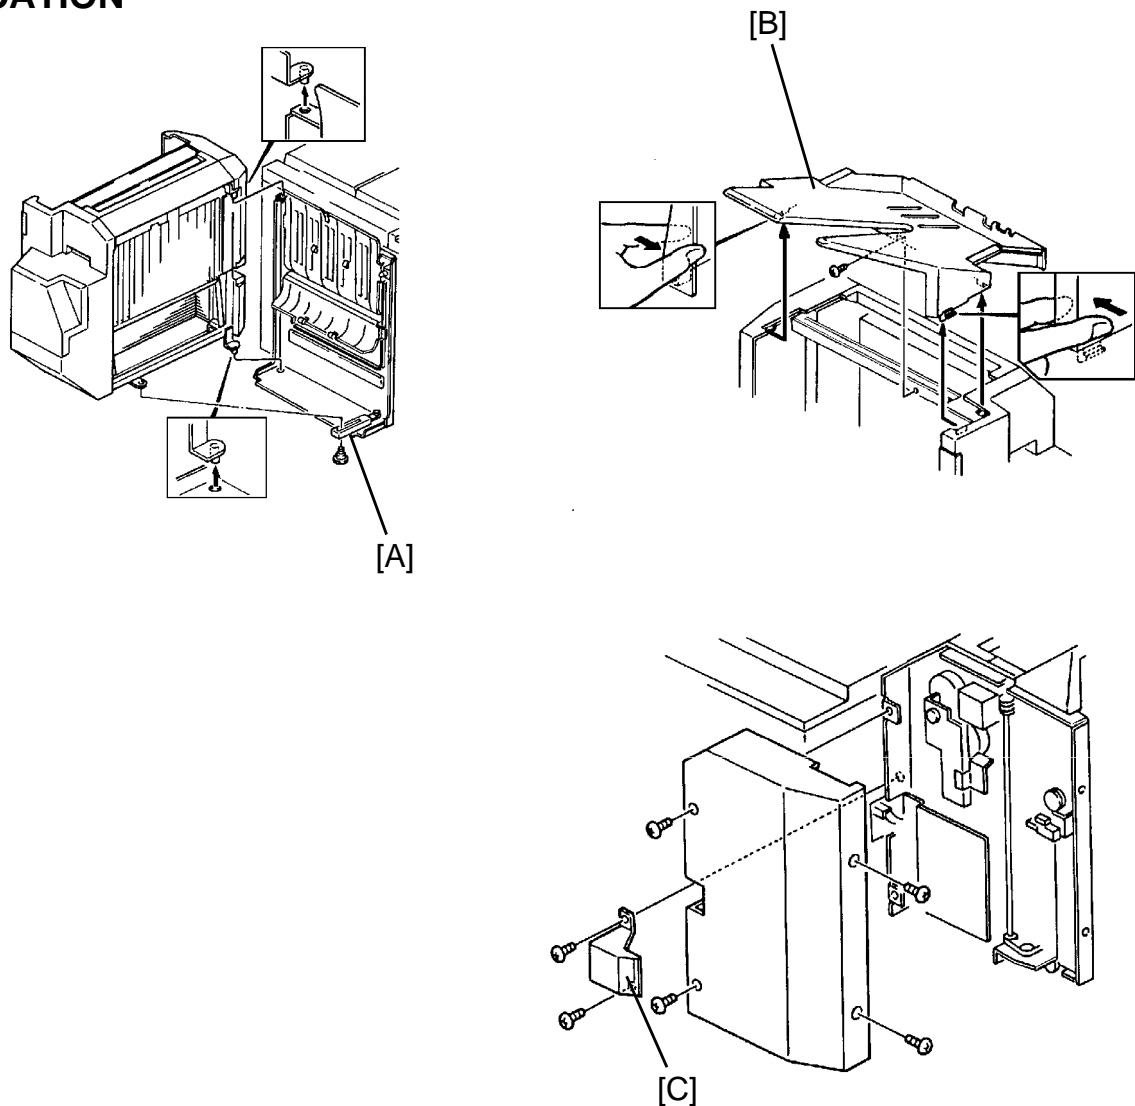
LUBRICATION

The load of the roller drive motor is excessive when the roller shafts and bushing became dirty, the friction between the roller shafts and bushings exceeds the roller drive motor torque.

To reduce the load to the roller drive motor, lubricate as follows at every PM:

1. Open the sorter stapler then disconnect the link lever [A] (1 stepped screw).
2. Disconnect the sorter stapler interface harnesses and a grounding wire (1 screw).
3. Remove the sorter stapler from the mounting frame.
4. Remove the proof tray [B] (1 screw).
5. Remove the rear covers [C] (6 screws).

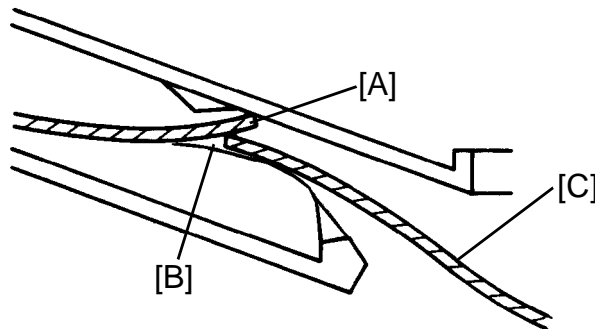
The copy's trailing edge [A] remains on the guide mylar [B]. When the following paper [C] comes to the bin, it hits the trailing edge of the proceeding paper, resulting in the paper jam, or incorrect copy order when the following paper goes underneath the proceeding paper.

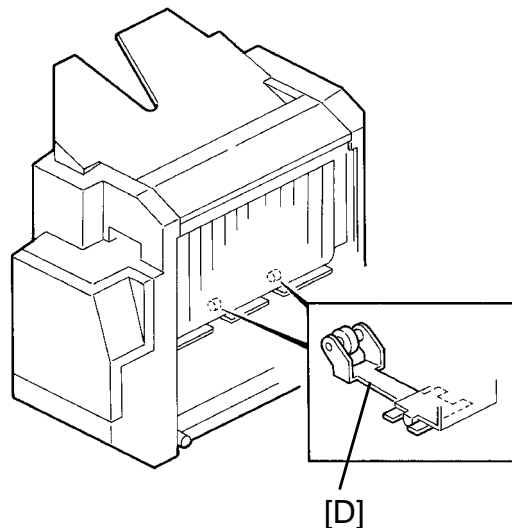
The technician bent the lower bin exit roller holder (spring plate) (P/N : A3742163) [D], trying to correct the normal paper skew when the paper exits into the bins. This reduces the paper transport ability causing bin jams.

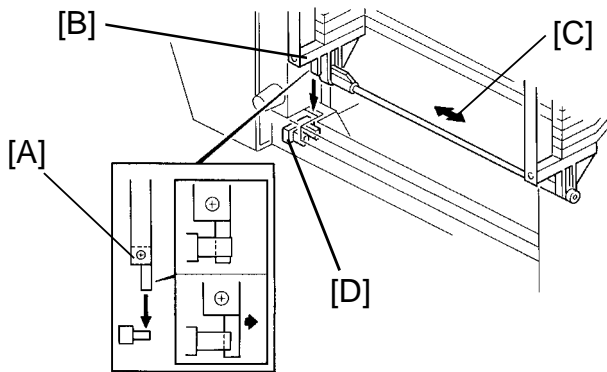
Due to gap between the projection [A] of the bin support block [B] and the side frame, the block can move in the arrow [C] direction. If the block moves away from the bin home position sensor [D] when the sensor should be actuated, the bin will not stop at the correct home position. In this case a paper jam occurs at the bin entrance.

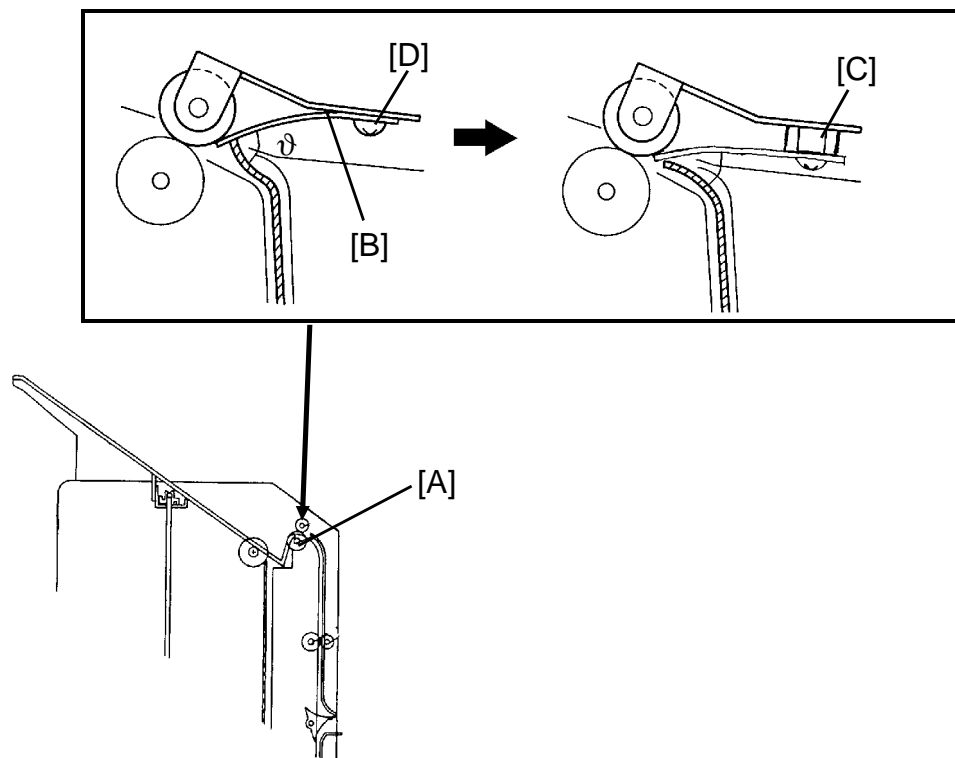
A hexagon nut (07100050B) [C] has been inserted between the plate spring [D] and the exit roller guide, so that the angle θ between the guide and paper has been reduced. Due to this modification, the length of the screw [D] fixing the plate spring has been changed from 6 mm to 8 mm. This modification has been applied from the March '94 production.

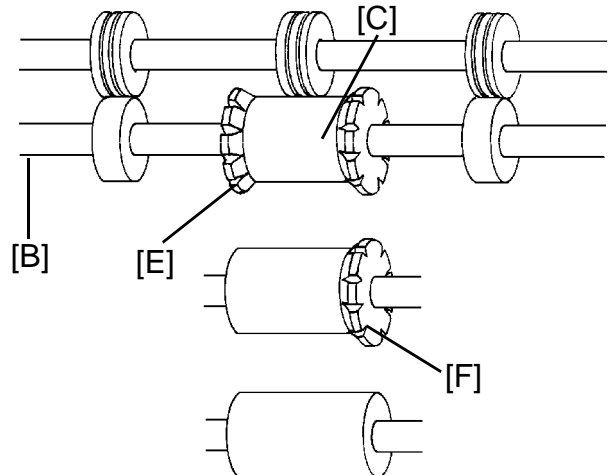
The rear side wave position may not be proper for one of the ribs on the sorter stapler vertical paper guide [D] especially when paper has excessive face curl. The rib may make a mark on the paper lead edge or may cause paper jams.

1. Cut off the rear flange [E] with cutting pliers and smooth the roller's edge with a knife. This will eliminate the rear side wave on paper.
(As the flanges have wedge grooves originally and the roller is turning in forwarding direction, the roller surface does not have to be completely smooth after you cut off the flange.)
2. If step 1 does not cure the problem, cut off the front flange [F] as well.
(Paper transport reliability without flanges on the roller was tested for thin paper under high humidity condition, resulting in no problem.)

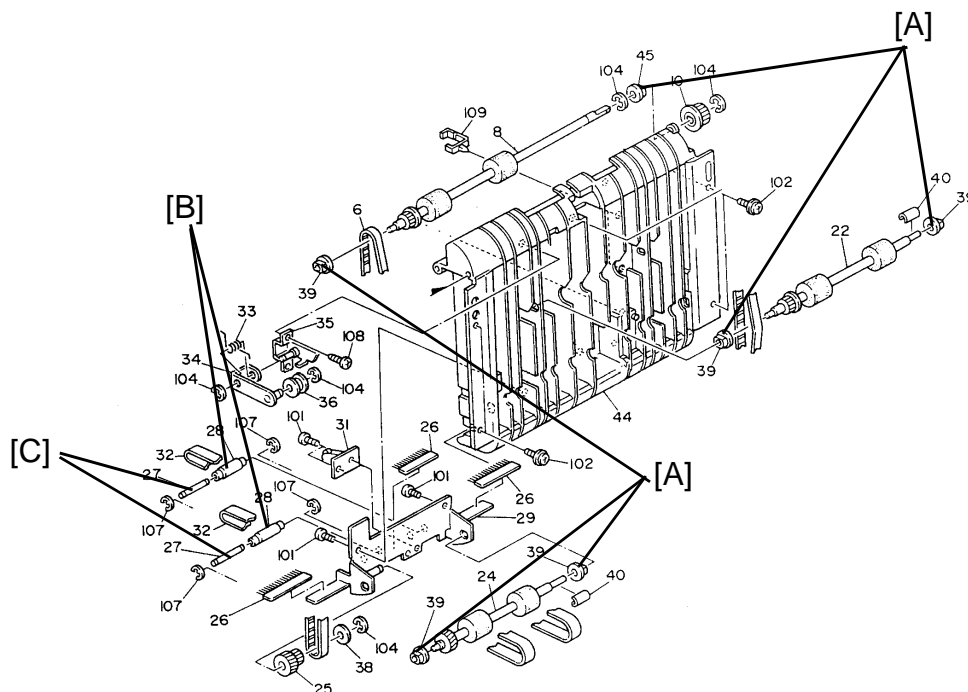
- 1) Between the bushings [A] and shafts
- 2) Between the exit rollers [B] and the shafts [C]

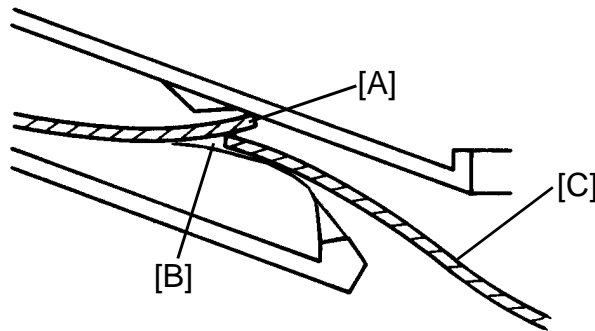
The copy's trailing edge [A] remains on the guide mylar [B]. When the following paper [C] comes to the bin, it hits the trailing edge of the proceeding paper, resulting in the paper jam, or incorrect copy order when the following paper goes underneath the proceeding paper.

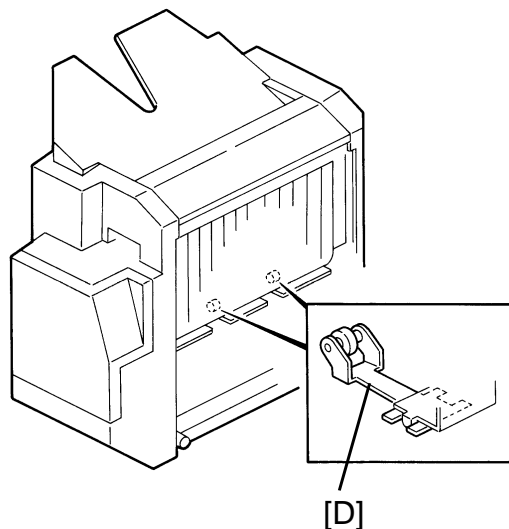
The technician bent the lower bin exit roller holder (spring plate) (P/N : A3742163) [D], trying to correct the normal paper skew when the paper exits into the bins. This reduces the paper transport ability causing bin jams.

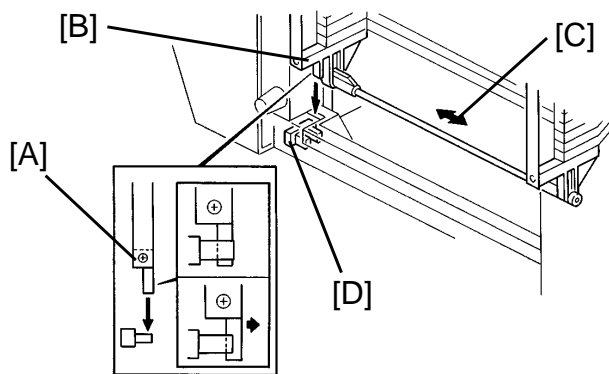
Due to gap between the projection [A] of the bin support block [B] and the side frame, the block can move in the arrow [C] direction. If the block moves away from the bin home position sensor [D] when the sensor should be actuated, the bin will not stop at the correct home position. In this case a paper jam occurs at the bin entrance.

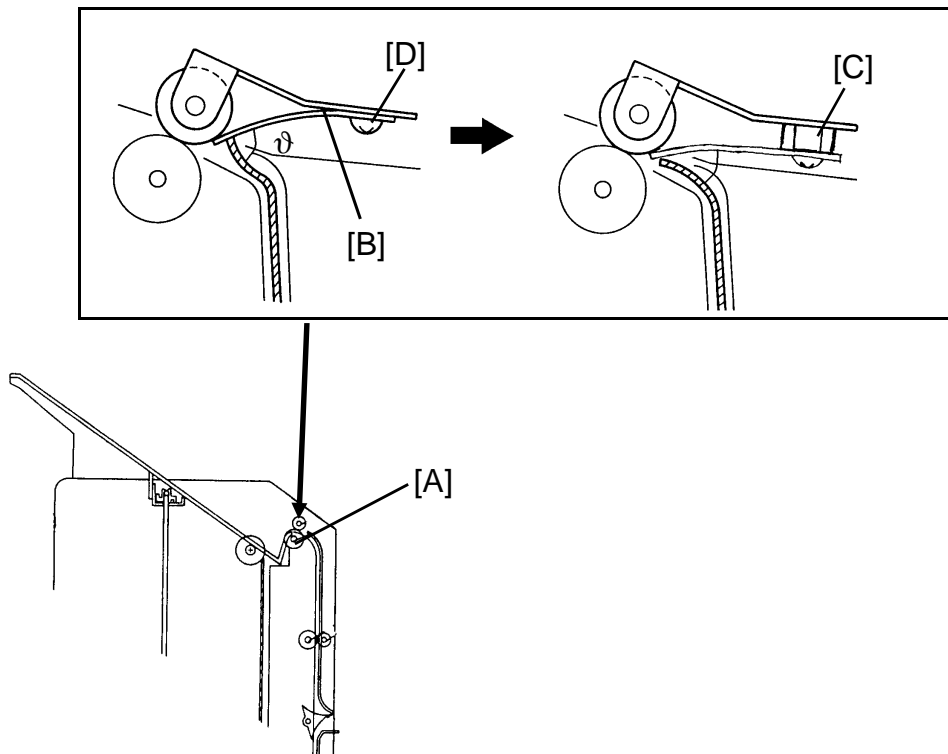
A hexagon nut (07100050B) [C] has been inserted between the plate spring [D] and the exit roller guide, so that the angle θ between the guide and paper has been reduced. Due to this modification, the length of the screw [D] fixing the plate spring has been changed from 6 mm to 8 mm. This modification has been applied from the March '94 production.

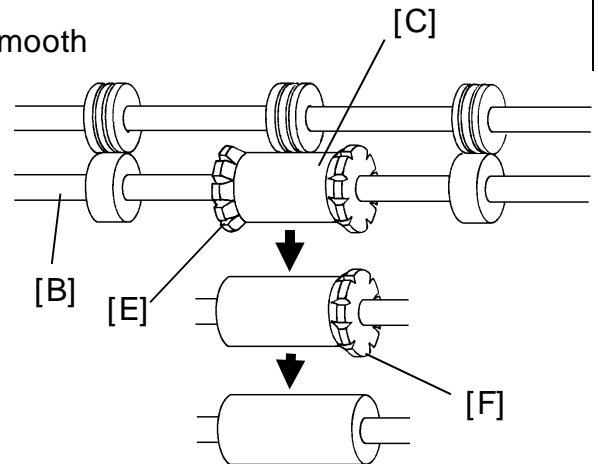
The rear side wave position may not be proper for one of the ribs on the sorter stapler vertical paper guide [D] especially when paper has excessive face curl. The rib may make a mark on the paper lead edge or may cause paper jams.

1. Cut off the rear flange [E] with cutting pliers and smooth the roller's edge with a knife. This will eliminate the rear side wave on paper.
(As the flanges have wedge grooves originally and the roller is turning in forwarding direction, the roller surface does not have to be completely smooth after you cut off the flange.)
2. If step 1 does not cure the problem, cut off the front flange [F] as well.
(Paper transport reliability without flanges on the roller was tested for thin paper under high humidity condition, resulting in no problem.)

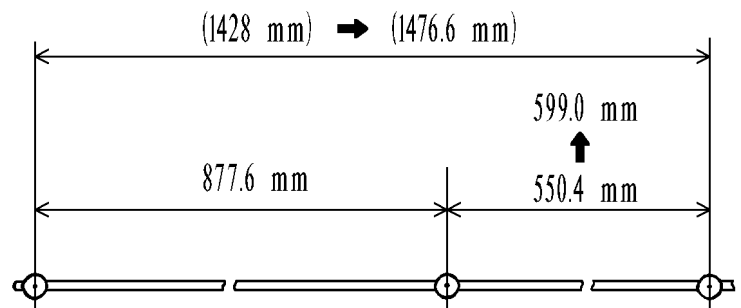
[Figure 1]

The bin lift wire may loosen on the wire pulley during transportation. When the wire pulley is driven from the home position under this condition, the wire may be wound up wrongly as shown in the figure 1. This will change the bin stop positions, resulting in paper jams.

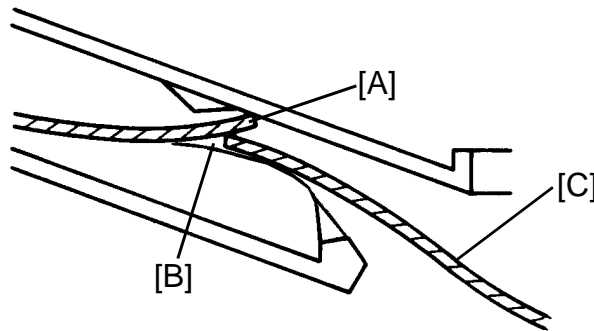
The copy's trailing edge [A] remains on the guide mylar [B]. When the following paper [C] comes to the bin, it hits the trailing edge of the proceeding paper, resulting in the paper jam, or incorrect copy order when the following paper goes underneath the proceeding paper.

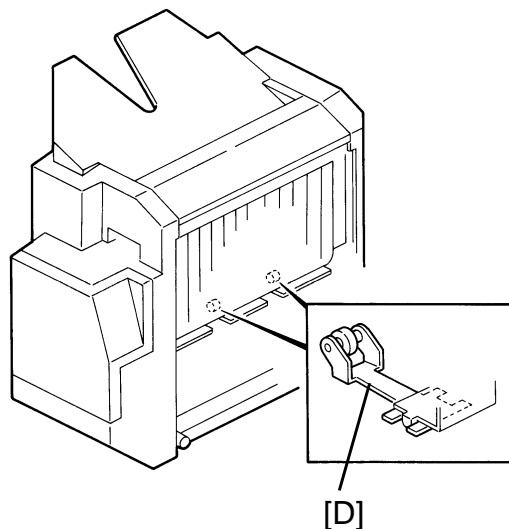
The technician bent the lower bin exit roller holder (spring plate) (P/N : A3742163) [D], trying to correct the normal paper skew when the paper exits into the bins. This reduces the paper transport ability causing bin jams.

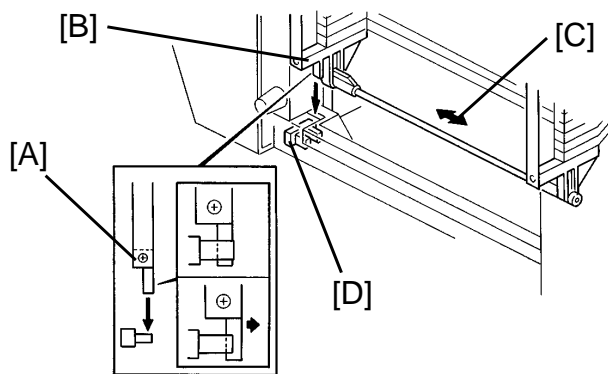
Due to gap between the projection [A] of the bin support block [B] and the side frame, the block can move in the arrow [C] direction. If the block moves away from the bin home position sensor [D] when the sensor should be actuated, the bin will not stop at the correct home position. In this case a paper jam occurs at the bin entrance.

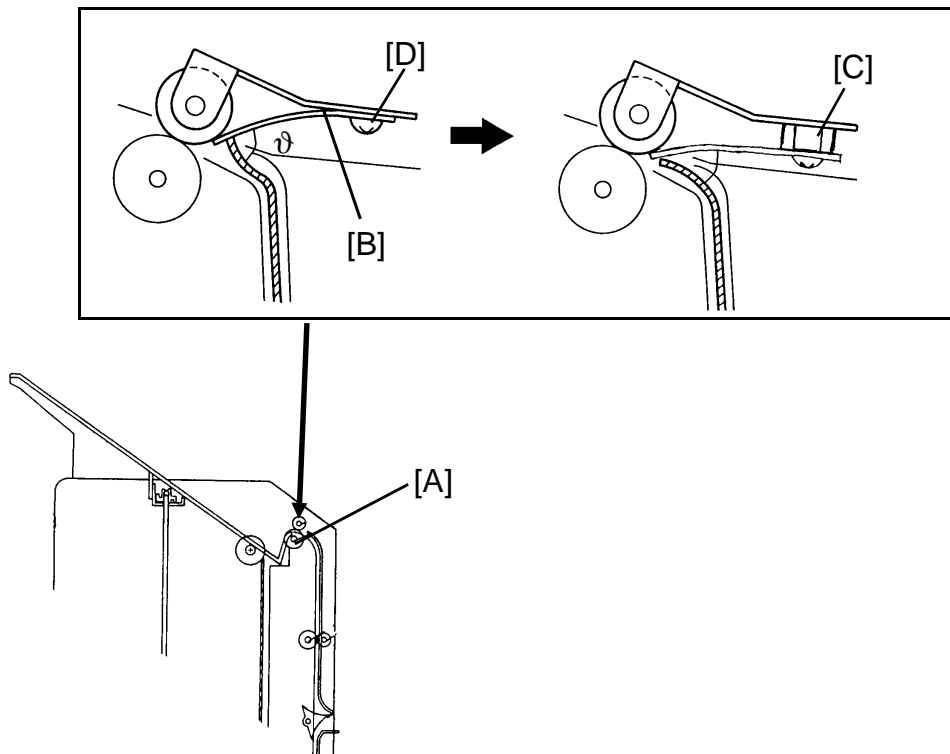
A hexagon nut (07100050B) [C] has been inserted between the plate spring [D] and the exit roller guide, so that the angle θ between the guide and paper has been reduced. Due to this modification, the length of the screw [D] fixing the plate spring has been changed from 6 mm to 8 mm. This modification has been applied from the March '94 production.

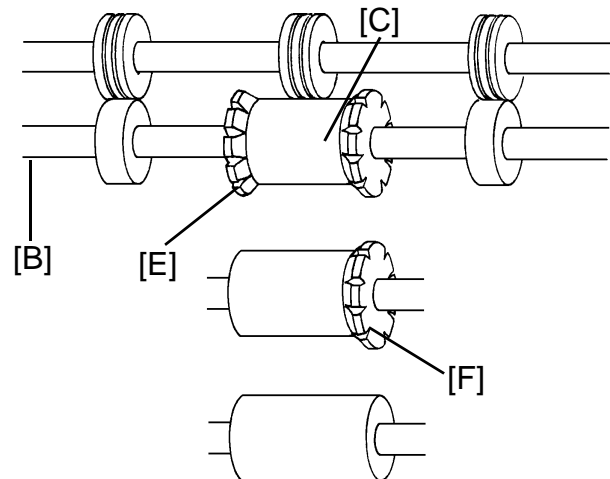
The rear side wave position may not be proper for one of the ribs on the sorter stapler vertical paper guide [D] especially when paper has excessive face curl. The rib may make a mark on the paper lead edge or may cause paper jams.

1. Cut off the rear flange [E] with cutting pliers and smooth the roller's edge with a knife. This will eliminate the rear side wave on paper.
(As the flanges have wedge grooves originally and the roller is turning in forwarding direction, the roller surface does not have to be completely smooth after you cut off the flange.)
2. If step 1 does not cure the problem, cut off the front flange [F] as well.
(Paper transport reliability without flanges on the roller was tested for thin paper under high humidity condition, resulting in no problem.)

paper transport ability. The part number of the vertical paper guide will remain as it is. This modification will be applied to the production machines from April, 1993.

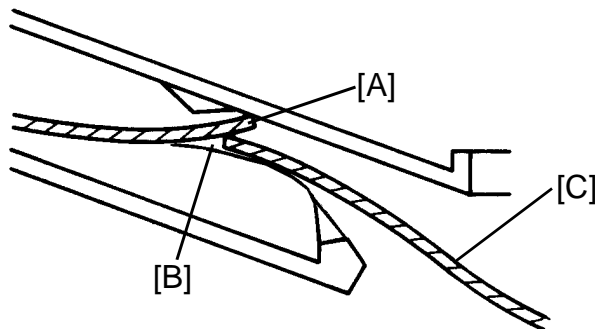
The copy's trailing edge [A] remains on the guide mylar [B]. When the following paper [C] comes to the bin, it hits the trailing edge of the proceeding paper, resulting in the paper jam, or incorrect copy order when the following paper goes underneath the proceeding paper.

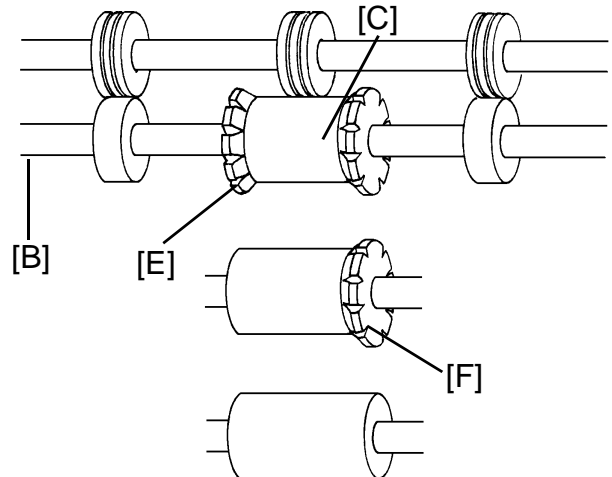
The rear side wave position may not be proper for one of the ribs on the sorter stapler vertical paper guide [D] especially when paper has excessive face curl. The rib may make a mark on the paper lead edge or may cause paper jams.

1. Cut off the rear flange [E] with cutting pliers and smooth the roller's edge with a knife. This will eliminate the rear side wave on paper.
(As the flanges have wedge grooves originally and the roller is turning in forwarding direction, the roller surface does not have to be completely smooth after you cut off the flange.)
2. If step 1 does not cure the problem, cut off the front flange [F] as well.
(Paper transport reliability without flanges on the roller was tested for thin paper under high humidity condition, resulting in no problem.)
