Model: Model K-P1		Date: 18-Jan-01	No.: RG058001
Subject: Printer Controller Firmware History		Prepared by: K. Misugi	
From: Technical Services Dept., GTS Division			
Classification:	<input type="checkbox"/> Troubleshooting	<input type="checkbox"/> Part information	<input checked="" type="checkbox"/> Action required
	<input type="checkbox"/> Mechanical	<input type="checkbox"/> Electrical	<input type="checkbox"/> Service manual revision
	<input type="checkbox"/> Paper path	<input type="checkbox"/> Transmit/receive	<input type="checkbox"/> Retrofit information
	<input type="checkbox"/> Other (        )

Model: Model K-P1		Date: 03-Apr-01	No.: RG058002
Subject: Printer Engine Firmware History		Prepared by: K. Misugi	
From: Technical Services Dept., GTS Division			
Classification:	<input type="checkbox"/> Troubleshooting	<input type="checkbox"/> Part information	<input type="checkbox"/> Action required
	<input type="checkbox"/> Mechanical	<input type="checkbox"/> Electrical	<input type="checkbox"/> Service manual revision
	<input type="checkbox"/> Paper path	<input type="checkbox"/> Transmit/receive	<input type="checkbox"/> Retrofit information
	<input checked="" type="checkbox"/> Othe

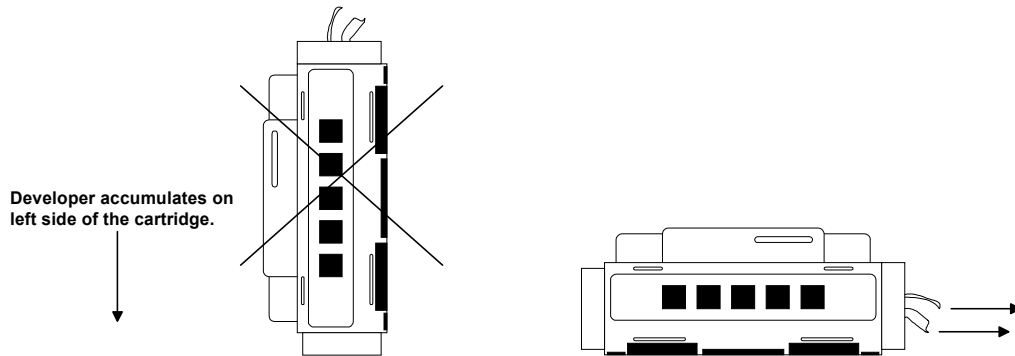
The developer will shift to the left side if the cartridge is tilted as shown below when the sealing tapes are being removed. This causes toner to be over-supplied on the right side of the cartridge, which in turn causes the dirty background on the right side of the printout.

When removing the tape, place the machine on a level surface.

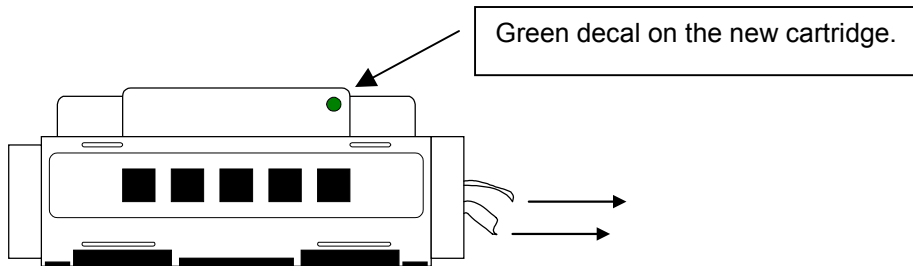
The cartridge has been modified from June production so that dirty background will not occur at installation even when the cartridge is tilted.

A green decal is added so the new cartridge can be distinguished from the old type. The same decal is also placed on the supply cartridge, next to the bar-code label on the box.

- Place the cartridge on a level surface when removing the sealing tapes on the cartridge.
  - Remove the sealing tapes on the cartridge before turning on the main switch.
  - Once the seals have been removed, do not shake the cartridge.
- Note:** This only applies to cartridge installation and replacement.

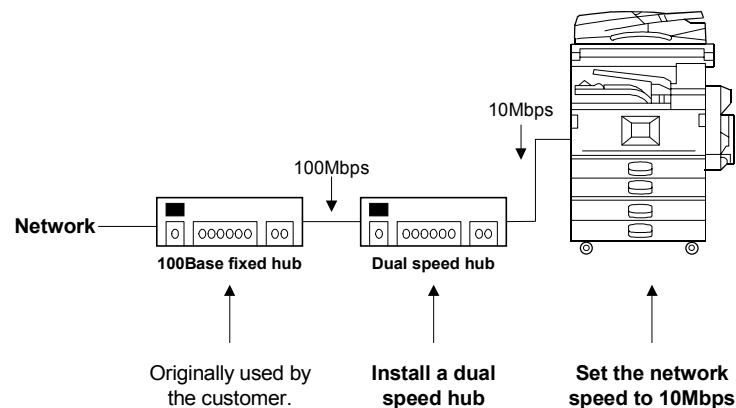
When the data is transferred at 100Mbps, depending on network conditions, the controller ASIC is not able to receive all data packets and a retry procedure occurs. As a result, print jobs from a Macintosh take a long time to print out.

- a) Set the network (ethernet) speed of the machine to 10Mbps.  
The default setting of the machine is "Auto." This setting can be changed in the "Network Setup" in the user mode "Host Interface" ("Interface Settings" in the "System Settings" for the Model A-C2).
- b) Install a dual speed hub between the 100Base fixed hub and the machine.

An interface board (GW-MAC) and a DIMM which contains firmware to drive the board will be supplied for attachment to the controller board. With these parts, the machine will work without installing a dual speed hub.

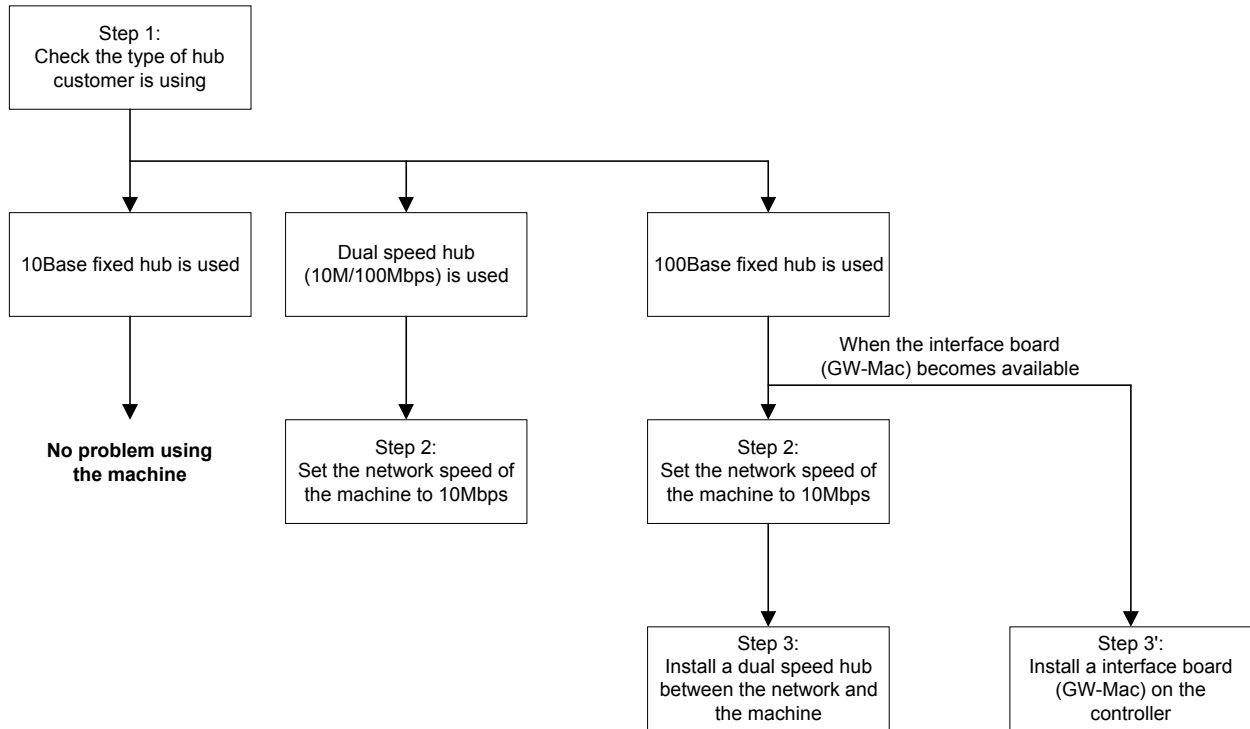
**Flow Chart:**

When machines are being connected to Macintosh with PowerPC G3/G4 processors with Apple Talk, check the type of hub being used and follow the steps explained below.

- 1) Check what type of hub the customer is using.  
If the customer is using a dual speed (10M/100Mbps) hub, go to step 2.  
If the customer is using a 100Base fixed (100Mbps only) hub, go to step 3.
- 2) For the customer using a dual speed hub:  
Set the network (ethernet) speed of the machine to 10Mbps.  
The default setting of the machine is "Auto." This setting can be changed in the "Network Setup" in the user mode "Host Interface" ("Interface Settings" in the "System Settings" for the Model A-C2).
